National Transportation Safety Board

Marine Accident Brief

Flooding and Sinking of Fishing Vessel *Lady Damaris*

Accident no.	DCA17FM019
Vessel name	<i>Lady Damaris</i>
Accident type	Flooding
Location	Gulf of Mexico, about 32 miles* southeast of Galveston, Texas 28° 52.72' N, 094° 24.78' W
Date	June 22, 2017
Time	About 1140 central daylight time (coordinated universal time – 5 hours)
Injuries	None reported
Property damage	\$210,000 est.
Environmental damage	About 5,000 gallons of diesel fuel and lube oil resulting in oil sheen on water
Weather	Tropical storm Cindy, overcast, visibility 8 miles; winds southwest at 18 knots gusting to 24 knots, seas about 6 ft, air temperature 79°F
Waterway information	Open waters of the Gulf of Mexico; water depth about 70 feet at accident site

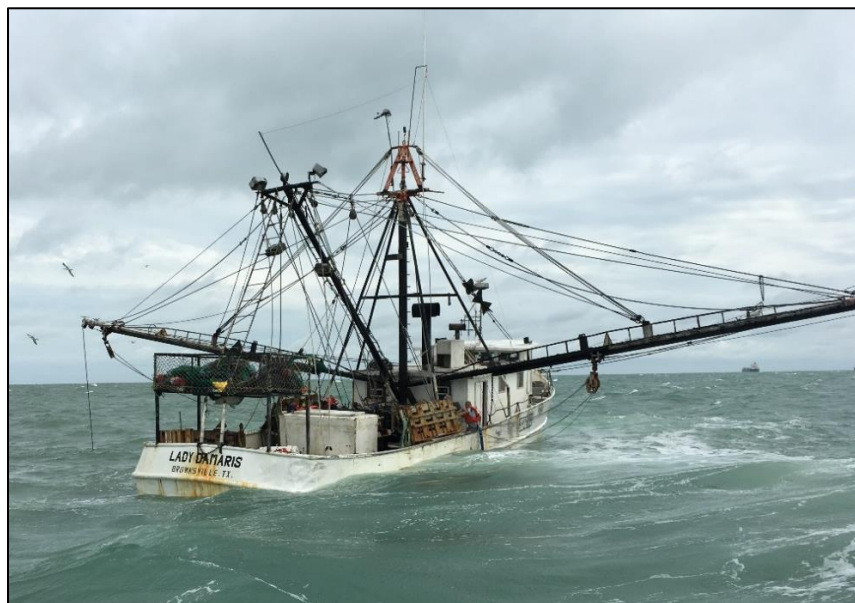
About 0903 on June 22, the *Lady Damaris* was approximately 32 miles southeast of Galveston and its engine compartment was flooded about 30 percent. Unable to stop the flooding, the crew broadcast a distress call over VHF radio. Coast Guard Sector Galveston responded by dispatching a helicopter from Air Station Houston and small boat from Station Galveston to proceed to the scene. A Good Samaritan vessel, the offshore supply vessel *Ajax*, had also heard the distress call while transiting the area. The *Ajax* proceeded to the trawler's location, arriving at 0914, and stopped to render assistance and relay communications to the Coast Guard. About 0925, with water in the engine room above the main engine, generator, and alternator, the vessel lost propulsion, electrical power, and the last working bilge pump.

Lady Damaris about 1049 on morning of accident. (Photo by Coast Guard)

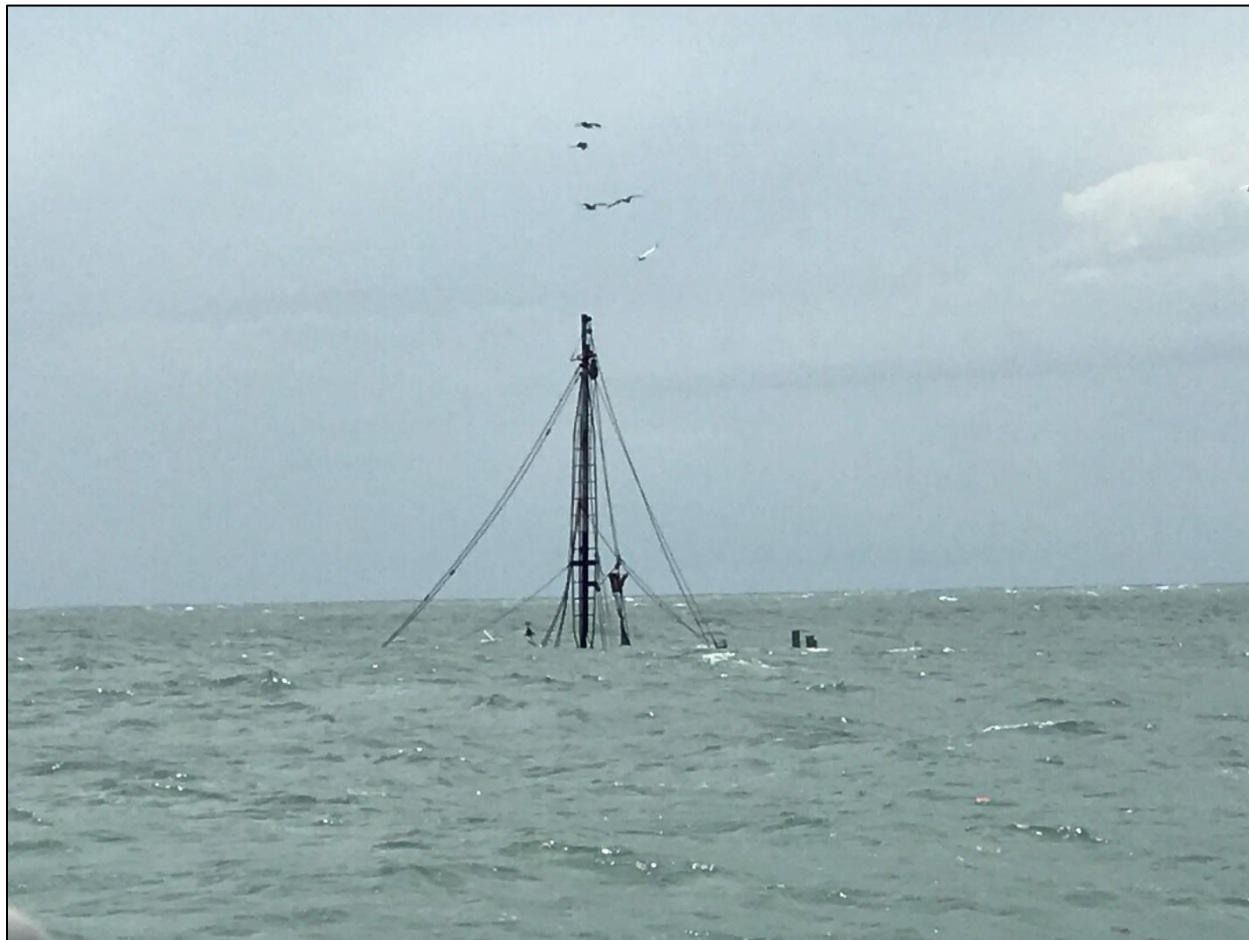
About 15 minutes after the transfer, the *Lady Damaris* rolled on its starboard side and sank. A large fuel slick developed over the sinking location. *CG 45630* transported the trawler's crew back to Station Galveston. The *Lady Damaris* was not salvaged.

Portside outrigger of sunken *Lady Damaris* about 1206 on day of accident. (Photo by Coast Guard)
