# National Transportation Safety Board

## Marine Accident Brief

### Flooding and Sinking of Towing Vessel *Savage Ingenuity*

<b>Accident no.</b>	DCA17FM026
<b>Vessel name</b>	<i>Savage Ingenuity</i>
<b>Accident type</b>	Flooding
<b>Location</b>	Gulf Intracoastal Waterway near mile marker 245, Sulphur, Louisiana 30°3.56' N, 093°22.43' W
<b>Date</b>	September 5, 2017
<b>Time</b>	About 0035 central daylight time (coordinated universal time – 5 hours)
<b>Injuries</b>	None
<b>Property damage</b>	\$1.35 million est.
<b>Environmental damage</b>	Approximately 11,800 gallons of diesel oil released, about 200 gallons recovered
<b>Weather</b>	Visibility 10 miles, winds calm, seas calm, air temperature 75°F
<b>Waterway information</b>	The Gulf Intracoastal Waterway is a toll-free canal that extends from Caloosahatchee, Florida, to Brownsville, Texas. The waterway has a controlling depth of 12 feet and a width of approximately 610 feet at the site of the accident.

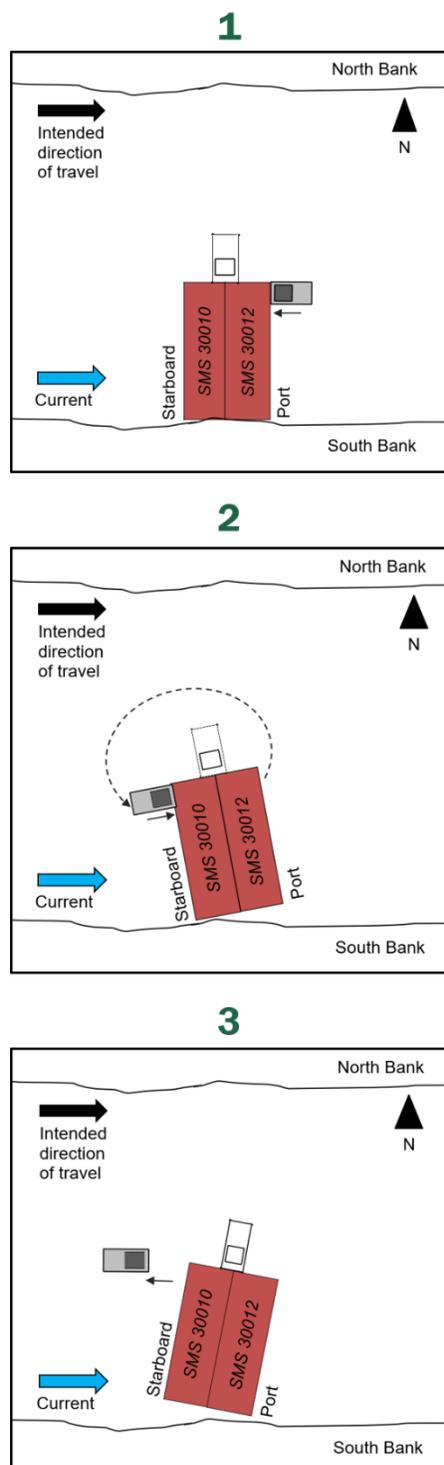
**Sequence of movements by *Alfred P Cenac III* (gray vessel), as described by pilot: (1) initial pushing position; (2) relocation to starboard side of tow following *Savage Ingenuity's* list to starboard and loss of power to engines; and (3) approximate final positions after sinking of *Savage Ingenuity*. Vessels not drawn to scale.**

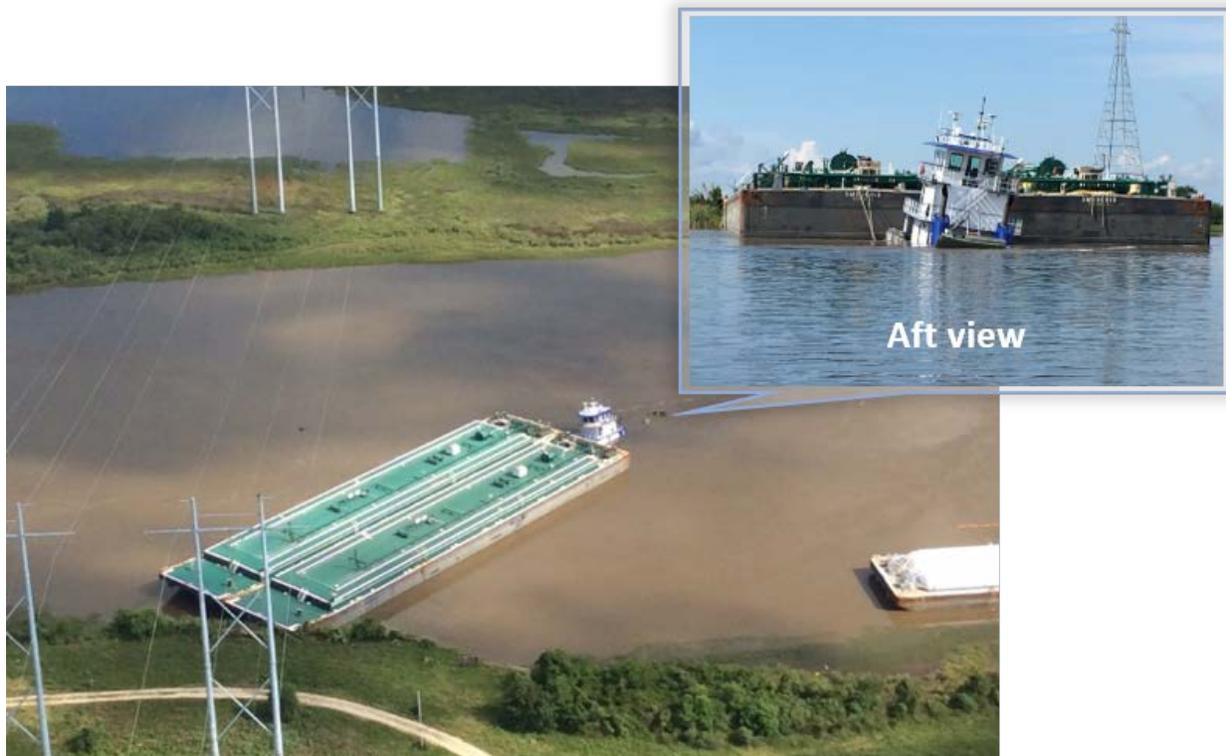
A post-casualty survey of the vessel stated that all the spaces from the second deck and below, including fuel and potable water tanks, and the forward storage and aft buoyancy compartments, were found fouled with mud, silt, and oily residue. The vents for the *Savage Ingenuity*'s fuel tanks were not fitted with ball check valves to prevent the release of oil. Although all doors and hatches were found closed once the vessel was brought to the surface, the Coast Guard noted that salvage divers had secured all doors and hatches, capped vents, and placed bags over the stacks before the vessel was lifted out of the water. The doors and hatches that divers found open were not specifically noted.

***Savage Ingenuity* and two empty tank barges on south bank of waterway postaccident. Aft view shows water up to second deck on starboard side of towboat. (Photos by Coast Guard)**
