National Transportation Safety Board

Marine Accident Brief

Breakaway of Containership *Helsinki Bridge* and Subsequent Allision with Black Falcon Cruise Terminal

Accident type	Allision	No. DCA18FM006
Vessel name	<i>Helsinki Bridge</i>	
Location	Conley Container Terminal, Reserved Channel, Boston, Massachusetts 42°20.61' N, 71°01.32' W	
Date	December 6, 2017	
Time	0003 eastern standard time (coordinated universal time – 5 hours)	
Injuries	None	
Damages	\$610,500 est.	
Environmental damage	None	
Weather	Visibility 3 miles (less in rain showers), winds south at 24 knots with gusts up to 37 knots, air temperature 55°F, water temperature 49°F	
Waterway characteristics	The Reserved Channel in the Seaport District of South Boston connects with Boston Harbor. The width of the channel was approximately 600 feet, and the tidal range was 9.49 feet. High tide was at 0040.

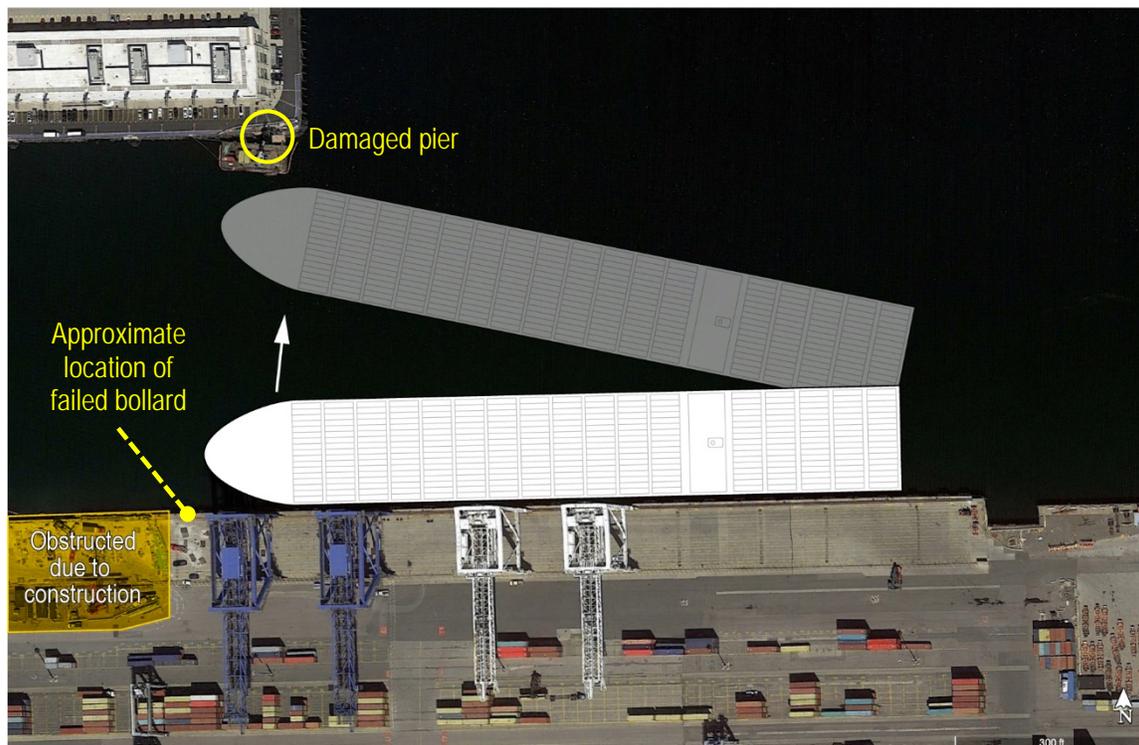
The chief mate then directed the line handlers to place the next two head lines on the next bollard forward of the bow—west of the 40-ton bollard—beyond where construction crews had placed a temporary fence. However, the line handlers were informed by representatives from both the construction crew and Massport personnel, who were on site, that they were not allowed to use any bollards west of the temporary fence. Once the chief mate was informed of this restriction, the next two head lines were placed on the same bollard as the first two. A fifth head line was added to the same bollard, as a precaution for the high-wind forecast. The remaining spring and stern lines were placed on bollards in accordance with a more typical spacing arrangement, the five stern lines being separated among three dockside bollards.

Approximate location and scale view of *Helsinki Bridge* alongside Conley Terminal and vessel's drift after breakaway. Also shown are area of terminal under construction and damaged pier at Black Falcon Terminal. Satellite image shows a work barge engaged in repair of pier. (Background from Google Earth)

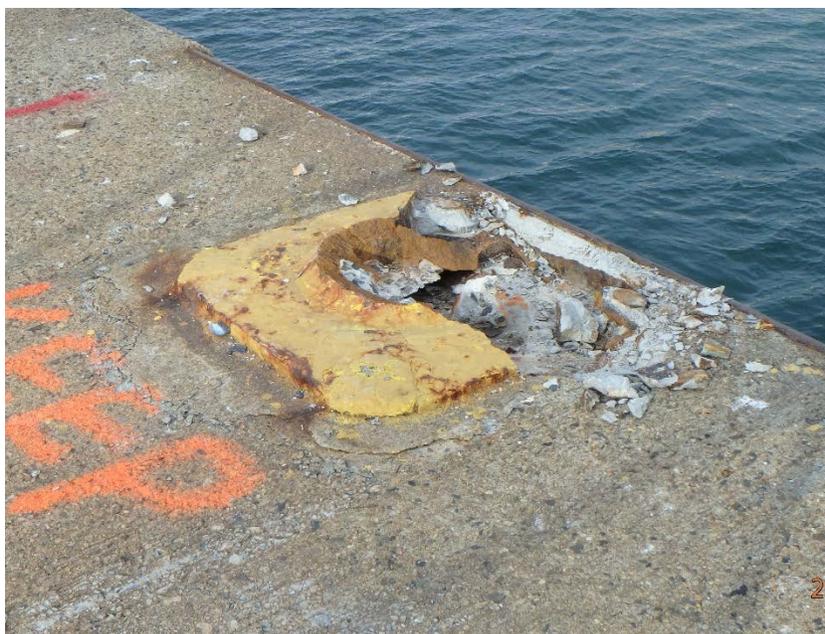
Later that night, the forecasted high winds arrived. At 0003, the wind acting upon the vessel caused the bollard to which the five head lines were secured to be torn off its base.⁴ The *Helsinki Bridge* began to drift away from the container terminal in a northerly direction. The ordinary seaman on watch at the gangway noticed that the bow was drifting away and that the five head lines were in the water. He then observed the two forward spring lines part. The ordinary seaman alerted the mate on watch along with the rest of the crew.

Remaining base of bollard that failed at Conley Terminal. (Photo courtesy of US Coast Guard)

Investigators could not determine the manufacturer of the bollard that failed at berth 11, and there was no metallurgical test performed to determine whether the material used was steel or ductile iron, which have different compressive strength-yield properties. However, construction

drawings from late 1979 indicated that this bollard type had an estimated 40-ton horizontal pull strength.

Massport did not have records indicating that the bollards at the Conley Terminal had been subjected to load testing to determine their integrity and continued suitability for intended service. Investigators found no written policy or procedures addressing the frequency of inspections for the terminal's bollards.

The survey stated that the condition of berth 11 was “overall fair” and berth 12 was “overall satisfactory.”⁶ The mooring bollards at these berths were determined to be in “fair condition with some scaling.” The concrete around the base of several bollards was found to show signs of “spalling,” which was common in colder climates where moisture in the concrete freezes and then causes delamination or fragmenting of the surface area.

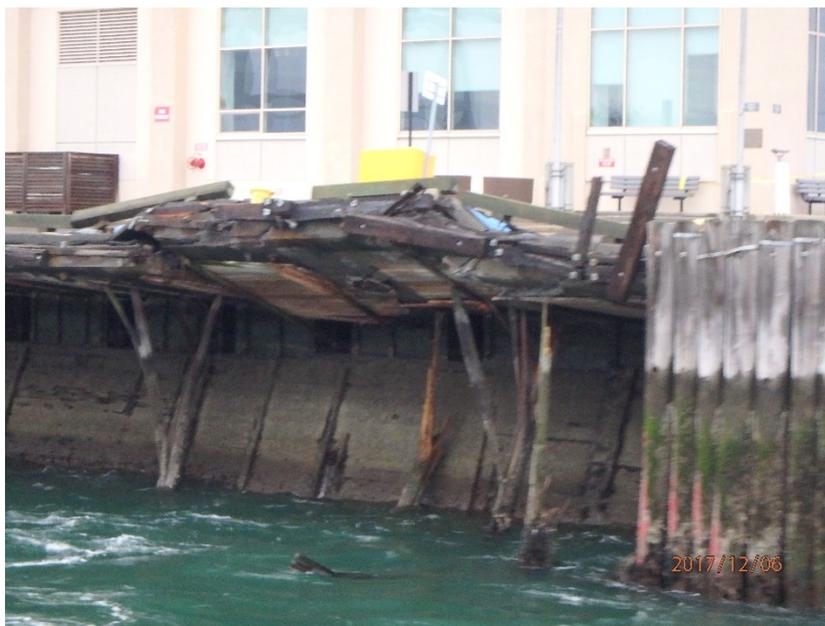
Damage to Black Falcon pier. (Photo courtesy of Coast Guard)

The allision resulted in damage to the Black Falcon pier's support pilings and concrete surface. The bulbous bow of the *Helsinki Bridge* and the starboard hull sustained minor damage, which was limited to paint scraping and some slight indentation of the steel plate. There were no punctures of the hull or distortion of the internal structural framing. During an examination of the vessel's propeller and rudder, one of the six adjustable blades was found to have a slight deformation on its tip, but that damage was determined to have been pre-existing.
