# National Transportation Safety Board

## Marine Accident Brief

### Engine Room Fire aboard Towing Vessel *J.W. Herron*

<b>Accident type</b>	Fire/Explosion	<b>No.</b> DCA18FM008
<b>Vessel name</b>	<i>J.W. Herron</i>	
<b>Location</b>	Big Bayou Canot, Twelvemile Island, near Mobile, Alabama 30°47.46' N, 087°59.55' W	
<b>Date</b>	December 13, 2017	
<b>Time</b>	1340 central standard time (coordinated universal time – 6 hours)	
<b>Injuries</b>	None reported	
<b>Property damage</b>	\$1.5 million est.	
<b>Environmental damage</b>	None reported	
<b>Weather</b>	Clear, visibility 10 miles, winds south-southeast 8 knots with gusts to 17 knots, air temperature 54°F, water temperature about 63°F	
<b>Waterway information</b>	Big Bayou Canot flows around Twelvemile Island opposite of the main navigation channel of Mobile River at mile 7. The bayou is 7–15 feet deep and approximately 500 feet wide at the accident site.

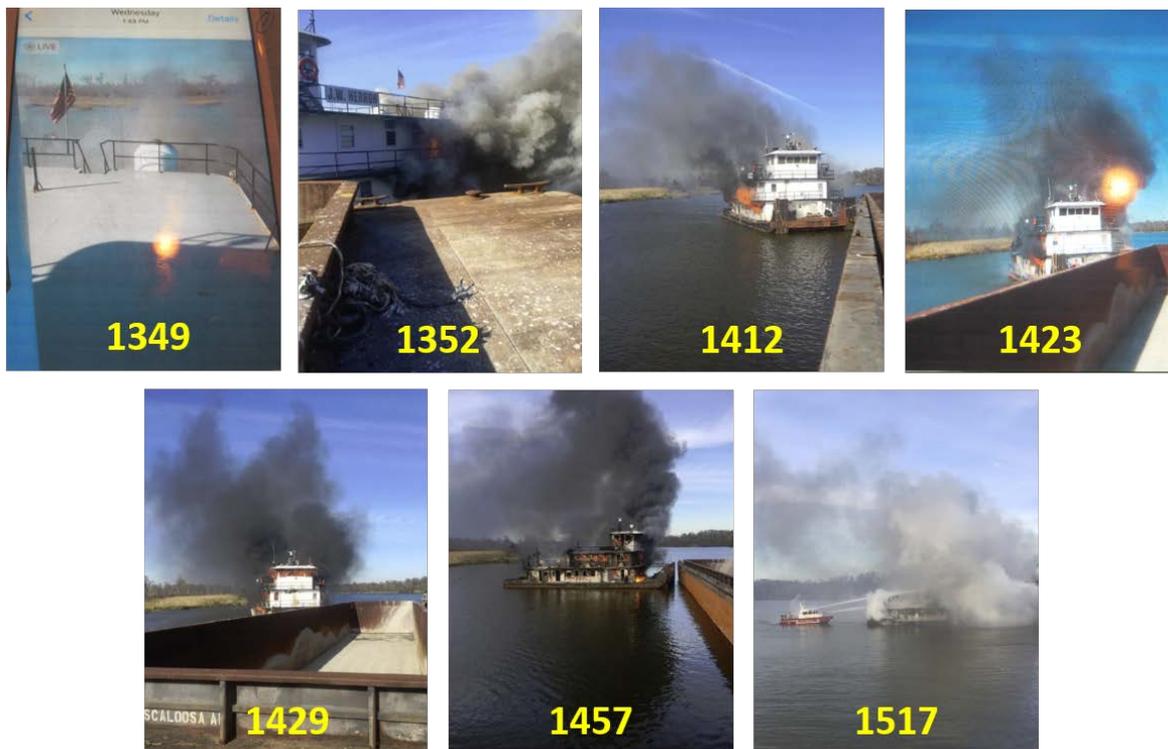
After the captain met the deckhand and engineer at the starboard tow knee, the captain and engineer proceeded down the starboard side of the towboat's main deck to access the engine room. According to the engineer, the engine room was filled with black smoke, but while looking through the forwardmost engine room window (of four windows) he saw a "glow" emanating from the back of the port engine, between the engine and the gearbox. The captain, who was a bit farther aft than the engineer, also saw thick black smoke, but he stated that he could not see anything through the window.

Images from captain's camera phone capture evolution of fire aboard *J.W. Herron*, 9 minutes after smoke was first noticed through when fire department began firefighting with water cannons.

The captain stated that all four engine room windows and the double doors on the main deck on both the port and starboard sides of the engine room were open. With the towboat positioned starboard-to the wind direction, he noticed that the smoke was blowing out of the port windows and door as it traveled through the engine room. The captain instructed the engineer to board the *Dana Jean* with the deckhand and move it away from the burning *J.W. Herron*. He then pulled the remote emergency fuel shutoffs for the starboard generator and starboard propulsion engine, which were located above the forwardmost engine room window. However, after he proceeded around the forward side of the wheelhouse, he was unable to reach the shutdowns for the port generator and propulsion engine due to the smoke. According to the captain, approximately 4,000 gallons of no. 2 diesel oil and approximately 200 gallons of lube oil were in the vessel's tanks.

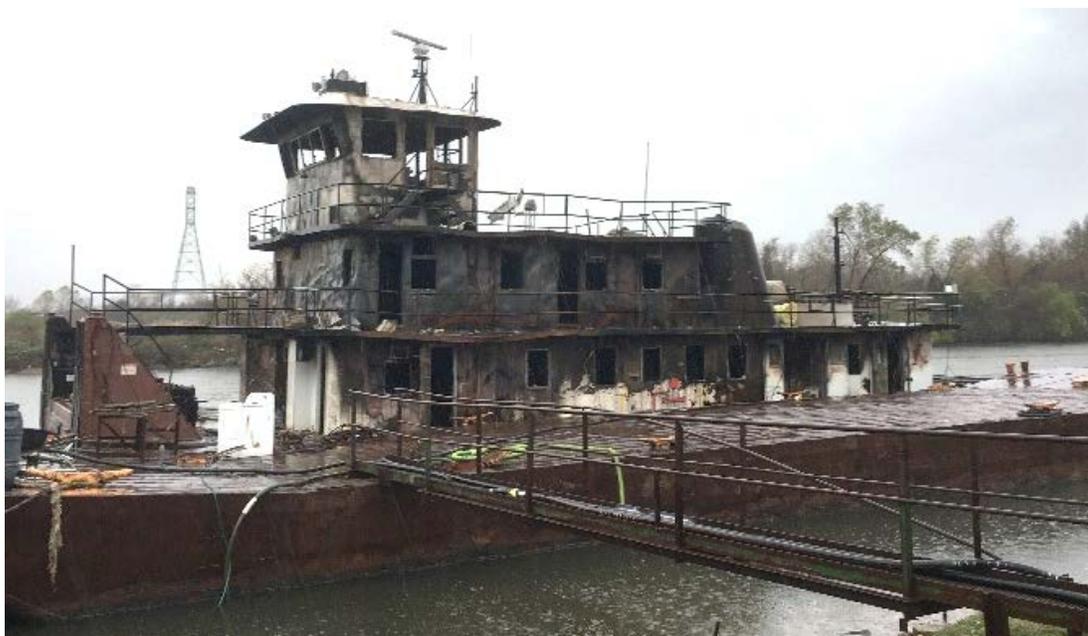
Another Three Mile towboat, the *Tommy Jack*, which had transited upriver to assist the crew of the *J.W. Herron*, towed the vessel back to the dock. The *J.W. Herron*'s hull was not breached during the fire, and the main structure and main propulsion system remained intact, despite the extensive fire damage throughout the vessel. There was no report of fuel or oil spilled.

*J.W. Herron* post-fire at Three Mile Dry Dock and Repair.

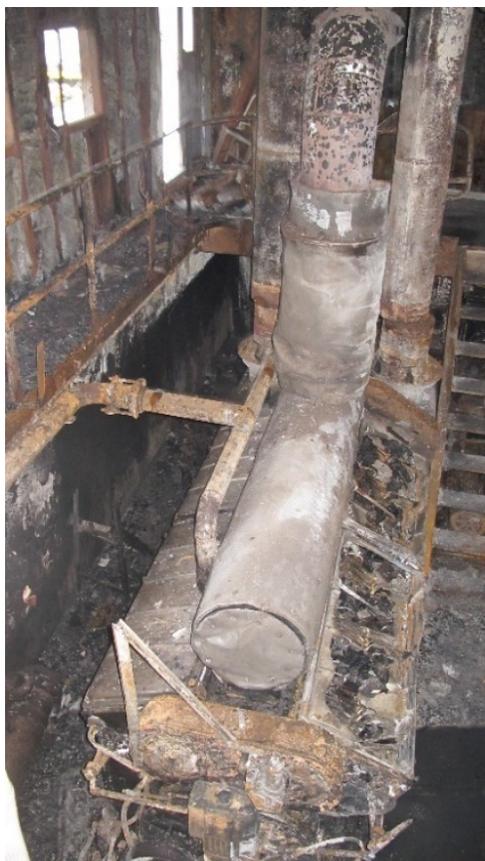
Starboard main engine (looking aft).

A day after the fire, a commercial forensic science firm contracted by the vessel’s insurer conducted an examination of the *J.W. Herron* to ascertain the source of the fire. The firm’s report classified the fire as accidental and noted that fire patterns indicated that damage to the starboard engine was more extensive than to the port engine, whose valve covers remained intact while the starboard’s were melted. The clutch tires for each engine were found to be equally damaged. A vacuum canister for the engine’s crankcase oil, which was located above the clutch tire area, had connecting hoses burned away at both engines. The firm concluded that the fire occurred near the aft end of the starboard engine, likely from a ruptured hose on the vacuum canister that would have

sprayed lube oil throughout the engine compartment and onto hot engine surfaces and the clutch tire, thus igniting the oil. Once the oil ignited, the fire would have spread by burning combustible materials as well as diesel fuel and lube oil systems in the engine compartment, before reaching the upper level via direct flame impingement and conduction. The report also noted that heat buildup from the slipping clutch, which was described by the captain, rendered the clutch tire a potential ignition source.

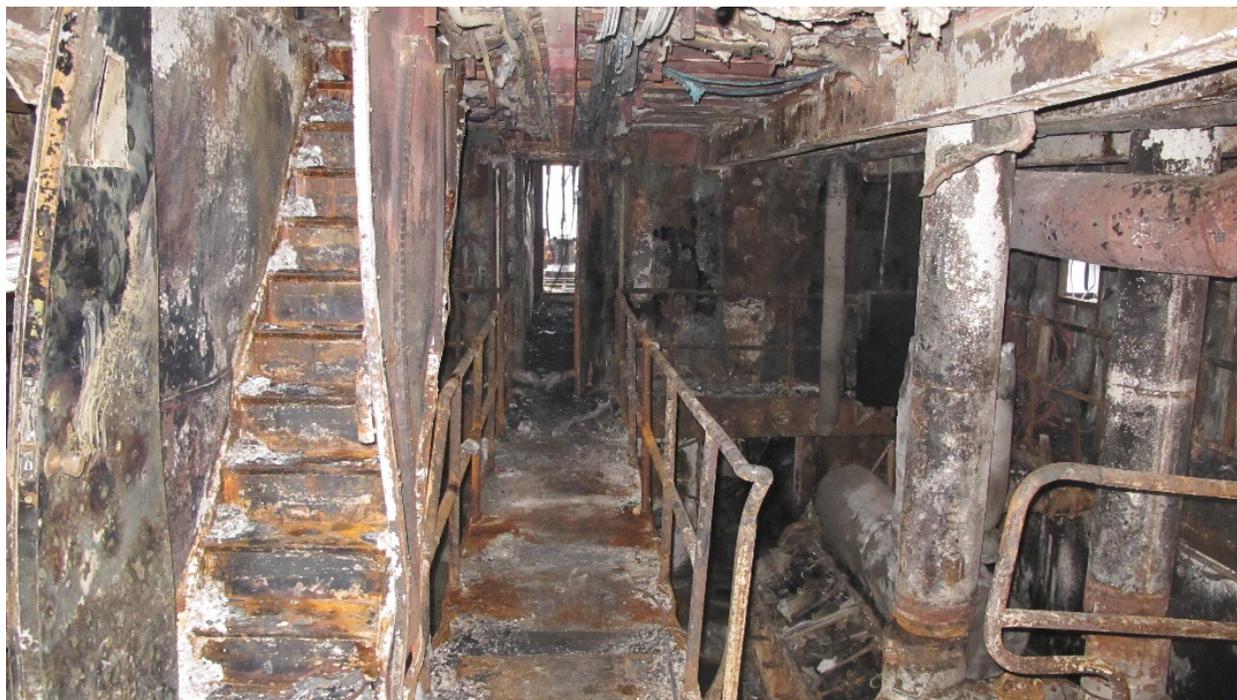
**Fire damage of engine room's upper level (looking forward).**

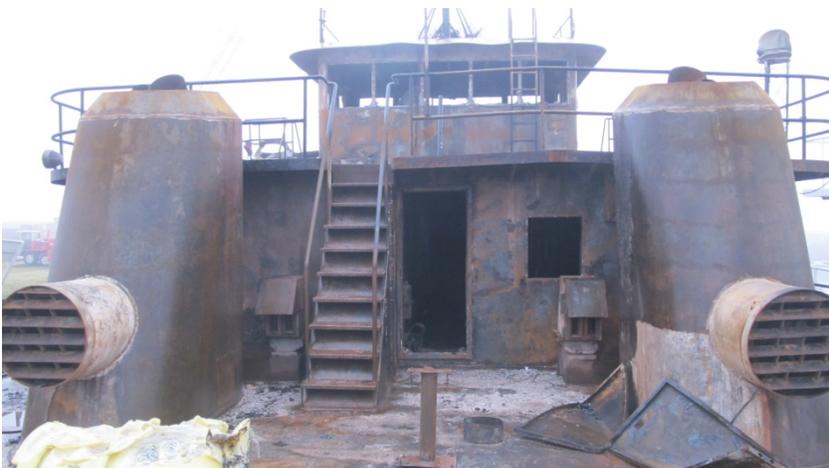
Aft side of *J.W. Herron* stacks, with engine room exhaust vents, post-fire.

supply and exhaust fans providing engine room ventilation as they were controlled from within the engine room, so they remained running during the fire. Additionally, the exhaust ventilation outlets for the engine room located on the aft side of the stacks had fixed louvers and thereby could not be closed.

When the captain first saw flames, they were coming from the aft side of the starboard stack, from the engine room exhaust ventilation louvers, indicating a fire in the starboard side of the engine room. Following the accident, the captain suspected that the initiating event was a slipping clutch, as evidenced by the loss of propulsion on the starboard engine before the fire. The clutch slipping was a potential source of ignition rather than a fuel source. The forensic fire report, which indicated that the fire was hottest near the aft portion of the starboard engine, stated that the likely initiating event was the heat of the slipping clutch or a hot engine surface that ignited lube oil from a ruptured hose on the vacuum canister. Investigators also found that copper tubing with flare fittings that carried pressurized lube oil to the engine blowers ran in the same area of the vacuum canister hoses above the clutches and therefore could have been a potential fuel source. As the engineer pointed out, the flare fittings had wept in the past from engine vibration. Because the crew was not able to reach the emergency engine shutdown, lube oil pressurized from a running engine would have fed the fire until the sump emptied or the engine stopped.

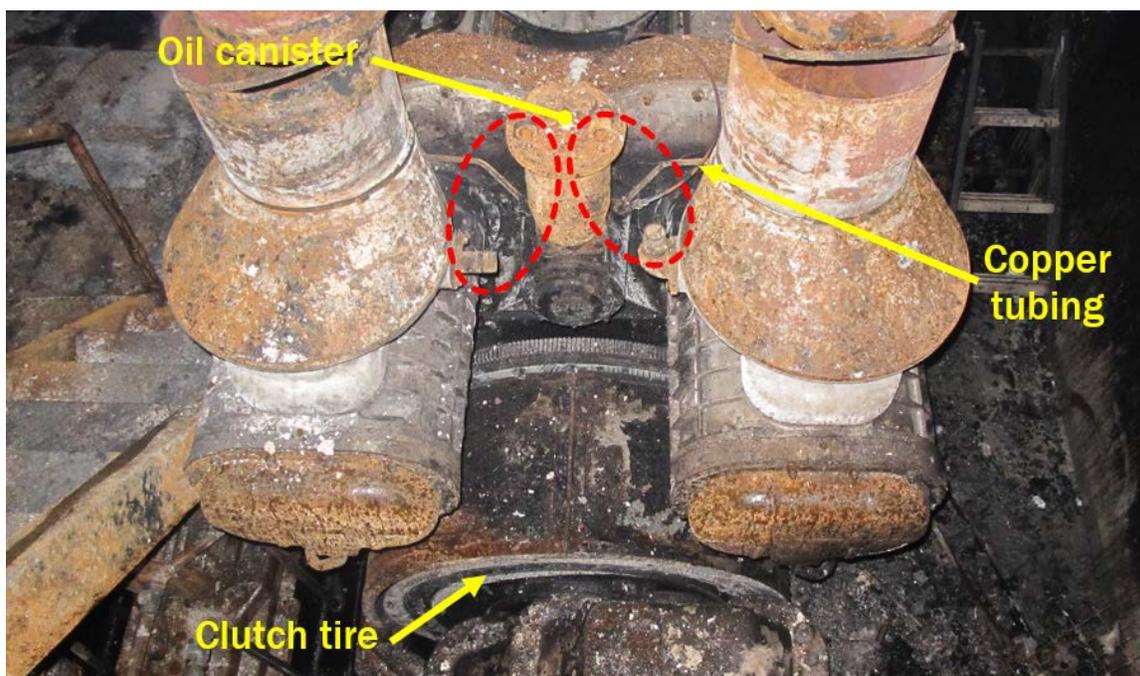
Although the engineer stated that he did not know the cause of the fire, he suggested that it might have been a lack of oil in the engine's gear-driven air blower or the heat of a slipping clutch. The vessel did not have an alarm alerting the crew to low air pressure to the clutch; however, the engineer checked the clutch pressure during the transit and stated that it was normal, as were the oil pressures and other machinery temperatures. He did not recall any fuel leaks from the engines under typical operation, but he had previously seen engine vibrations loosen copper tubing flare fittings, which would then weep oil. He resolved the leaking fittings by tightening them while under way. According to the engineer, a 3/8-inch copper tubing with flare fittings was supplying lube oil to the air blowers above the clutch; the operating pressure in the line was approximately 18 pounds and the engine sump held approximately 80 gallons of oil. Investigators confirmed that the oil supply line constructed of steel ran inside the valve covers down the starboard side of the engine, transitioned to copper tubing upon exiting the valve covers, and remained copper to the blowers. The fittings and tubes appeared to be intact post-fire but were not pressure-tested. In the past, the engineer had attempted to replace the copper tubing with steel per the engine manual, but he could not find the part in steel.

Above the clutch were also twin 1.5-inch stainless steel-braided rubber hoses, held in place with double hose clamps, that vented the engine crankcase to the air blowers. After the fire, these hoses were missing.

Aft side of starboard engine (viewed from above), with oil canister, remnants of clutch tire, and copper tubing identified. Red circles indicate areas where 1.5-inch stainless steel-braided rubber hoses were missing.

The National Transportation Safety Board determines that the probable cause of the engine room fire aboard the towing vessel *J.W. Herron* was leaking lube oil from a propulsion diesel engine hose or tubing fitting that was ignited off an exposed hot engine surface or slipping clutch. Contributing to the severity of the fire was the location of the emergency engine shutdowns and fuel supply shutoffs near the exterior engine room doors, which proved to be inaccessible. Contributing to the spread of the fire was the inability to secure ventilation to the engine room.

The location of remote emergency shutdowns to the engine room—quick-closing valves for fuel and lube oil systems, remote stops for ventilation fans, and engine stops—as well as fire pump start controls may not be accessible during a fire. Therefore, the accessibility of these shutdowns and controls should be evaluated during fire-response planning. Alternative remote emergency shutdown locations, such as the wheelhouse, should be considered for redundancy.
