National Transportation Safety Board

Marine Accident Brief

Capsizing and Sinking of Fishing Vessel *Misty Blue*

Accident type	Capsizing/Listing	No. DCA18FM005
Vessel name	<i>Misty Blue</i>	
Location	Atlantic Ocean, 9 miles southeast of Nantucket, Massachusetts 41°11.35' N, 69°46.03' W	
Date	December 4, 2017	
Time	1806 eastern standard time (coordinated universal time – 5 hours)	
Injuries	2 fatalities	
Property damage	\$1.25 million est.	
Environmental damage	Oil sheen observed; about 2,700 gallons diesel fuel and 225 gallons of hydraulic fluid and lube oil were on board	
Weather	Visibility 10 miles, seas at 3–4 feet, winds north-northeast at 6 mph with gusts to 9 mph, air temperature 42°F, water temperature 46°F	
Waterway information	East side of Old South Shoal, Atlantic Ocean; water depth about 80 feet

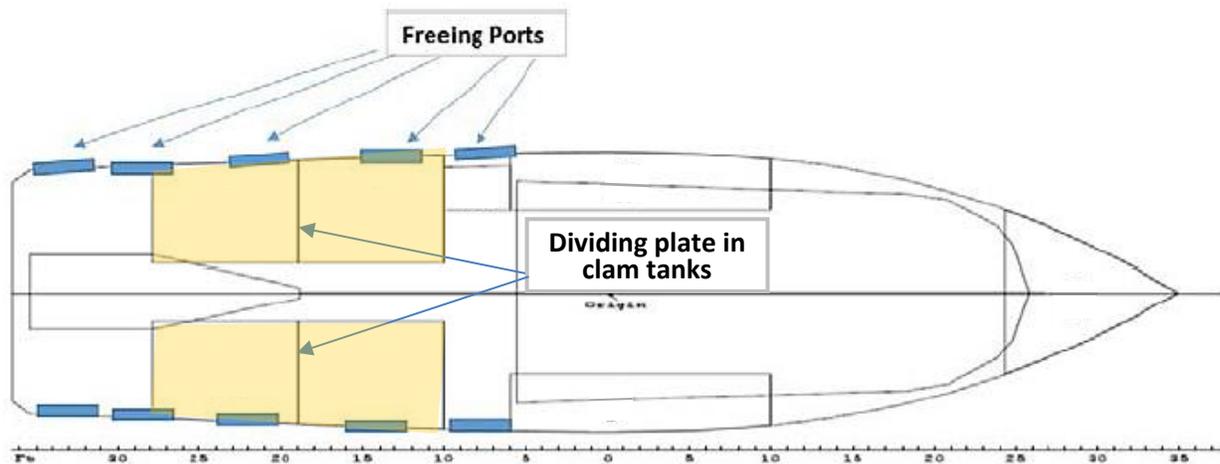
Plan view of *Misty Blue*'s tank layout and freeing port locations. The clam tanks are highlighted in yellow. (Modified image from US Coast Guard model)

Early surveys indicated that the port and starboard bulwarks each had four scuppers on the main deck, each roughly 8 inches by 15 inches. Photographs of the vessel in the years preceding the accident show that there had been another scupper the approximate size of the original ones, and a second, much smaller one cut into both bulwarks. Later, the last scupper added on the starboard side was converted to a gate-style opening for easier access to the main deck.

In our review of the vessel's loading and witness reports provided for the day of the sinking, the off-center flooding of the port clam tanks could have created the port list noted by survivors. We estimate that this list would have brought the bottom of the freeing ports to about the water line in a static condition. While our analysis provides insight into the vessel's stability in static conditions, we are not able to quantify the effects of the many external and dynamic forces that likely acted on MISTY BLUE at the time of the casualty. We did estimate the impact of water trapped on deck and found that even small amounts of water on deck would significantly reduce stability of the vessel. Wind and wave action would have further negatively impacted stability. We found that the freeing port area on this vessel was relatively small compared to a vessel which must comply with the regulatory requirements of 46 *Code of Federal Regulations* §28.555 which likely resulted in compounding water accumulation on the main deck.

The National Transportation Safety Board determines that the probable cause of the capsizing and sinking of fishing vessel *Misty Blue* was flooding of the port clam tank from an undetermined point of ingress, which led to a decreased freeboard and a list allowing boarding seas to be trapped on deck, thereby decreasing the vessel's stability. Contributing to the sinking was the relatively small freeing port area of the vessel, which likely increased water accumulation on deck.
