National Transportation Safety Board

Marine Accident Brief

Flooding and Sinking of Towing Vessel *Ms Nancy C*

Accident type	Flooding	No.	DCA18FM015
Vessel name	<i>Ms Nancy C</i>		
Location	Everett Lake, mile 832 on Lower Mississippi River, near Dyersville, Tennessee 36°3.71'N, 89°40.05'W		
Date	March 6, 2018		
Time	1630 central standard time (coordinated universal time – 6 hours)		
Injuries	None reported		
Property damage	\$667,306		
Environmental damage	>830 gallons of fuel and lube oil discharged into the water		
Weather	Clear, visibility 10 miles, winds west at 28 mph (gusting to 34 mph), wave heights 3–4 feet, air temperature 54°F, water temperature 48°F		
Waterway information	Lake Everett is a tributary of the Lower Mississippi River. Its mouth is at mile 832, near the town of Dyersville, Tennessee. The lake's water depth is 6–18 feet.

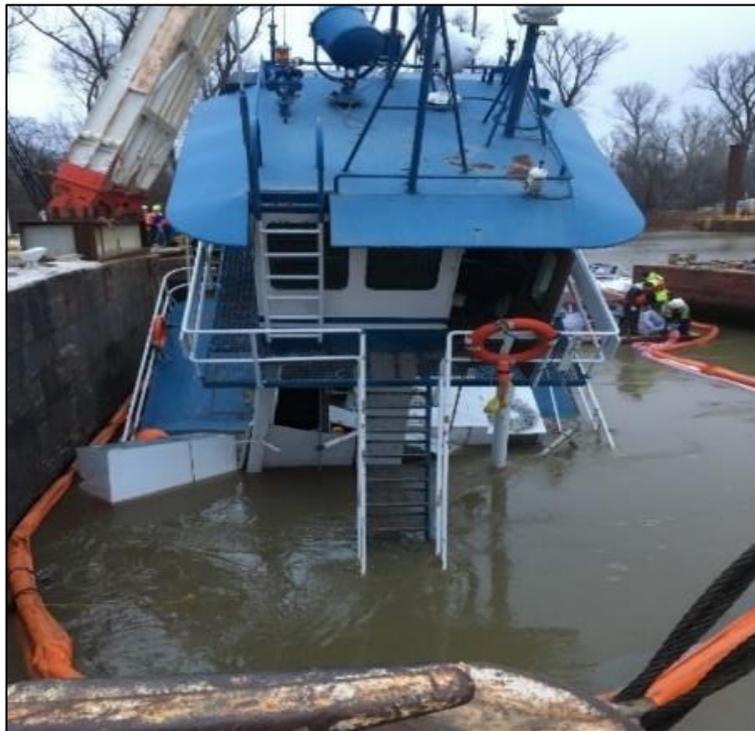
Ms Nancy C prior to salvage.

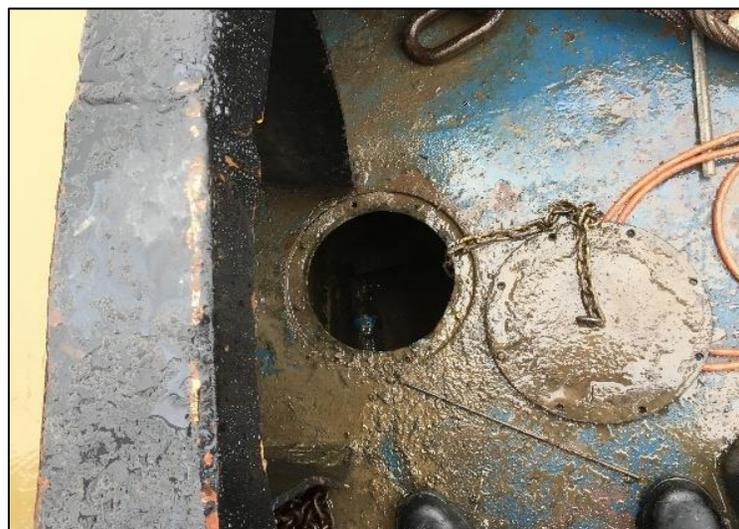
The *Ms Nancy C* was refloated 5 days later, on March 11. As the vessel was being raised, investigators noted that the access cover and manhole cover to the aft stern void that the deckhand had opened prior to the sinking were still open. The starboard access cover was connected to a chain that was attached inside the void. The electric pumps were still in place in the stern void accesses. Investigators noted that both pumps had been plugged into electrical receptacles located in the galley of the towing vessel.

Starboard deck access to aft stern void found open during salvage, with broken and missing access cover screws.

Investigators discovered numerous potential sources of water ingress on the main deck, in the engine room, and in the voids. On the main deck, in addition to the two access covers that were opened just prior to the sinking, a third access cover to the aft voids was found open after the accident. The starboard aft access cover was connected to a chain and not secured by any of its retaining screws, which indicates that it was never permanently secured, and the chain was attached to prevent it from being lost. Other covers were missing the designed number of securing screws, and gasket material was scarred or hardened, preventing it from effectively creating a seal. Furthermore, silicone sealant was used around the covers in an apparent attempt to provide a seal. All of these factors suggest that the covers on the main deck with accesses to the aft voids could not effectively be made watertight.

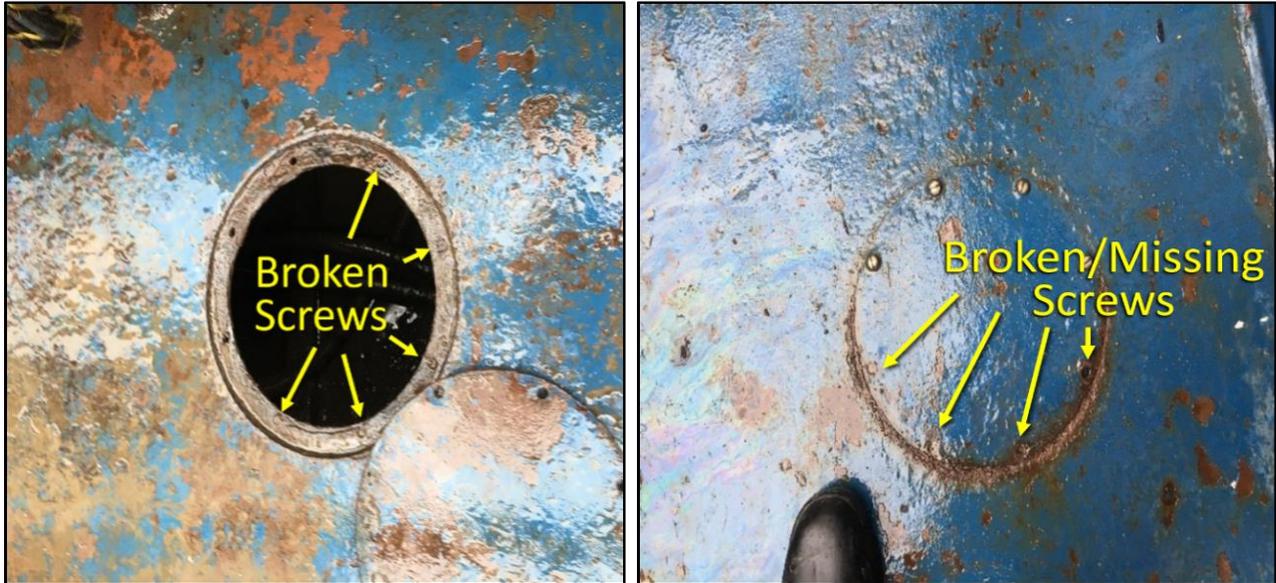
A starboard-side access cover for the forward stern void of the *Ms Nancy C* was also found open when the vessel was salvaged. This cover was not one of the covers that the deckhand stated that he had opened prior to the accident. When investigators conducted an examination of the openings to both of the aft voids, they discovered several broken screws in the lip of each access. Other access covers located on the main deck were also examined. The covers were designed to be secured with eight screws; however, only two of the five access covers on the vessel's main deck were found secured with all eight screws. Further examination of the unsecured covers identified pitting and wastage along the edge of the covers and heavily scarred gaskets. In addition, all of the remaining manhole covers into the voids and fuel tanks were sealed with silicone sealant.

At left, starboard deck access to forward stern void found open during salvage. At right, port deck access to aft stern void, with broken and missing access cover screws.

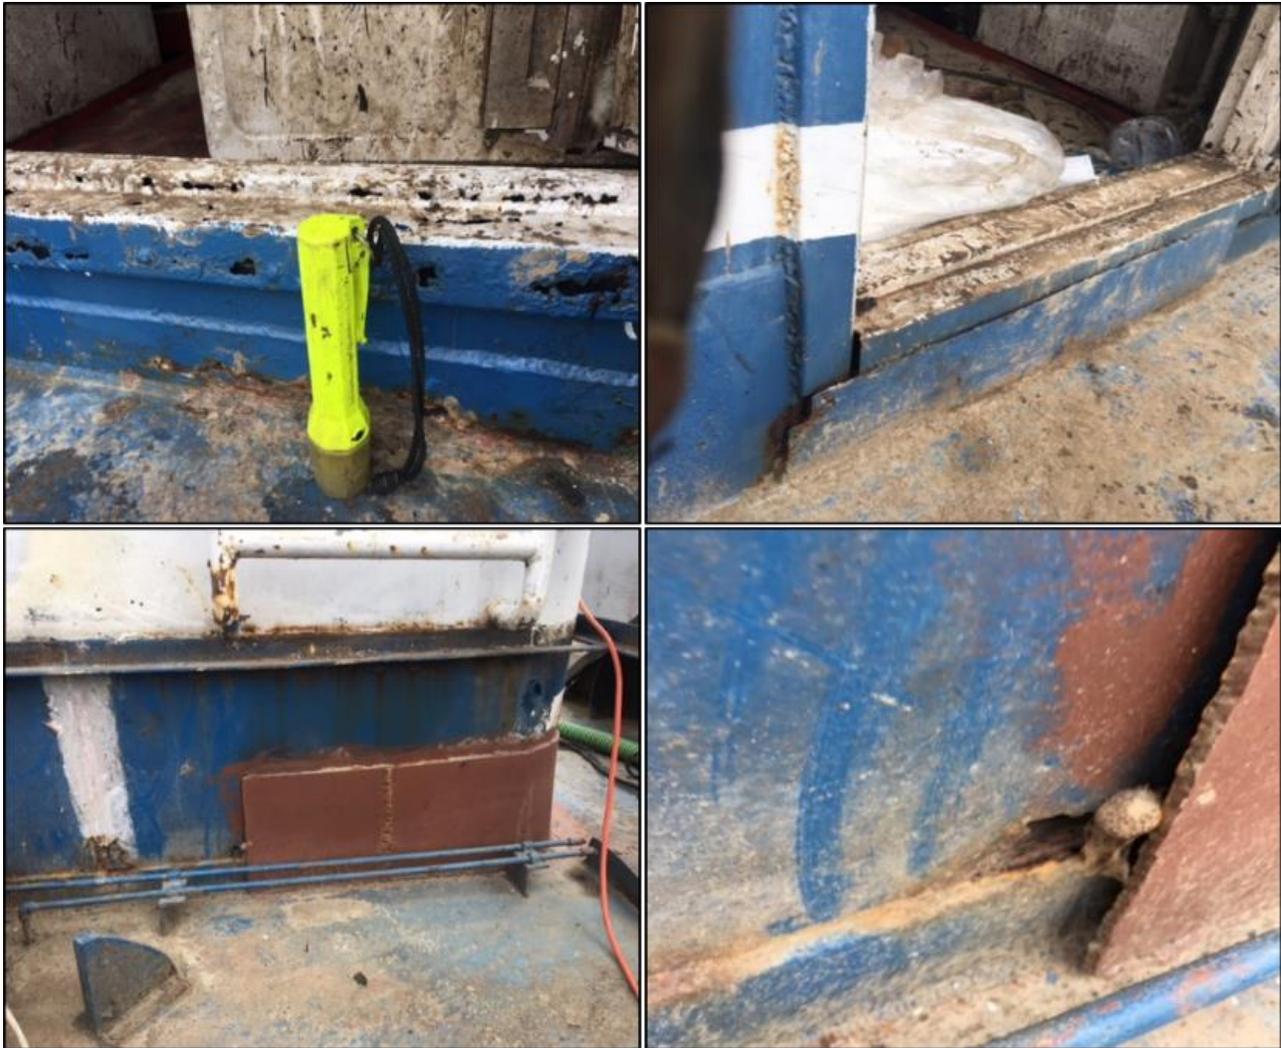
The aft end of the towing vessel's deckhouse, where it met the main deck above the forward stern void, was examined for fittings or corrosion that could have allowed water to ingress. Investigators noted that there was significant steel wastage that extended from the port engine room door, around the aft side of the house, and up to the starboard engine room door. This wastage reached into the overhead of the forward stern void. The company that owned the towing vessel had welded doubler plates (patches) over the corroded areas; however, investigators found gaps between the doubler plates and the side of the house.

Wastage and doubler plates as found on *Ms Nancy C* deckhouse. Top left: doubler plate over wastage below starboard engine room entrance. Top right: doubler plate over wastage below port engine room entrance. Bottom left: doubler plates over wastage on starboard aft deckhouse. Bottom right: closeup of starboard aft doubler plate showing gap between plate and wastage area.

On the deckhouse along the engine room door sills, poorly installed doubler plates designed to address wastage near the seam between the deckhouse and the main deck created another potential source of water ingress from the main deck into the hull. Gaps between the doubler plates and bulkheads were large enough to have allowed water on deck to enter the vessel. The wastage, which extended into the overhead of the forward stern void, may have been the source of, or contributed to, the flooding of the space and the eventual sinking of the vessel.

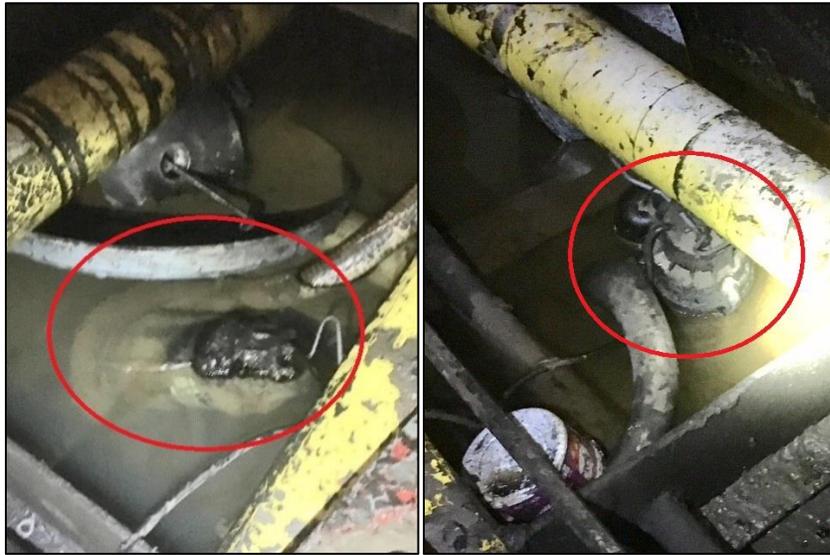
During the postaccident inspection of the *Ms Nancy C*'s engine room, cofferdams were discovered below each of the vessel's two stern tubes, through which the propulsion shafts ran. Float-switch-activated, positive-displacement submersible pumps were found in each of the cofferdams, indicating that the pumps were used to remove excess water leaking from the stern tube packing where the shafts passed through the hull. The two pumps were made for residential use. The starboard pump had a 40-gallons-per-minute output and the port pump had a 60-gallons-per-minute output.

At left, pump in cofferdam below port shaft. At right, pump in cofferdam below starboard shaft.

In the engine room, the installation of cofferdams fitted with pumps under the shafts indicate that the shaft seals were typically leaking. Although the cofferdams would have contained the water to a confined area in the engine room, a hose carrying the discharge water from the port pump was leaking as it passed through the forward stern void. Therefore, while water was being pumped out of the engine room, this hose would have leaked water into the forward stern void. Around the discharge hose where it penetrated the main deck, sealant had been poorly applied. The sealant application, which had holes, was potentially an additional source of water ingress into the forward stern void.

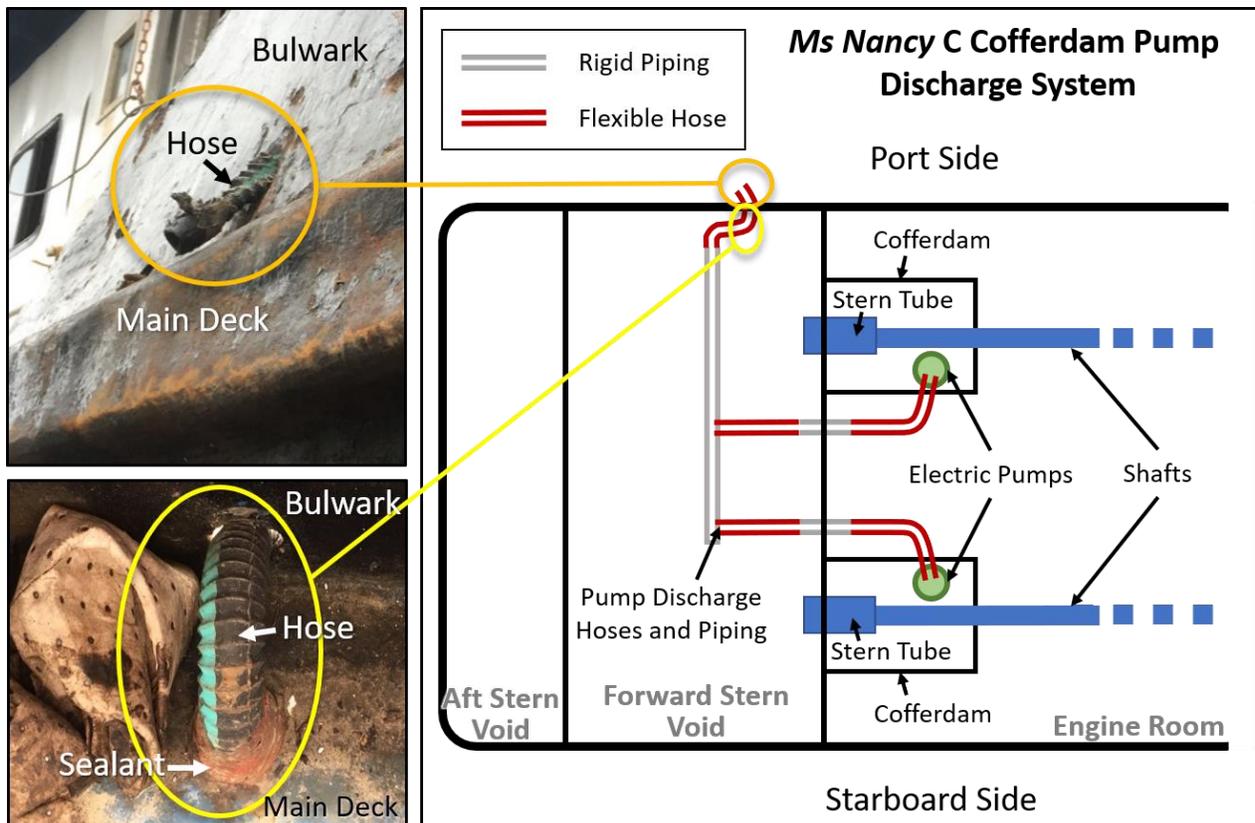
Cofferdam pump overboard discharge system (diagram not drawn not to scale). Photos on the left show, at top, the hose as it passed outboard from the main deck through the port side bulwark, and, at bottom, the discharge hose as it passed up through the main deck from the forward stern void.

Investigators noted during their examination that the hose in the forward stern void that connected the port side pump discharge to the transverse pipe was leaking. The hose still contained water but was not under pressure. Also, sealant around the hose that ran from the transverse pipe to the overboard discharge had several small holes in it where it breached the main deck.

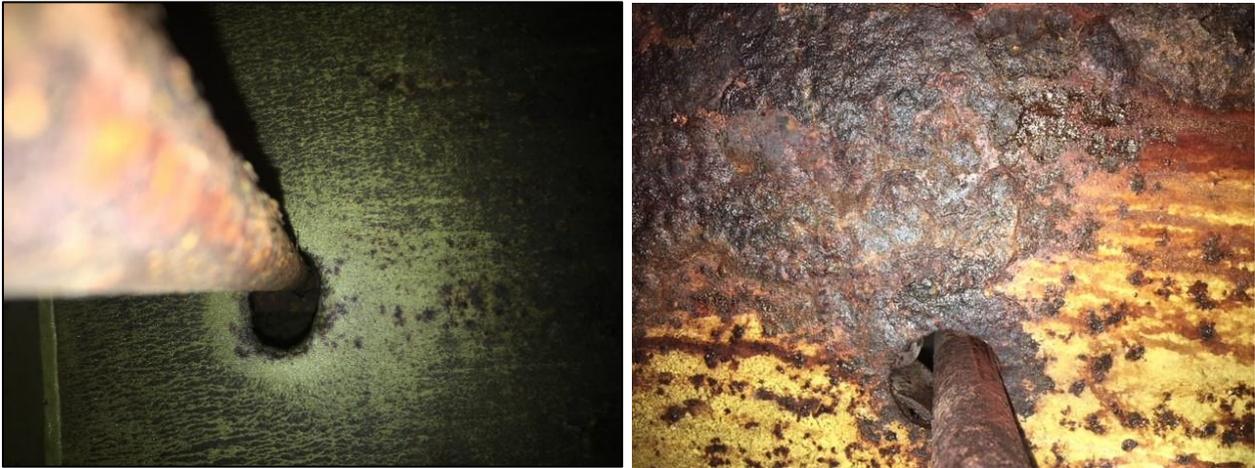
Investigators also found two unsealed (not watertight) pipe penetrations through the bulkhead between the forward stern void and the aft stern void. These holes were both about 36 inches from the bottom of the space and would have allowed water above these penetrations to move continuously between the forward and aft stern voids.

Bulkhead penetrations between forward stern void to the aft stern void.

Two penetrations found between the forward and aft stern voids rendered the bulkhead between the spaces non-watertight. Thus, water flooding one space would eventually flood the other space once the water level rose above the height of the penetrations. The deckhand stated that the aft stern void was about three quarters full when he first opened the cover, which was a level above the penetrations. Therefore, flooding of the forward stern void would have been ongoing. The flooding of the two stern voids would have increased stern trim and thereby decreased freeboard at the aft part of the vessel.
