National Transportation Safety Board

Marine Accident Brief

Fire and Sinking of Fishing Vessel *Ole Betts Sea*

Accident type	Fire/Explosion	No. DCA18FM018
Vessel name	<i>Ole Betts Sea</i>	
Location	Gulf of Mexico, 18 miles ¹ northeast of Garden Key, Dry Tortugas, Florida Keys 24°52.80' N; 082°41.80' W	
Date	March 18, 2018	
Time	0615 eastern daylight time (coordinated universal time – 4 hours)	
Injuries	None	
Property damage	\$200,000 est.	
Environmental damage	None reported	
Weather	Visibility 10 miles, winds calm, seas 1–2 feet, air temperature 78°F, water temperature 75°F	
Waterway information	Open waters of the Gulf of Mexico north of the Dry Tortugas archipelago in the Florida Keys; water depth of about 100 feet.

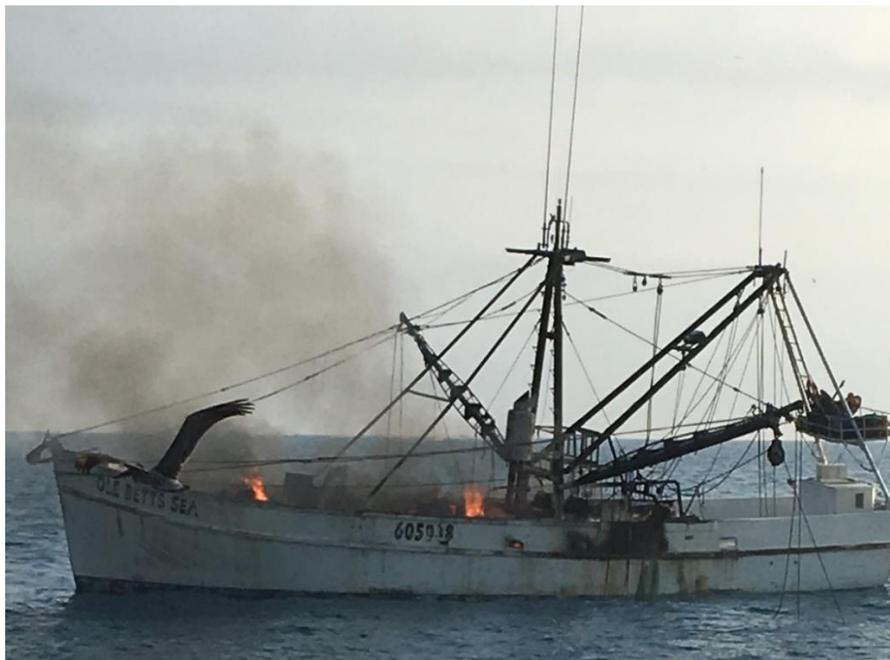
Burning hull of *Ole Betts Sea*. (Photo provided by Trico Seafood, Inc.)

The National Transportation Safety Board determines that the probable cause of the fire and sinking of fishing vessel *Ole Betts Sea* was a mechanical failure of the generator’s diesel engine, which led to a fuel-fed fire that burned out of control.

Following the initiation of an engine room fire, it is imperative to remove the source of available fuel to the fire found in the fuel oil and lube oil systems. In this accident, the vessel had no remote emergency cut-off valves for fuel and lube oil systems outside the engine room, and thus fuel to the fire could not be stopped and the vessel was eventually consumed by the flames. Vessel designers, builders, owners, and operators are encouraged to install, regularly test, and have emergency drills that incorporate remote cut-off valves for fuel and lube oil lines.

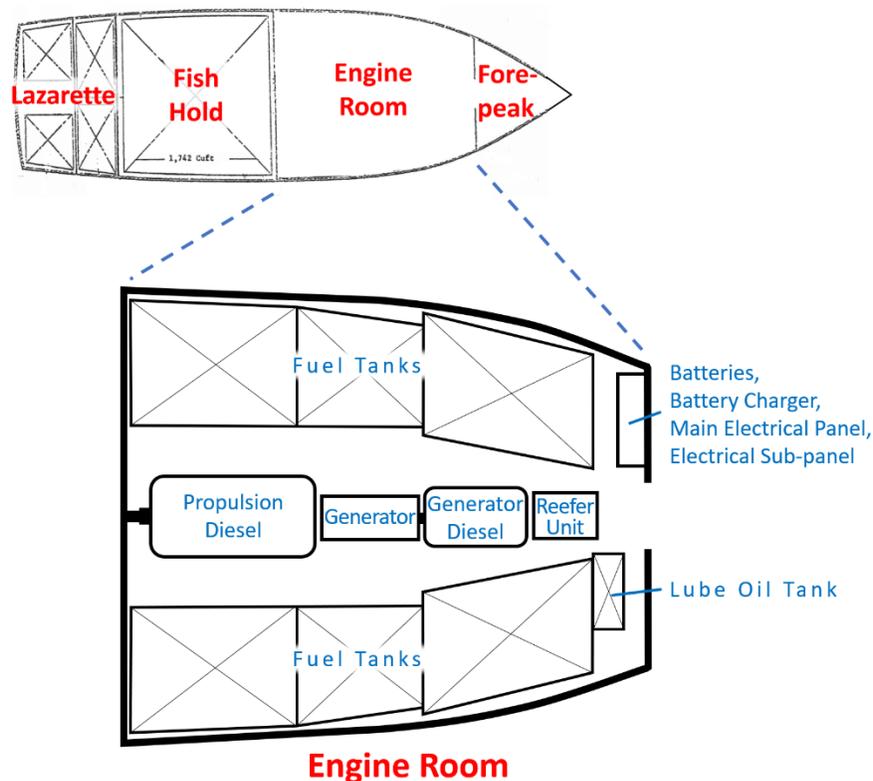
Diagram of 68-foot shrimp trawler of similar design to *Ole Betts Sea*, with engine room detail. (Engine room equipment not drawn to scale; adapted from hull diagram provided by Trico Shrimp Co., Inc.)

Further, because the shaking stopped before the propulsion diesel engine ceased operating and the vessel ceased forward movement, it is believed that the shaking was caused by a failure in the diesel engine driving the generator. Because lights continued to operate until the vibration (diesel generator) stopped, it is unlikely that the generator itself failed.

When the large explosion occurred, thick black smoke spewed from the engine room, indicating a fuel fire. The fire was likely fed by diesel oil from a failed fuel line to the propulsion or generator diesel engines. Investigators noted that there was no way for the crew to shut off the fuel flow to the diesel engines, such as a remote quick-closing (cutoff) valve, outside of the engine compartment. Depriving the fire of fuel, especially during the early stages of the incident, could have prevented further ignition of flammable materials—such as the fiberglass hull and bulkheads—and increased the likelihood of saving the vessel.
