# National Transportation Safety Board

## Marine Accident Brief

### Capsizing and Sinking of Towing Vessel *Natalie Jean*

<b>Accident type</b>	Collision	<b>No.</b> DCA18FM017
<b>Vessel name</b>	<i>Natalie Jean</i>	
<b>Location</b>	Lower Mississippi River, mile 90.5, near New Orleans, Louisiana 29° 56.27' N, 89° 59.98' W	
<b>Date</b>	March 12, 2018	
<b>Time</b>	About 0938 central daylight time (coordinated universal time – 5 hours)	
<b>Injuries</b>	2 fatalities	
<b>Damage</b>	>\$500,000 est.	
<b>Environmental damage</b>	Unknown amount of diesel fuel released into the river	
<b>Weather</b>	North winds at 10–15 knots, gusting to 20–26 knots; air temperature 62°F; water temperature 54°F	
<b>Waterway information</b>	The Lower Mississippi River measured 16.5 feet on the river gauge at mile 102 (flood stage is 17 feet). The current was estimated at 5 mph.

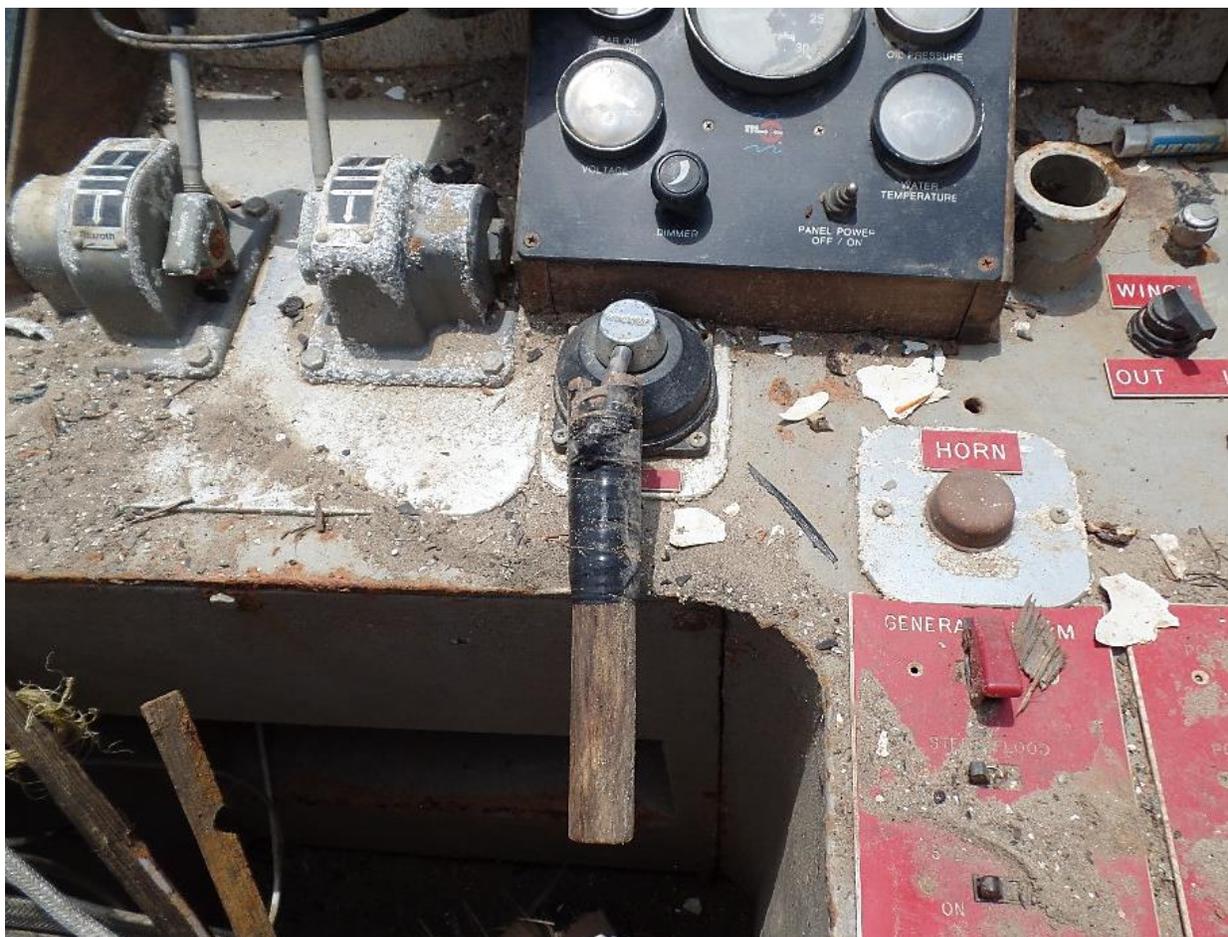
The pilot told investigators that he was not familiar with the vessel's steering system and that it took some time for him to get used to it. The *Natalie Jean* was equipped with a double-flanking rudder system and the primary steering control consisted of a short "stick" with a wooden rod taped to the end in order to extend it. The pilot told investigators that he "had to kind of work with that a bit," but he did not elaborate.

Postaccident photo of the *Natalie Jean*'s primary steering control, which had been modified with a wooden rod taped to the end to extend it. (Photo by Coast Guard)

The pilot's decision to transit upriver in the general anchorage, given his unfamiliarity with the vessel (including its modified steering stick extension) and the close proximity to both anchored and underway vessels in high-water conditions and strong winds, increased the navigational challenges leading up to the accident. The pilot said that the current was not as strong outside the main shipping channel. However, transiting in the general anchorage confined him as fleeting operations were being conducted inside the anchorage, which eventually forced him to try to return the tow to the main shipping channel. AIS data showed the *Natalie Jean* transiting on a parallel course on the port side of the *Atlantic Fairy*, and as the towboat passed the bow, the vessel turned sharply to the right, indicating the moment that the towboat likely caught the bulker's port anchor chain. The pilot's decision to transit closely alongside the *Atlantic Fairy* resulted in the contact with the chain.

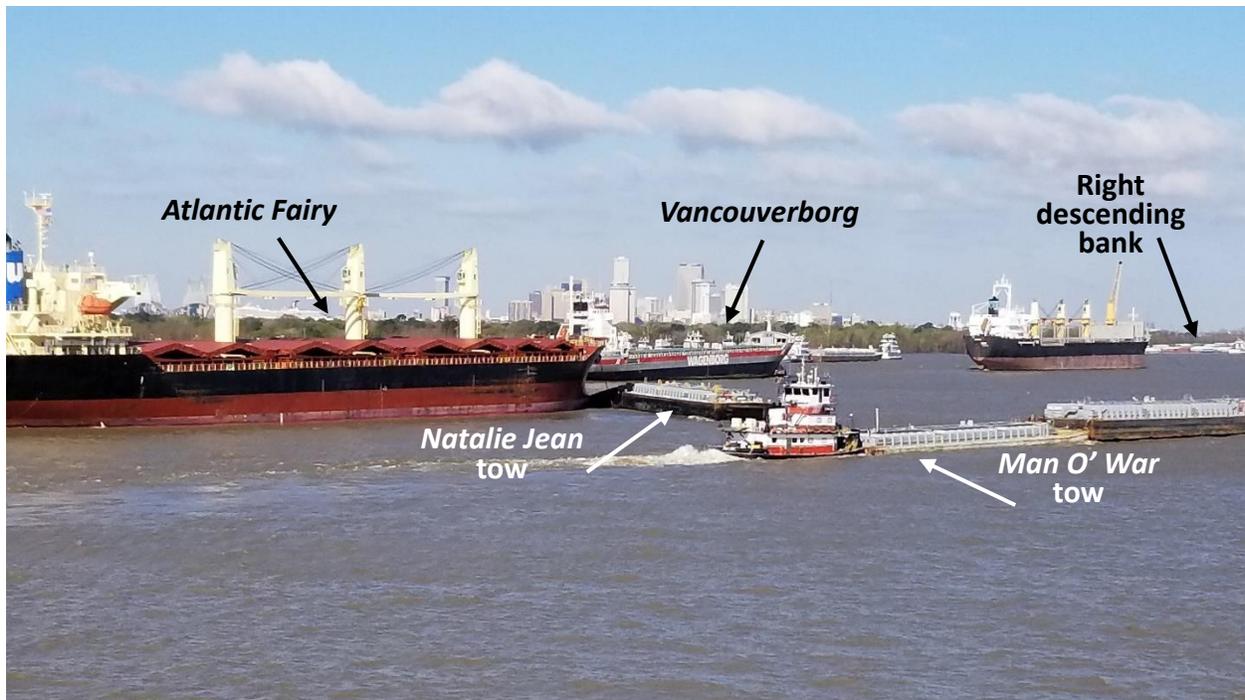
The tow then became pressed about perpendicularly against the bulbous bow of the *Atlantic Fairy* and also against the bulker's starboard anchor chain. The *Natalie Jean* subsequently heeled to port, and the port tow wire parted under tension. Seconds later, the *Natalie Jean* capsized and the barge broke free. The *Natalie Jean* then quickly sank.

Photo (looking upriver) of the *Natalie Jean* tow perpendicular to the *Atlantic Fairy*. The towboat has capsized and is sinking. (Photo by Moran Towing)

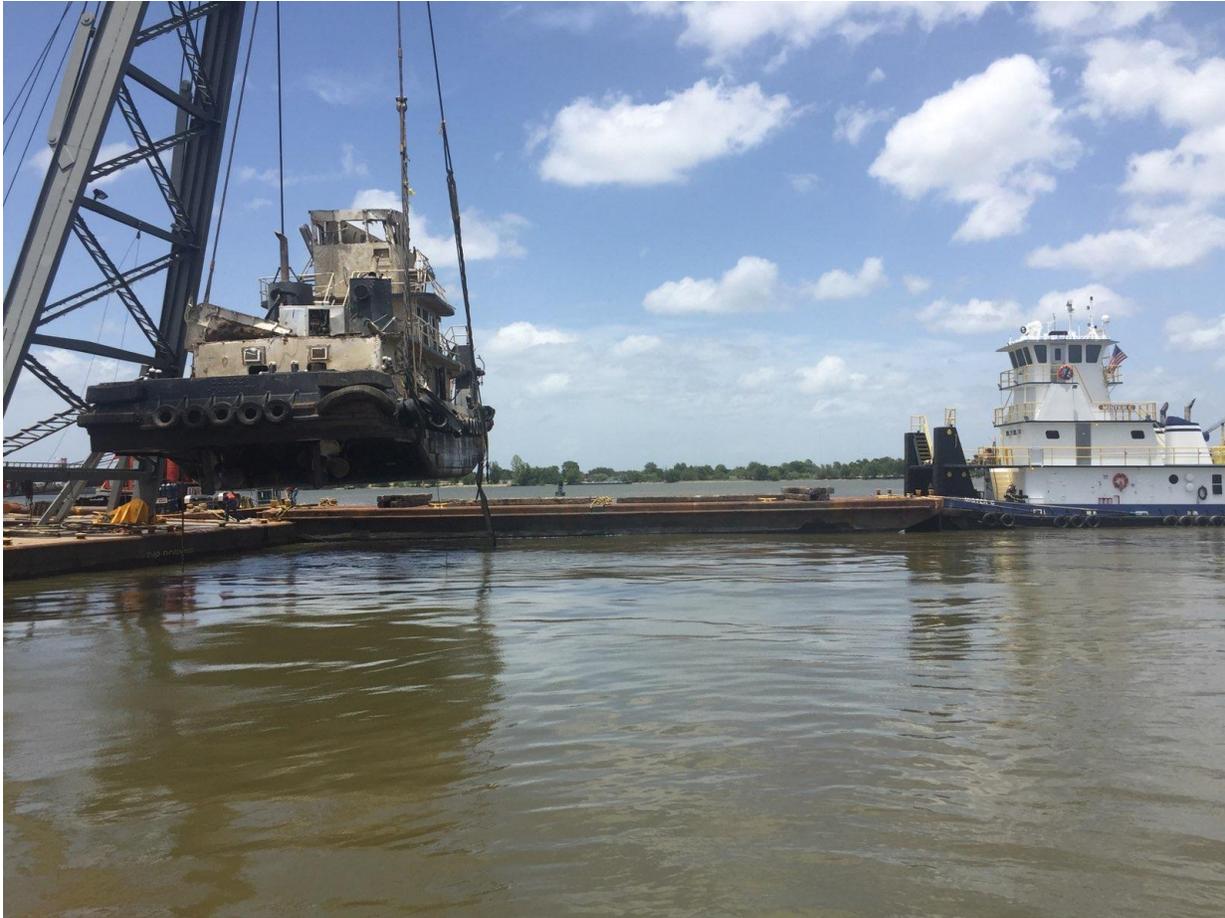
According to the damage survey report, the *Natalie Jean*'s shaft, propellers, and flanking rudders were severely damaged, likely during salvage operations. Because the vessel was upside down on the river bottom, it had to be strapped in order to flip it, causing damage around the shaft and flanking rudders. The steering linkage was sheared on the starboard side, near the piston. It could not be determined if the steering gear was sheared following the casualty, prior to the casualty, or during salvage operations.

*Natalie Jean* being salvaged. The vessel was upside down on the river bottom and sustained damage to the shaft and flanking rudders in the recovery efforts. (Photo by Coast Guard)
