National Transportation Safety Board

Marine Accident Brief

Pipeline Breach and Subsequent Fire aboard Cutter Suction Dredge *Jonathon King Boyd* and Towboat *Bayou Chevron*

Accident type	Fire/Explosion	No. DCA18FM021
Vessel names	<i>Jonathon King Boyd</i> (dredge), <i>Bayou Chevron</i> (towboat)	
Location	Matagorda Bay, Texas, 28°27.54'N 96°23.02'W	
Date	April 17, 2018	
Time	2014 central daylight time (coordinated universal time – 5 hours)	
Injuries	None	
Property damage	Total of about \$7.3 million est.	
Environmental damage	3,458 barrels of condensate and 12,680 MSCF of natural gas released, est. ¹	
Weather	Clear, visibility 8 miles, winds south-southeast at 8–10 mph, less than 1-foot waves, air temperature 72°F, water temperature 71°F ²	
Waterway information	Matagorda Bay is a large estuary on the Texas coast, about 80 miles northeast of Corpus Christi. The Gulf Intracoastal Waterway channel at the intersection with Matagorda Ship Channel has a controlling depth of 10 feet.

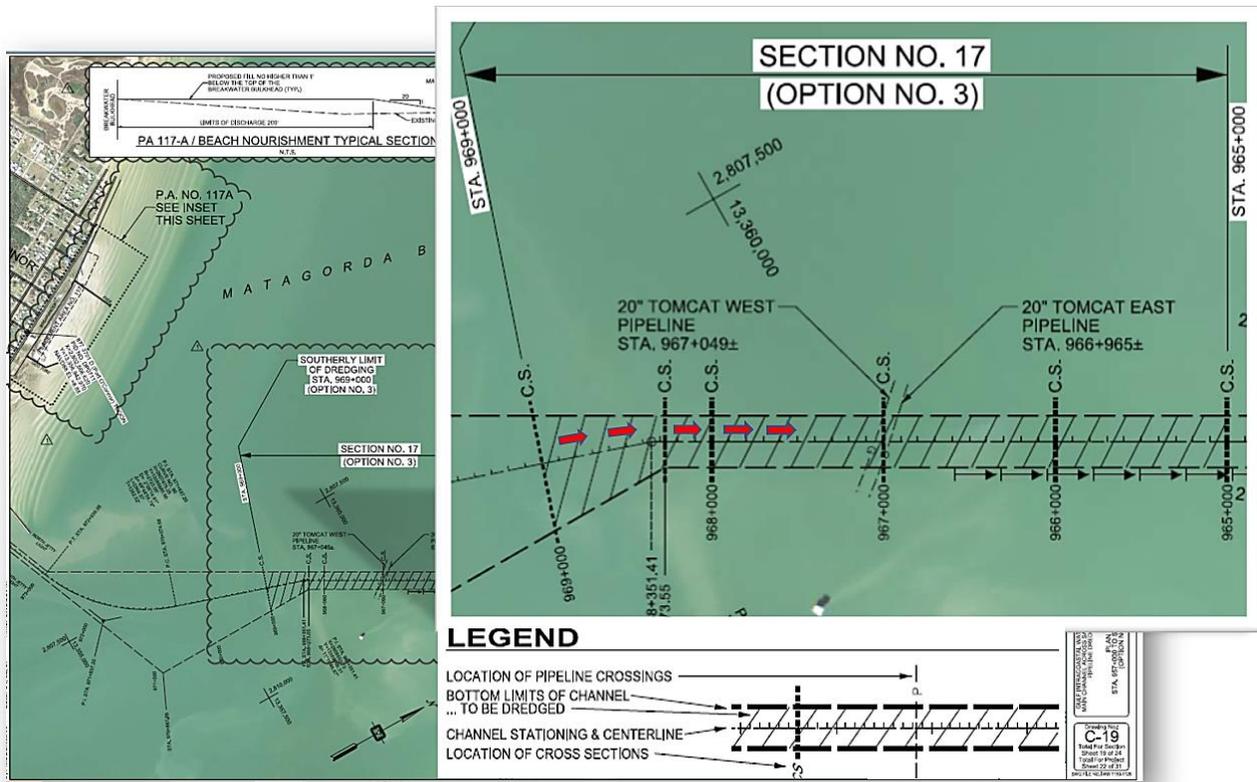
Extracts from USACE Drawing No. C-19 depicting the dredging plan for Option No. 3, Section No. 17 for the Gulf Intracoastal Waterway. The red arrows display *Jonathon King Boyd's* easterly dredging trajectory, commencing at the southern section (STA. 969+000).

Jonathon King Boyd commenced round-the-clock dredging operations in a northeast direction toward the Matagorda Ship Channel intersection from station 969+000 (see image above). Two crews, each with a rotation of 14 days on and 7 days off, dredged in 12-hour shifts. During each 12-hour shift, the vessel advanced about 100–150 feet through dense compact sand on the north (red buoy) side of the channel's centerline. The contracted depth of dredging was 14 feet, with an over-depth allowance of 2 feet. The dredge operators (levermen) were instructed to dig to a depth of 16 feet. The operations were progressing as scheduled; neither the dredging crew nor USACE reported any delays or issues.

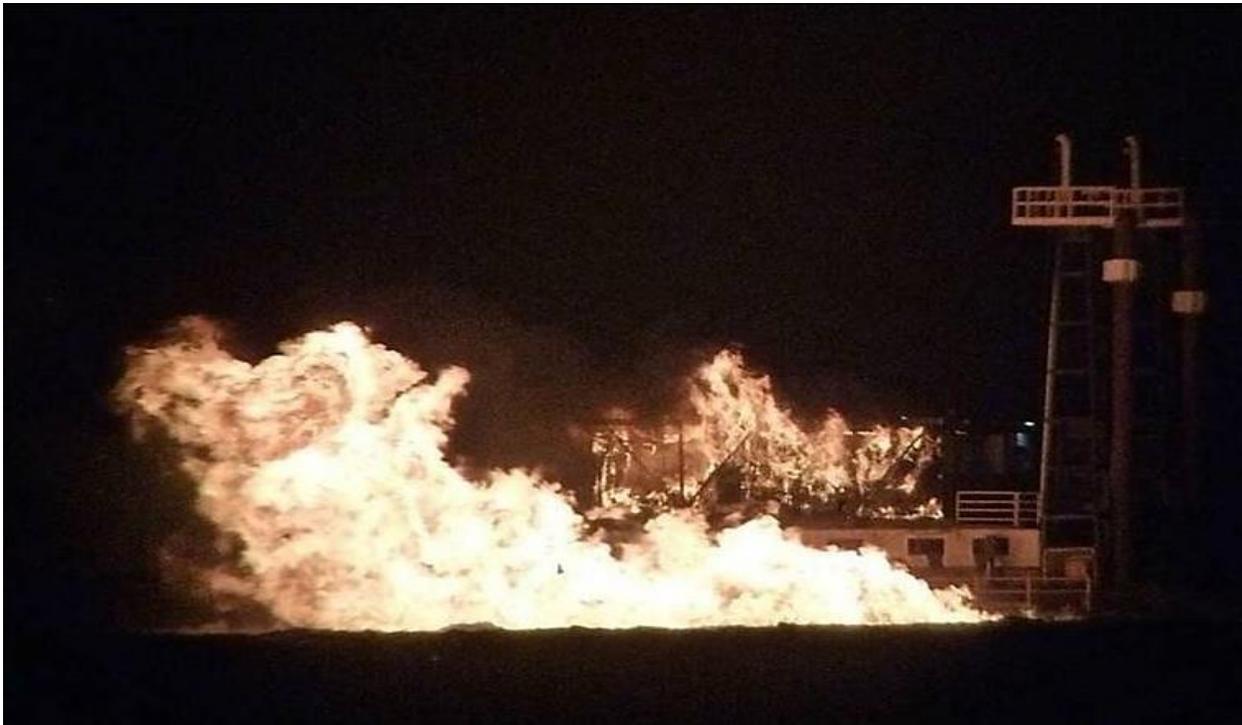
based on the wind and current and previous experience. The leverman informed the captain, who along with the chief mate was ashore eating dinner. The captain instructed the crew to cease operation and replace the pipeline with a spare located on the nearby supply barge. The captain and chief mate hurried back to the *Jonathon King Boyd* via a workboat. The mate and deckhand returned with the spare pipeline aboard the towing vessel *First State* while the boatman and engineer raised and inspected the discharge line. The mate also examined it for signs of damage and found none, but still noticed bubbles rising to the surface off the stern. He asked if a pipeline was present at the location. None of the crew recalled smelling natural gas at that time. The leverman and engineer went to the galley to look at the nautical charts where they discovered a charted submarine pipeline at their location. They informed the captain, who then ordered the mate and deckhand (aboard the *First State*) to pick up the anchors and move the dredge away from that location for the safety of the crew and vessel. The captain contacted the company, who in turn notified the Coast Guard, National Response Center, and Texas General Land Office. As the crew prepared to move the dredge and as the leverman was raising the port spud, a geyser of gas and water—35–40 feet high by crew accounts—erupted from the stern of the vessel. The crew immediately smelled gas and headed for the muster station, which was located on the dredge's main deck, forward on the starboard side. The mate and the deckhand, who were retrieving the port anchor, also saw the plume of gas and water and immediately returned to the vessel. Shortly thereafter, about 2014, fire erupted near the stern of the dredge port side. All 10 crewmembers were accounted for. They followed their emergency response procedures and abandoned the dredge to the *First State*, which then quickly moved away as fire consumed the dredge and the *Bayou Chevron*. No one was injured.

***Jonathon King Boyd* burns after striking a submarine gas pipeline. (Source: Coast Guard video)**

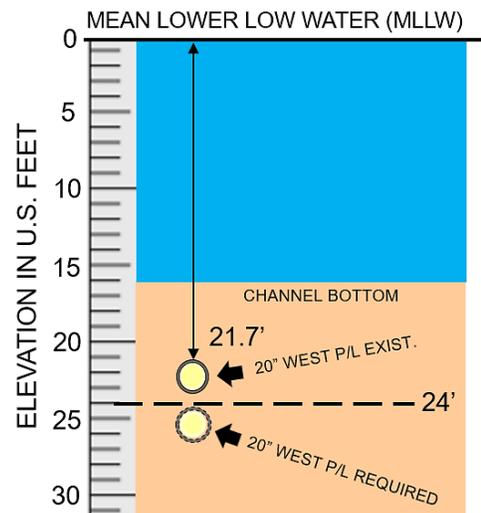
USACE has regulatory responsibilities pursuant to Section 10 of the Rivers and Harbors Act of 1899 (33 *United States Code* §403) under which the Corps authorizes structures and work in or affecting the course, condition, or capacity of navigable waters. The Corps required the top of the West pipeline to be below 24 feet at mean lower low water (MLLW).⁴ According to the *U.S. Coast Pilot*, under ordinary weather conditions, the mean tidal range was about 1.5 feet for Matagorda Bay. Hydrographic surveys completed after the accident by USACE and Genesis Energy found that the water depth in the accident area was between 14 and 16 feet deep, corrected for tidal height at MLLW. A postaccident dive survey was conducted by Oceaneering International Inc. on April 26. The survey estimated the elevation at the top of the pipeline, at the ruptured location, to be about 21.7 feet below MLLW.

20-inch TOMCAT West pipeline (P/L) existing and required depth. (Source: *U.S. Coast Pilot*)
