National Transportation Safety Board

Marine Accident Brief

Fire aboard Fishing Vessel *Rose Marie*

Accident type	Fire/Explosion	No. DCA18FM033
Vessel name	<i>Rose Marie</i>	
Location	Atlantic Ocean, 67 miles east of Chatham, Massachusetts ¹ 41°36.68' N, 068°26.87' W	
Date	August 23, 2018	
Time	1030 eastern daylight time (coordinated universal time – 4 hours)	
Injuries	None	
Property damage	\$700,000 est.	
Environmental damage	None	
Weather	Visibility 10 miles, overcast, winds south-southeast 7 knots, seas 1–2 feet, air temperature 54°F, water temperature 44°F, sunrise 0545, sunset 1927	
Waterway information	Open waters in the Atlantic Ocean

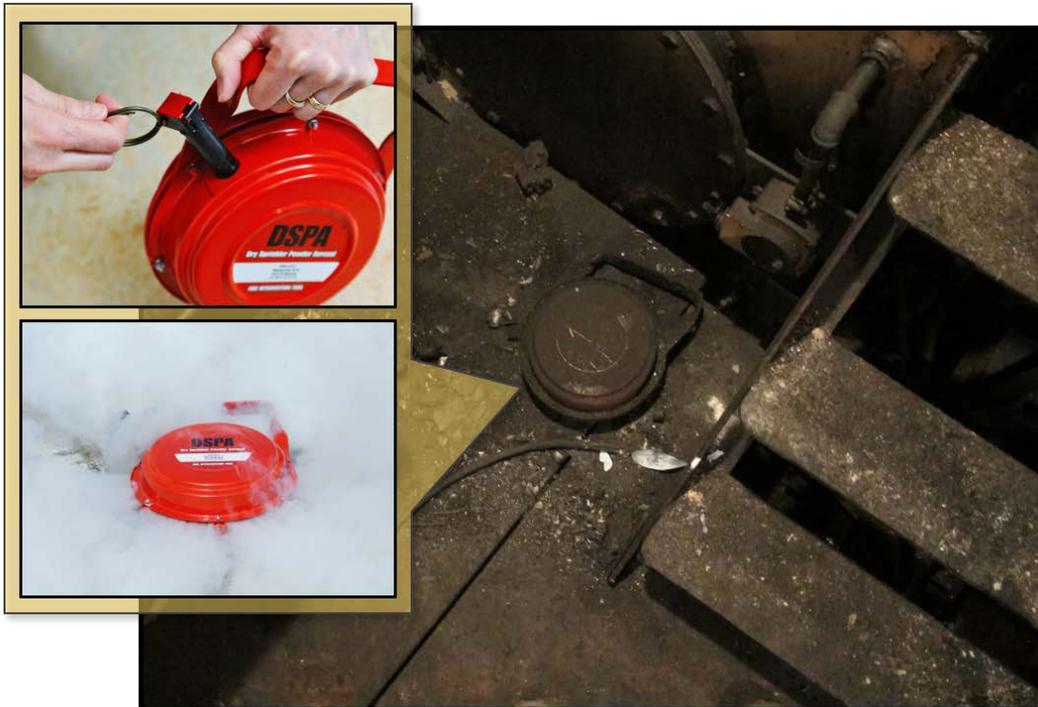
Grenade-type aerosol fire extinguisher used initially to combat the fire sits on the deck of the engine room near the entrance ladder. At left, two photos from the manufacturer's website demonstrate how the device activates.

Crewmembers attempted to fight the fire using a grenade-type aerosol extinguisher in the engine room. It was rated for spaces up to 5,300 cubic feet in volume, “considering there are no big (ventilation) holes or openings,” according to the manufacturer. Although investigators calculated that the engine space was less than 5,300 cubic feet, the aerosol extinguisher was not effective. The manufacturer recommended that spaces be sealed completely when using the handheld aerosol grenade, yet the engine room door and vents remained open throughout the fire. Further, the wooden cable trunk served as a ventilation path. Therefore, the handheld aerosol grenade was rendered ineffective. Although fishing vessels the size of, and operating in water similar to, the *Rose Marie* are uninspected by the Coast Guard, fire extinguishers aboard these vessels are regulated by the Coast Guard. The owner chose to carry the grenade-type aerosol extinguisher in addition to the other fire equipment on board the vessel, although it did not meet the requirements for portable fire extinguishers established by the Coast Guard.

Grenade-type aerosol fire extinguishers were used to fight engine room fires in this accident and an earlier fire on the fishing vessel [Logger](#)—but did not extinguish the fire in either accident. In both cases, the crews did not close all openings, such as engine room doors and other ventilation, thus reducing the effectiveness of the extinguisher. When using such devices or designing any vessel space for the prevention of fires, vessel owners and operators should identify openings, provide means to ensure they can be properly secured in order to contain a fire, and train crewmembers on how to secure them during a fire emergency.

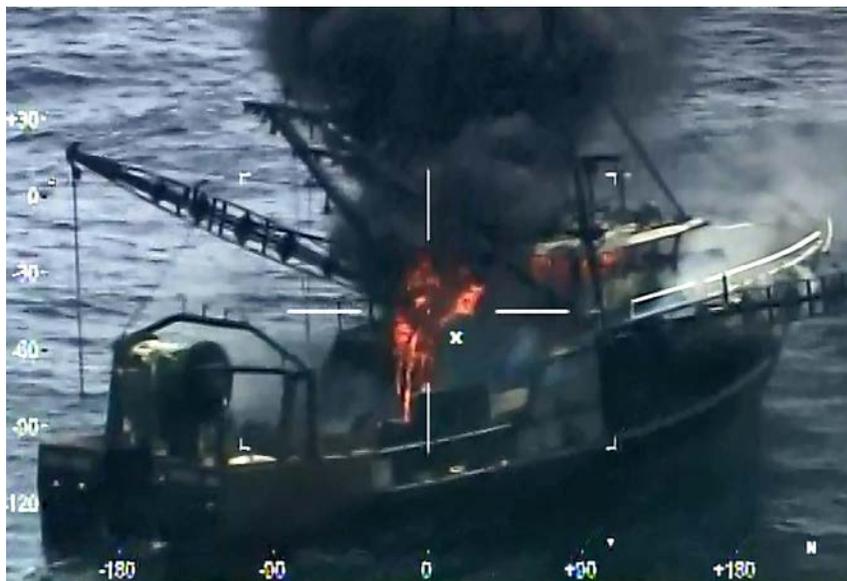
Video screenshot of the *Rose Marie* from the Coast Guard's aircraft, which had been dispatched to the fire. The camera's crosshairs capture the flames consuming the net on the drum.

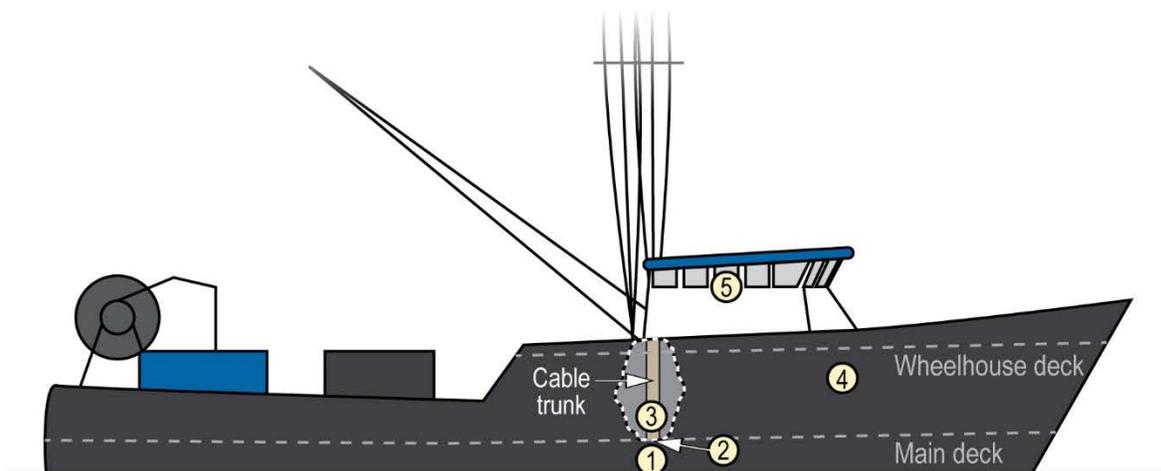
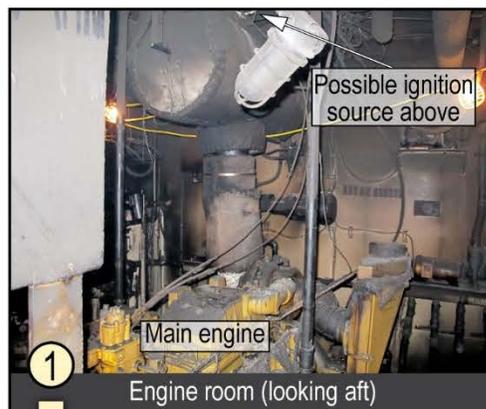
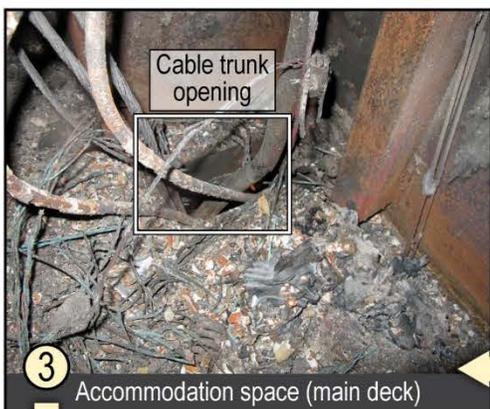
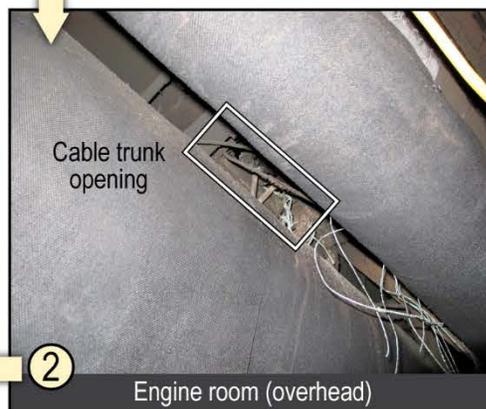
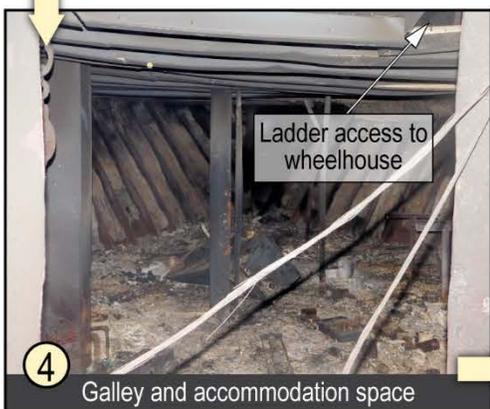
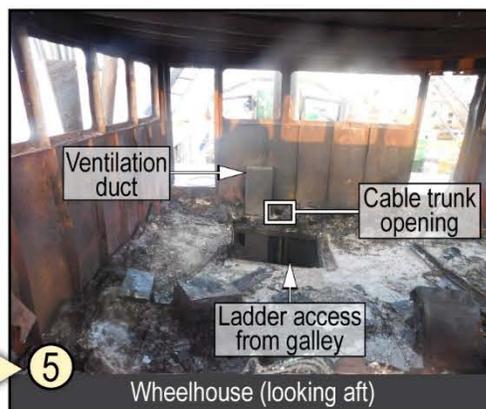
Photos of fire damage trace the fire's path through the *Rose Marie* as flames

1. began above the main engine in the engine room,
2. traveled through the wooden cable trunk opening overhead,
3. entered the accommodation space through the cable trunk opening,
4. spread to the galley and throughout the accommodation space, and
5. entered the wheelhouse through the cable trunk and ladder access.

The exact source of the fire could not be determined, but investigators concluded that an electrical ignition source was more likely than a hydraulic fluid leak because of (1) the heat required to generate the initial cable trunk fire and (2) the fire damage in the vicinity of the base of the trunk compared to the minimal damage near the main engine.

Flames cannot spread easily through insulated steel decks or bulkheads. The deck between the accommodation space and the wheelhouse on the *Rose Marie* was steel, but the cable trunk running through it was constructed of uninsulated flammable material (wood). As an uninspected fishing vessel, the construction of the cable trunk on the *Rose Marie* was not subject to any fire-protection regulations, as required for the construction on Coast Guard-inspected vessels. For example, on inspected passenger vessels, regulations stipulate the length of time bulkheads, decks, and overheads must prevent the passage of flames and smoke.⁷ A vertical trunk penetration through an overhead must be designed or insulated to withstand the same temperature rise limits as the boundary (bulkheads and decks) penetrated. Had the trunk opening on the *Rose Marie* been sealed and its surrounding structure insulated with fire-retardant materials, the fire would not have been able to rapidly spread, and damage may have been limited to the engine room.

The National Transportation Safety Board determines that the probable cause of the fire aboard the fishing vessel *Rose Marie* was arcing of an electrical wire in the engine room overhead igniting a wooden cable trunk. Contributing to the severity of the damage was the installation of a trunk that compromised the steel boundary of the engine room, allowing the flames to spread to the combustible materials in the upper decks.
