National Transportation Safety Board

Marine Accident Brief

Flooding and Sinking of Hopper Barge *PTC 598*

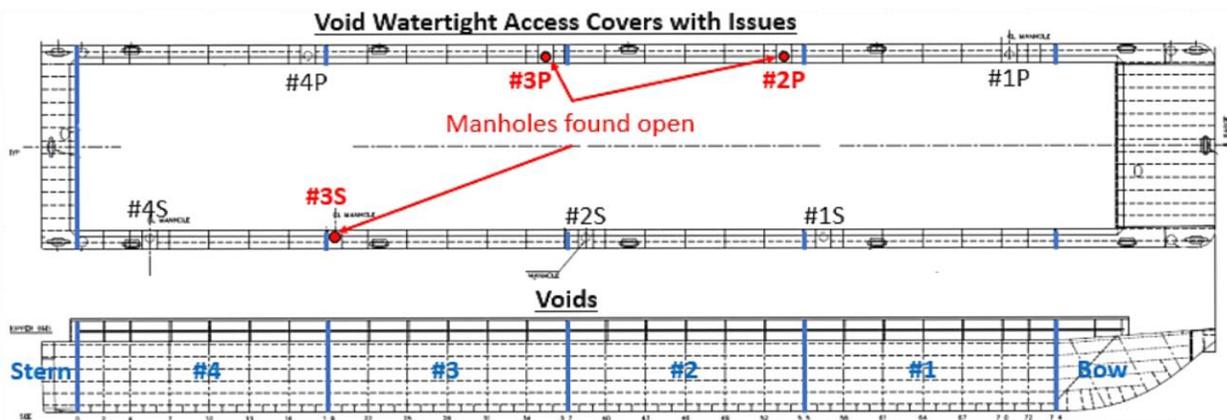
Drawings of *PTC 598* as viewed from above and from the starboard side: The top image shows the three manhole covers found open during the underwater survey. The bottom image shows the six void spaces.

In the underwater video of the barge’s deck, three of the eight manhole covers to the side voids were found open: both port and starboard covers to void no. 3 and the port cover to void no. 2. It is not known if these covers were insufficiently secured, left open, or possibly popped

open when the barge struck the seafloor. The covers to the bow and stern voids were found in the closed position.

only about 2 feet 6 inches of freeboard. The postaccident dive survey found that the port and starboard manhole covers to void no. 3 and the port cover to void no. 2 were open, indicating that they were likely not properly secured or left open before sailing, and would therefore have allowed water ingress to both voids. As the voids filled with water, the barge's draft would have increased and its freeboard concurrently decreased, allowing boarding seas to more easily reach the lower edge of the weathertight fiberglass cargo covers and flood the barge's single cargo hold, causing the barge to sink rapidly.

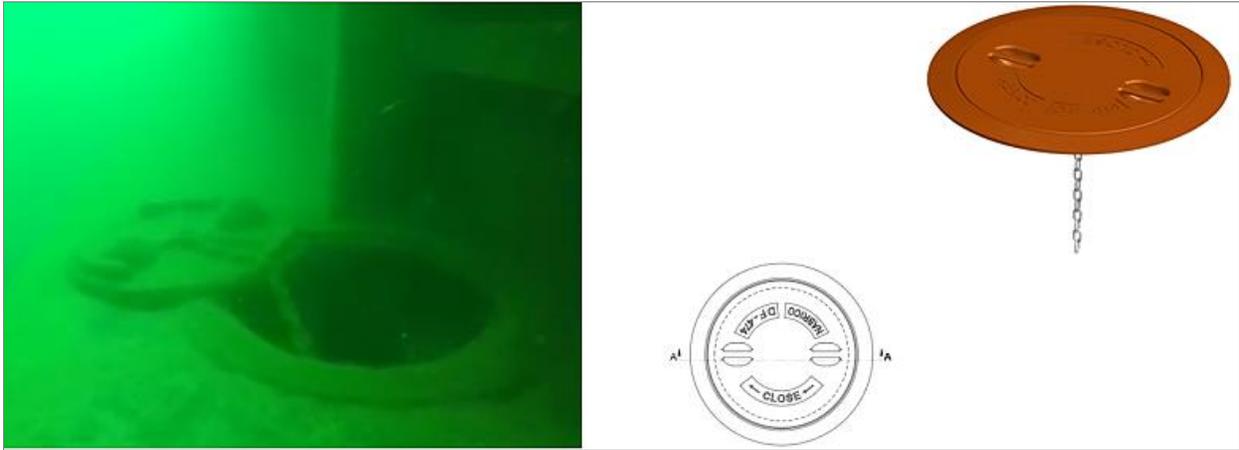
Left, the open starboard manhole to void no. 3. Right, two views of a manufacturer's twist-lock manhole cover. (Photo by MAB Inc; courtesy of NABRICO)

In postaccident interviews, the marine surveyor who had examined the barges before the accident told investigators that the *PTC 598*'s twist-lock manhole covers (flush to the barge's deck) that accessed the side voids appeared serviceable and that the gaskets were intact. He said that all the manhole covers were open during the survey and he did not physically operate any of the securing mechanisms at that time. The surveyor also stated that because of the damaged and inoperative dog assemblies, the hatches on the *PTC 625*'s bow and stern voids would not be watertight.

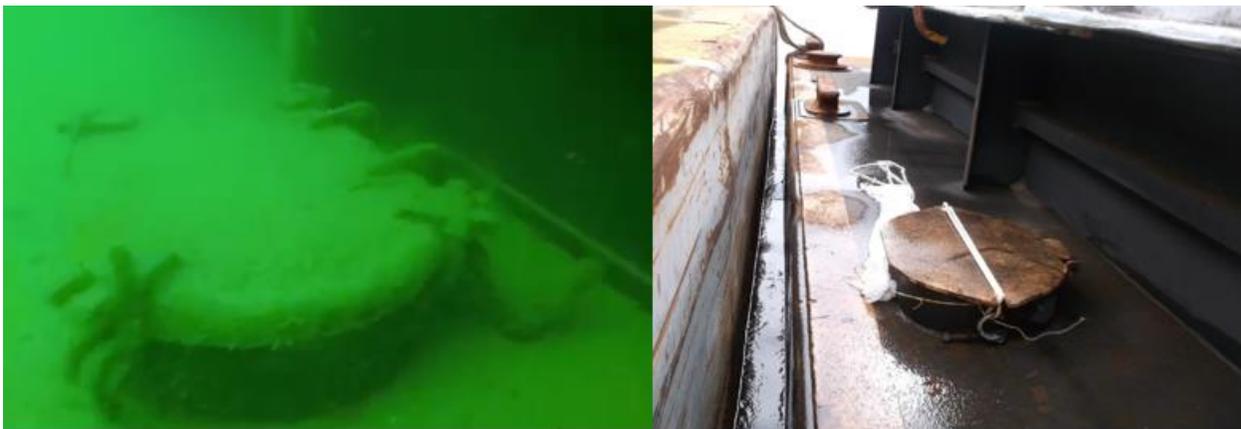
Postaccident views of two manhole hatch covers to stern voids. Left, a cover on the sunken *PTC 598* is dogged down and secure. Right, a manhole cover on the *PTC 625* is in poor condition, with missing dogs, and strapped down with line. (Photos by MAB Inc and The Shear Group)

Barge *PTC 625* lacked watertight integrity when it was surveyed in Mobile and accepted for bareboat charter and when the tow got under way on the accident voyage. The barge owner offered *PTC 625* for charter with inoperative dogs on the watertight manhole covers accessing the bow and stern voids, and LA Carriers accepted the barges despite being made aware of the issue by the on-charter marine surveyor. During the same survey, the *PTC 598* appeared to have all weather- and watertight closures in proper working condition.

1. Stricter barge acceptance terms will require that all dogs be in working order (voids watertight);
2. Barges must not be older than 10 years;
3. Barge depths must be 13–14 feet high to give the loaded barges 1–2 feet more freeboard (the *PTC 598* depth was 12 feet, giving it a freeboard of only 2 feet 6 inches in 4–5-foot seas);
4. LA Carriers will provide weather and seas information to crews for determining whether to get under way or remain in port until conditions improve;
5. On-charter surveys must be fully completed; and
6. On-charter surveyors will recommend whether or not to charter the barges.
