National Transportation Safety Board

Marine Accident Brief

Contact of the Cruise Ship *Nippon Maru* with Mooring Dolphins

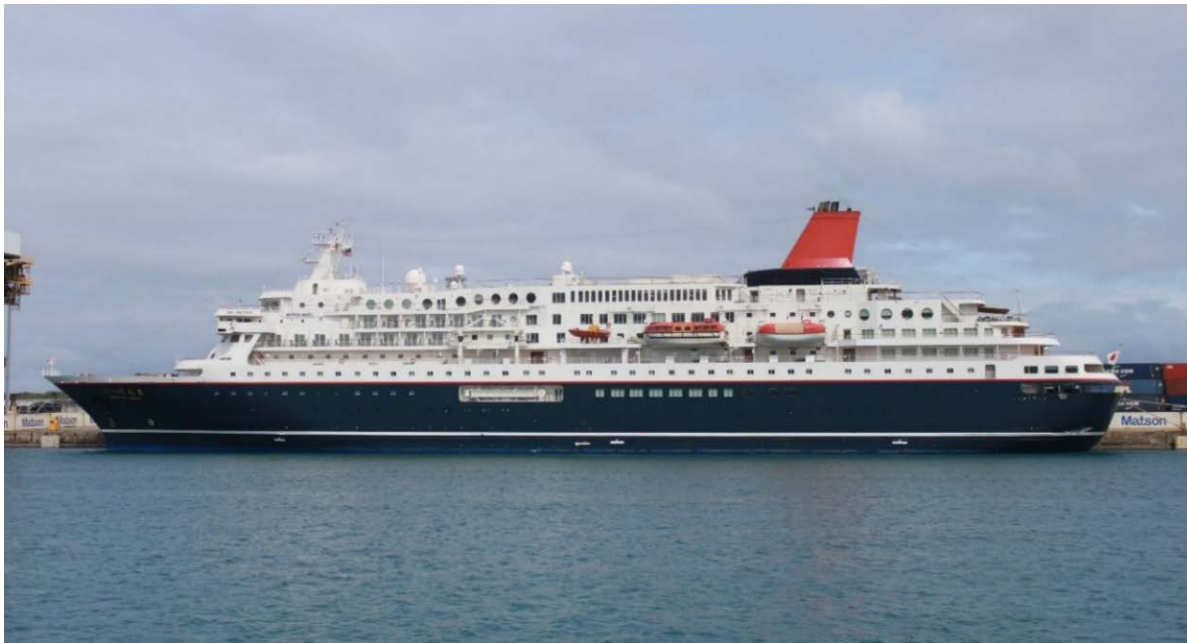
Nippon Maru in Apra Harbor postaccident. (Source: US Coast Guard)

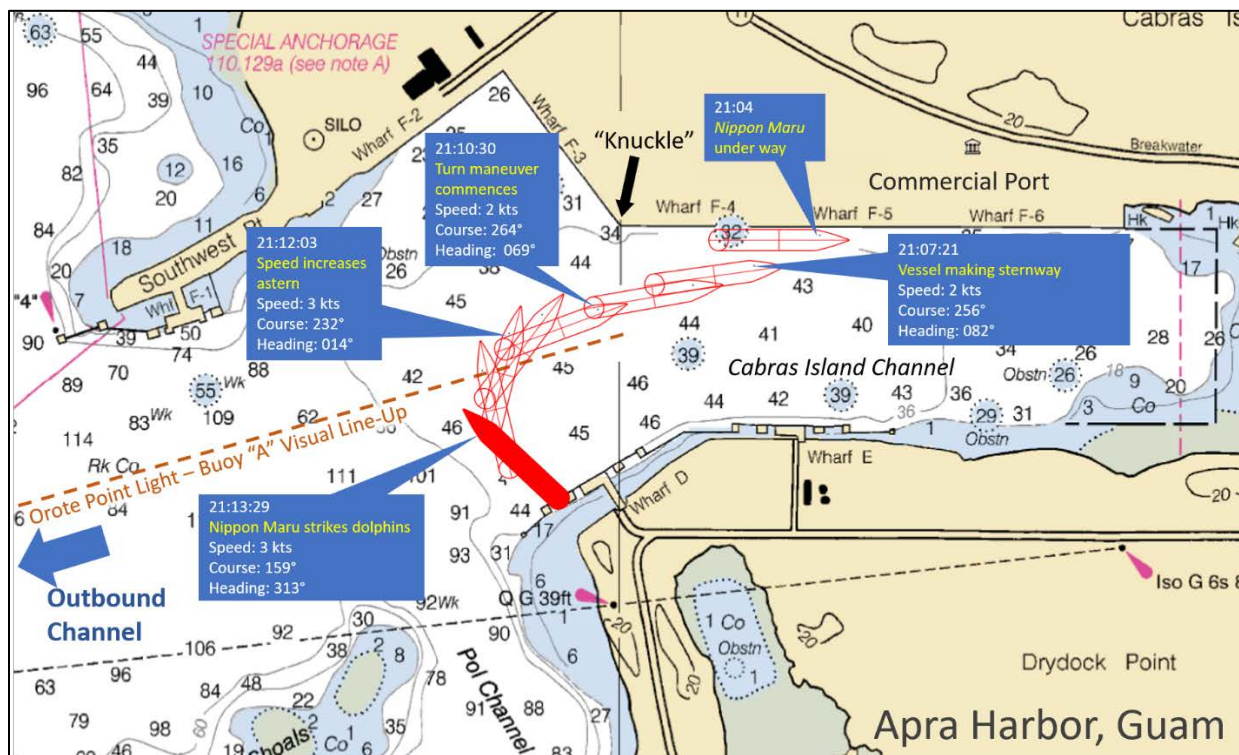
Accident timeline reconstructed from automated identification system (AIS) data. (Background adapted from National Oceanic and Atmospheric Administration chart 81054)

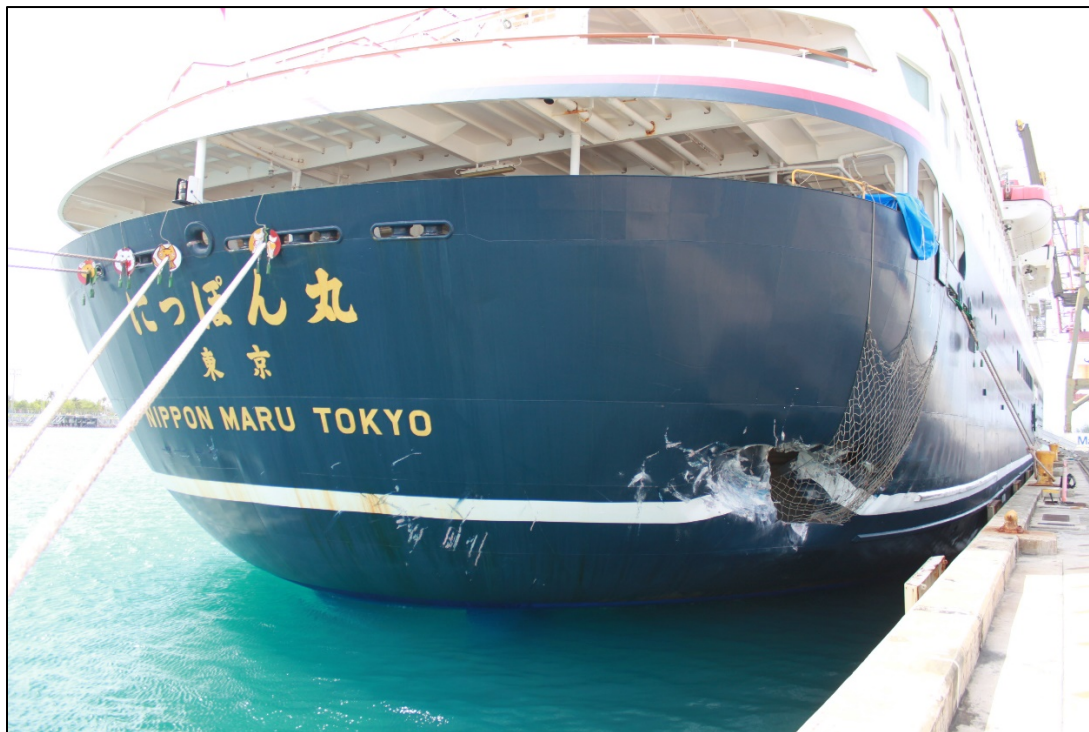
Damage to the *Nippon Maru*'s starboard stern. (Source: Coast Guard)

The strike opened a large hole in the starboard side of the *Nippon Maru*'s stern and a gash in the port side stern. Both of the concrete dolphins at the D wharf were damaged in the accident, and a catwalk that spanned the gap between the dolphins was destroyed.

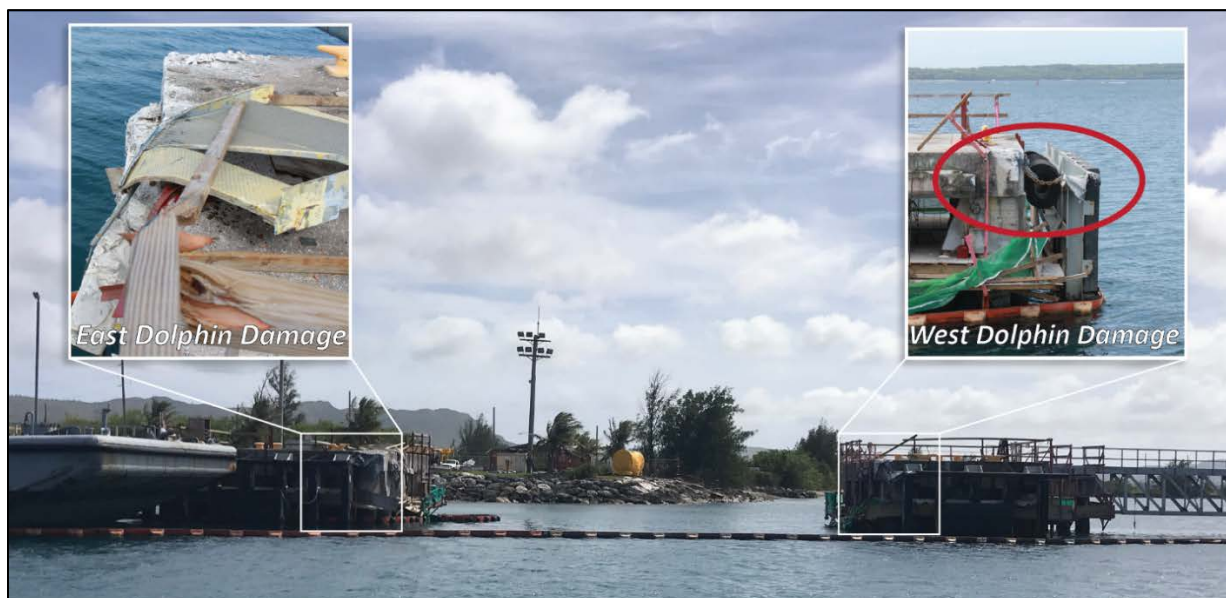
Damage to Navy D Wharf dolphins. (Source: Coast Guard)

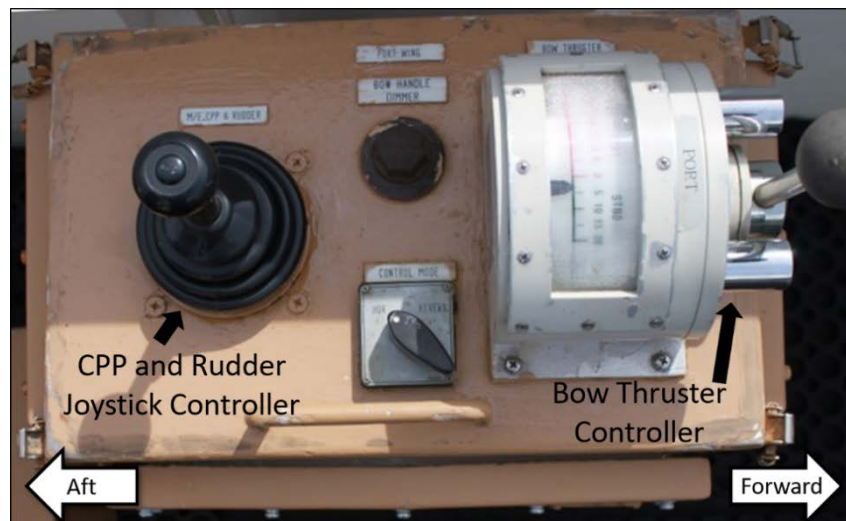
to the astern position. Statements from the third officer and bridge wing VDR audio recorded during the accident sequence confirm that the master moved the joystick astern, eventually moving it to full astern, and kept it there until after the vessel struck the mooring dolphins.

Port bridge wing control station. (Source: Coast Guard)
