National Transportation Safety Board

Marine Accident Brief

Flooding and Sinking of Fishing Vessel *Aaron & Melissa II*

Accident type	Flooding	No. DCA19FM006
Vessel name	<i>Aaron & Melissa II</i>	
Location	Gulf of Maine, 70 nautical miles southeast of Portland, Maine ¹ 43°11.2' N, 068°37.3' W	
Date	November 14, 2018	
Time	0800 eastern standard time (coordinated universal time – 6 hours)	
Injuries	1	
Property damage	\$650,000 est.	
Environmental damage	3,000 gallons of fuel and lube oil	
Weather	Overcast with precipitation, visibility 12 miles, winds east 41 knots gusting to 50 knots, wave heights 19–20 feet, air temperature 33°F, water temperature 50°F	
Waterway information	Gulf of Maine, Atlantic Ocean

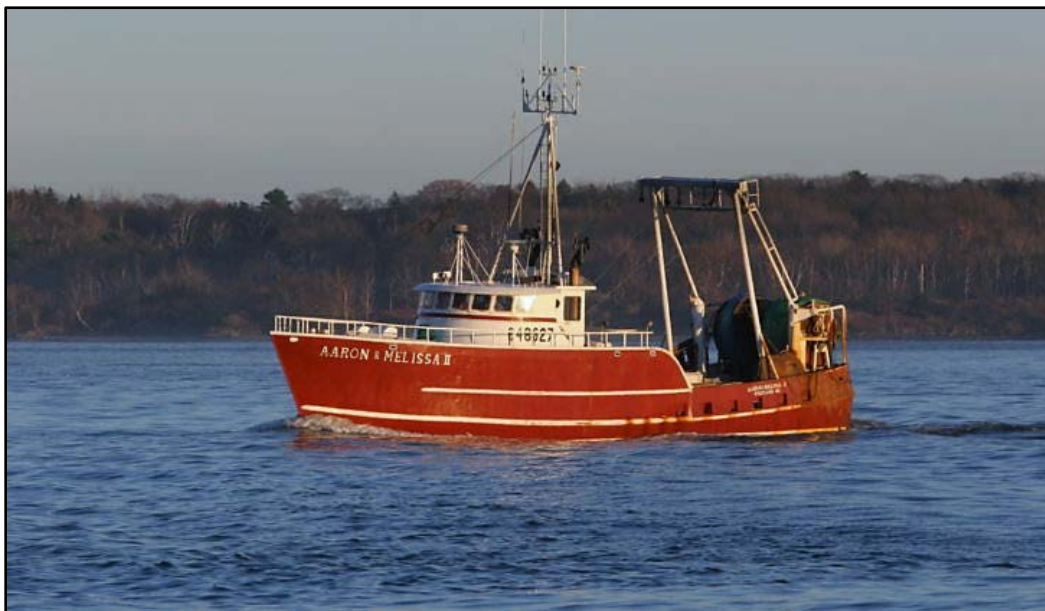
Aaron & Melissa II prior to sinking.

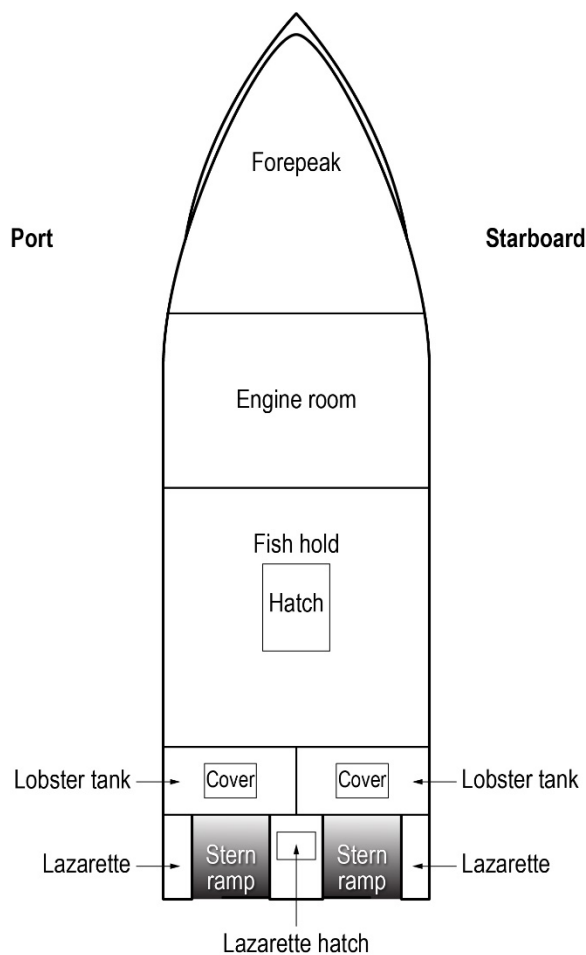
Schematic of *Aaron & Melissa II*.

Each of the two lobster tanks located just forward of the lazarette had the capacity to hold approximately 3,500 gallons of water (7,000 gallons combined) within the hull of the vessel. The captain told investigators that the lobster tanks were routinely used by the crew to ballast the vessel when it had no catch on board and to trim the vessel when loaded. Fishing gear (including nets, ropes, and twine) also was routinely stored in these holding tanks. During the transit, the captain wanted both tanks empty because the vessel was loaded (85 percent full of catch). Both the owner and captain stated that they understood the vessel was designed to operate with the lobster tanks full.

The hatch covers for the two lobster tanks were located on the main deck where the nets were hauled in. When the vessel was constructed, these hatches were originally round and made of aluminum. Sometime in the late 1990s, the tanks were modified by the current owner, and rectangular-shaped, steel hatches were installed. The switch from aluminum to steel hatch covers was due to the damage sustained by the aluminum covers during normal fishing operations. The weight of each steel hatch cover required two people to lift and move them. The rectangular hatch covers, as described by the crew, were flush with the deck and did not have gaskets.

There were no high-water alarms located in the lobster tanks. The captain and crew told investigators that the covers were not watertight; even when the tanks were secured, water on deck would often leak into them. Thus, the captain had a standing verbal order for crewmembers at the helm to pump the tanks when they saw water collecting on deck aft of the deckhouse: water pooling in this area was an indication that the tanks were flooding, consequently increasing the vessel's trim by the stern (i.e., the stern sat lower in the water). Additionally, he said that with full lobster tanks and water on deck, the vessel's freeboard decreased.³ According to the captain, with the stern deeper in the water, the rudder post gland would leak at a higher rate—fast enough to flood the lazarette.

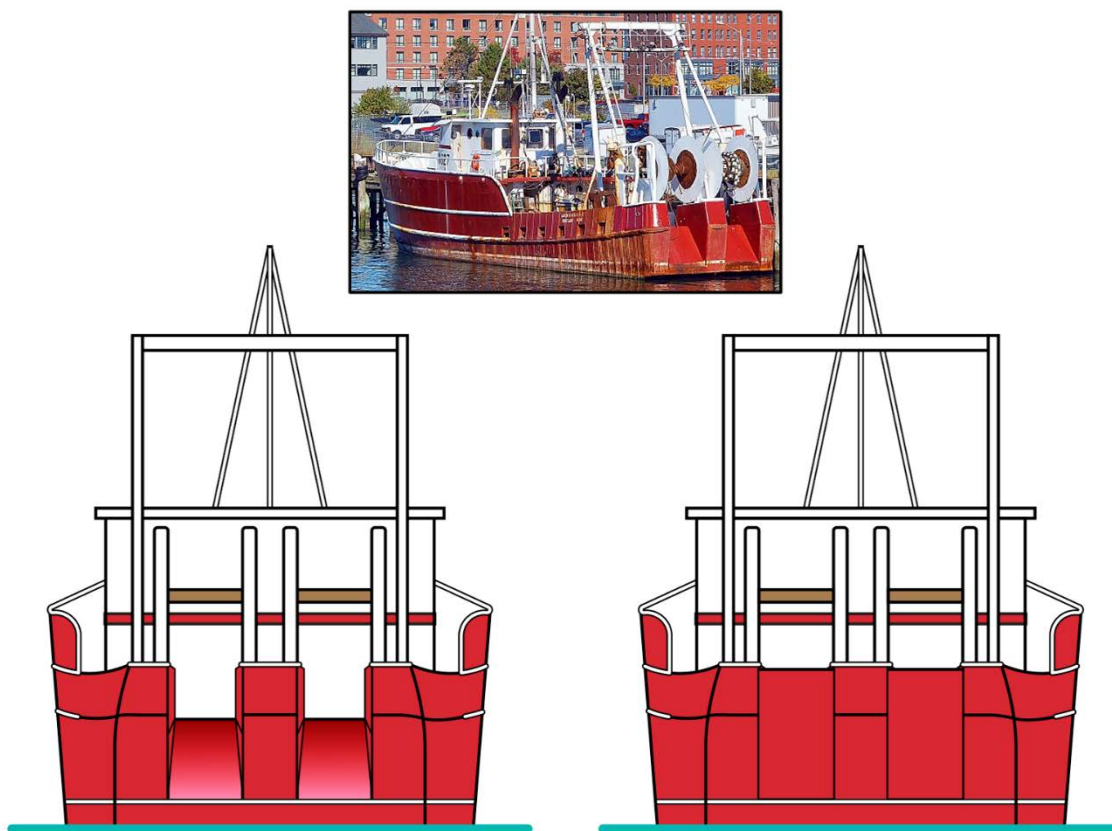
A diagram of the stern ramp gates in the open (at left) and closed (at right) positions.

At 0200, waves hitting the stern of the vessel sheared the two securing pins on the port stern ramp gate, causing it to open and resulting in an increase of water on the deck. The engineer woke

The crew was able to secure the two stern ramp gates despite water on deck and waves crashing on them. However, the makeshift rebar pins kept breaking, so the gates would open again. Shortly thereafter, the hinges connecting the bottom of both gates to the vessel's hull also broke, which meant the gates could no longer be secured, so the crew returned to the wheelhouse.
