National Transportation Safety Board

Marine Accident Brief

Contact of the *Andrew Cargill MacMillan* Tow with Grain Conveyor

| Accident type | Contact | No. DCA19FM004 |

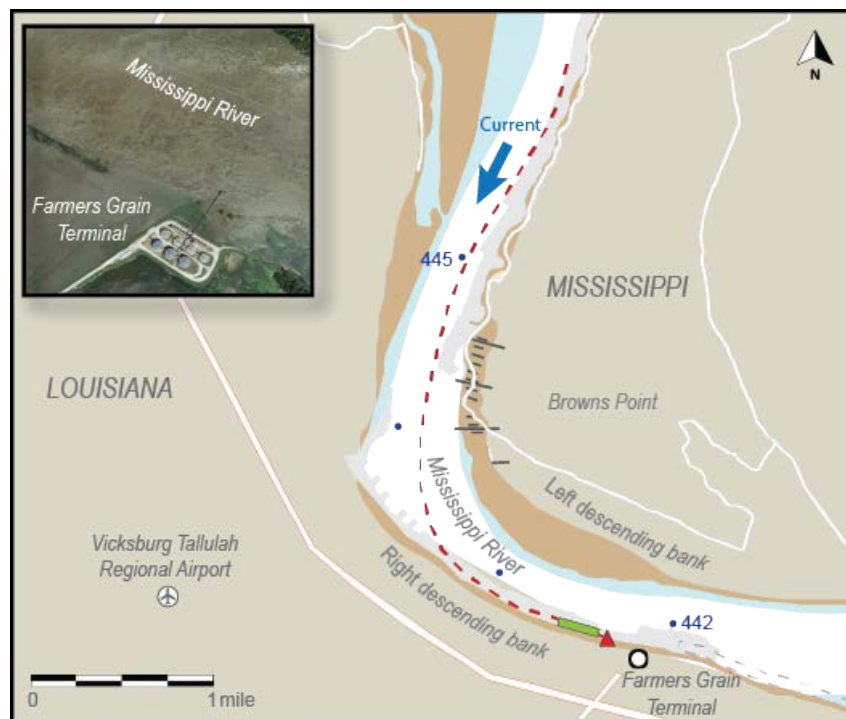
Trackline of the *Andrew Cargill MacMillan* showing the vessel's course from north of mile 445 to the accident location at Farmers Grain Terminal. (Inset image background source: Google Earth)

About 1410, he steered the head of the tow toward a line of three red, conical buoys (which were not shown on the navigation chart displayed on the ECS) marking shallow water on the left descending bank to commence his turn through the bend.⁴ About a minute later, he lost sight of the closest red buoy. Sighting an object in the water in the vicinity of the red buoy, and thinking it was the buoy, he steered the vessel toward it. About two minutes passed before the pilot saw the

red buoy pop up from under the water. By that time, the head of the tow was in the center of the river and in the trough of the current. Realizing the *Andrew Cargill MacMillan*'s tow had “slid out of the turn,” with the current pushing the vessel and tow towards the right descending bank, the pilot applied hard rudder to steer the head of the tow to port toward the other red buoys and the left descending bank.⁵

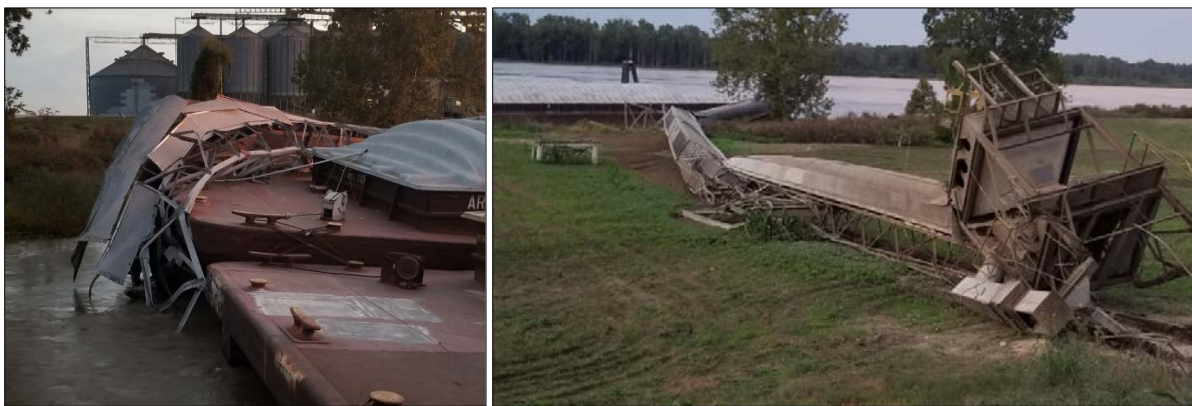
About 1426, the barges at the head of the tow contacted the breasting dolphins and grain conveyor. The third lead barge from the starboard side came to rest on top of the dolphins, and two of its voids were punctured and began to take on water. Two (of four) steel breasting dolphins and the conveyor were knocked over. Once the vessel came to a stop, the pilot used the flanking rudders and astern propulsion to keep the stern of the *Andrew Cargill MacMillan* off the bank. The captain arrived in the pilothouse shortly after the contact and relieved the pilot at the controls.

Left: Postaccident photo of the damaged conveyor and catwalk laying across the forward deck of barge ART 44160. Right: Postaccident picture of damaged conveyor as seen from the bank looking toward the river. (Source: Budwine and Associates Inc.)

The tow of the *Andrew Cargill MacMillan* remained on the bank at the site of the contact until the next morning. The vessel departed and resumed its voyage with all but three of the barges. Of those three barges, two were damaged: *ART35743* had two voids penetrated on its starboard side but remained afloat, and *ART44160* sustained minor damage. The damage cost to the barges was estimated at \$74,000. The breasting dolphins, catwalk, and conveyor sustained substantial damage; representatives for the terminal estimated the cost of the damage at \$8 million.
