# National Transportation Safety Board

## Marine Accident Brief

### Capsizing and Sinking of Barge *Dredge200* and Loss of Workboat *R.E. Pierson 2* Pushed by Tugboat *Big Jake*

<b>Accident type</b>	Capsizing/Listing	No. DCA19FM009
<b>Vessel names</b>	<i>Big Jake, Dredge200, R.E. Pierson 2</i>	
<b>Location</b>	Massachusetts Bay, Massachusetts, 5 miles east of Minots Ledge Light <sup>1</sup> 42°16.06' N, 70°38.63' W	
<b>Date</b>	December 2, 2018	
<b>Time</b>	0930 eastern standard time (coordinated universal time – 5 hours)	
<b>Injuries</b>	2	
<b>Property damage</b>	\$1.98 million est. ( <i>Dredge200</i> \$1,150,000; Excavator \$685,000; and <i>R.E. Pierson 2</i> \$150,000)	
<b>Environmental damage</b>	500 gallons of diesel and 400 gallons of hydraulic oil (aboard <i>Dredge200</i> )	
<b>Weather</b>	Fog, light to moderate rain, visibility 1 mile, winds southeast 15–20 knots gusting to 30 knots, seas southeasterly 4–6 feet, air temperature 45°F, water temperature 48°F	
<b>Waterway information</b>	In the southwestern portion of Massachusetts Bay, the coastline is rocky with numerous detached islands.

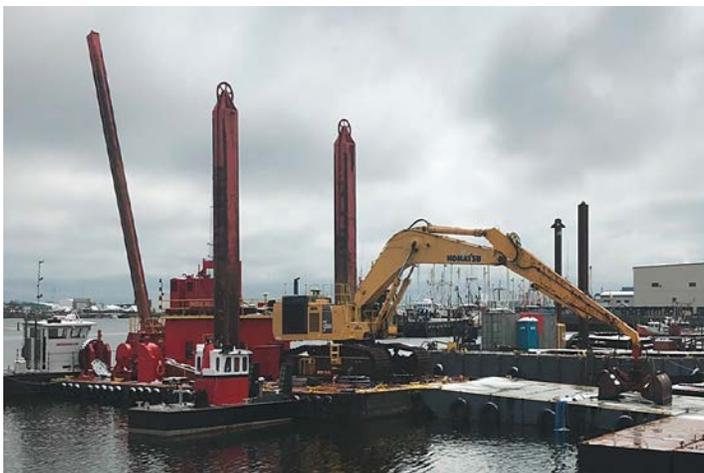
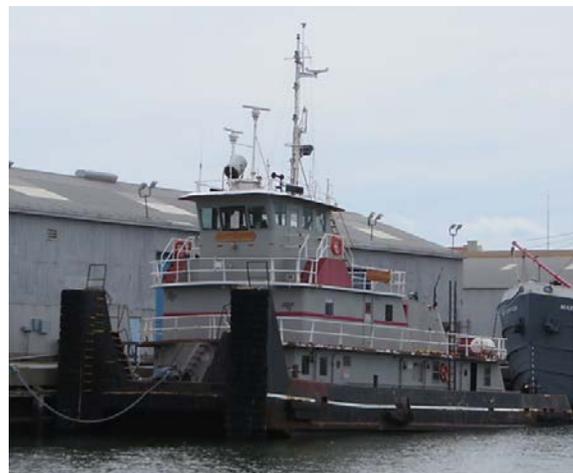
At left, the *Dredge200* in the foreground with excavator boom extended aft. At right, the *Big Jake*, pier side before the accident. (Source: Riverside Marine Construction [left image], Safer Tug & Barge [right image])

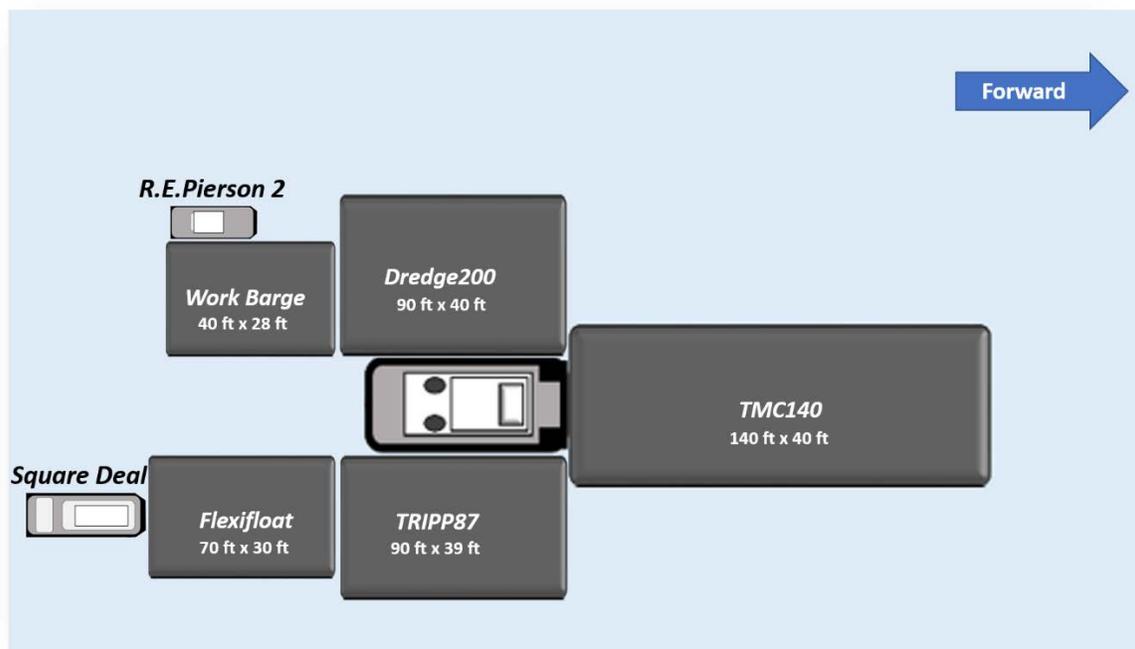
Representation (not to scale) of *Big Jake*'s tow arrangement of the five barges and two work boats during the majority of the voyage to Hingham Bay, Massachusetts.

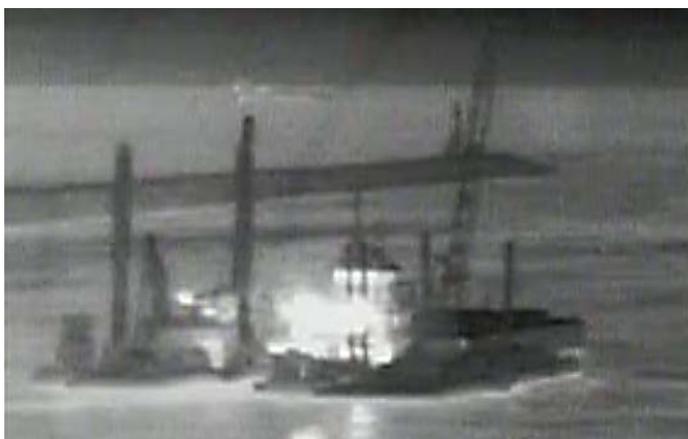
Aft view of the towing vessel *Big Jake* and barges transiting the Cape Cod Canal. (Source: US Army Corps of Engineers)

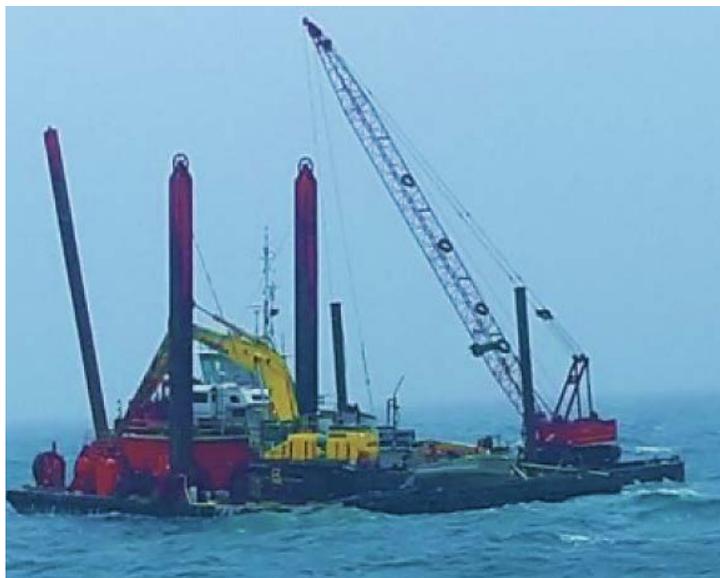
The *Big Jake*'s tow with the *Dredge200* in the foreground during the accident.

As the tow continued to rotate, now beam to the seas, *Dredge200* started to rock back and forth, striking the *Big Jake*'s port quarter. The crane operator and deckhand both stated that they believed this contact may have resulted in the *Big Jake*'s port quarter piercing the starboard-side shell plating of the *Dredge200*.

The *Dredge200* started to take on water and was down by the bow. Over the course of about 30 minutes, the crew attempted to keep the barges and workboats together, to no avail. When the crew deemed it was unsafe to continue their efforts, the barges and workboats drifted away from *Big Jake*, with the exception of *TRIPP87*, which remained tethered to the *Big Jake*'s starboard side by a 5-inch towing hawser.

Although underwater imagery was reviewed, investigators could not definitively determine the extent of the damage to the hull or verify the condition and closure of the hatchways, ventilators, doors, scuttles, manholes, and other openings on board the *Dredge200*. However, based on crew statements, the source of flooding that led to the sinking of the *Dredge200* was likely hull damage from contact with the *Big Jake* when the tow broke apart.

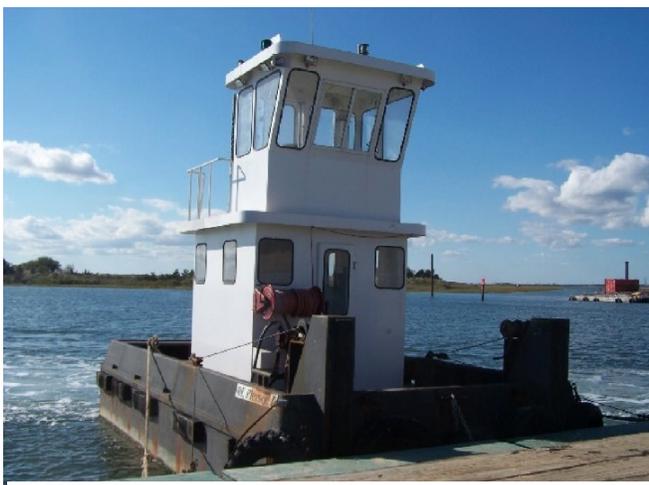
On December 4, the *Dredge200* was found in Broad Sound approximately 2 miles southeast of Nahant, Massachusetts, about 15 miles from where it broke free. The barge was located with multi-beam sonar just north of the North Channel, the major shipping lane into Boston Harbor, in approximately 100 feet of water. A remotely operated underwater vehicle surveyed the site and found the *Dredge200*'s hull inverted with its main deck equipment imbedded into the seafloor. Investigators reviewed the underwater footage, but the survey did not cover the entire hull nor clearly show damage to the barge. The *Dredge200* was carrying approximately 500 gallons of diesel fuel and 400 gallons of hydraulic oil when it sank. At the time of this report, the barge has not been salvaged. The *R.E. Pierson 2* was not recovered and was assumed to have sunk.

The *R.E. Pierson 2* before the accident.
