# National Transportation Safety Board

## Marine Accident Brief

### Contact of *Bettye M. Jenkins* Tow with Bunge Grain Facility

<b>Accident type</b>	Contact	<b>No.</b> DCA19FM018
<b>Vessel names</b>	<i>Bettye M. Jenkins</i> and barge <i>T9353</i>	
<b>Location</b>	Lower Mississippi River, mile 361, near Vidalia, Louisiana 31°32.95' N, 091°26.43' W	
<b>Date</b>	February 15, 2019	
<b>Time</b>	0130 central standard time (coordinated universal time – 6 hours)	
<b>Injuries</b>	None	
<b>Property damage</b>	\$3.3 million est.	
<b>Environmental damage</b>	None	
<b>Weather</b>	Visibility 10 miles, partly cloudy, winds south 4 knots, air temperature 60°F	
<b>Waterway information</b>	The Lower Mississippi River near mile marker 361 is 0.6 mile wide with a maintained channel depth of 9 feet. At the time of the accident, the river near mile marker 361 was at flood stage, and a high-water safety advisory was in effect. The river stage near Vidalia, at Natchez, Mississippi, was 49.1 feet.

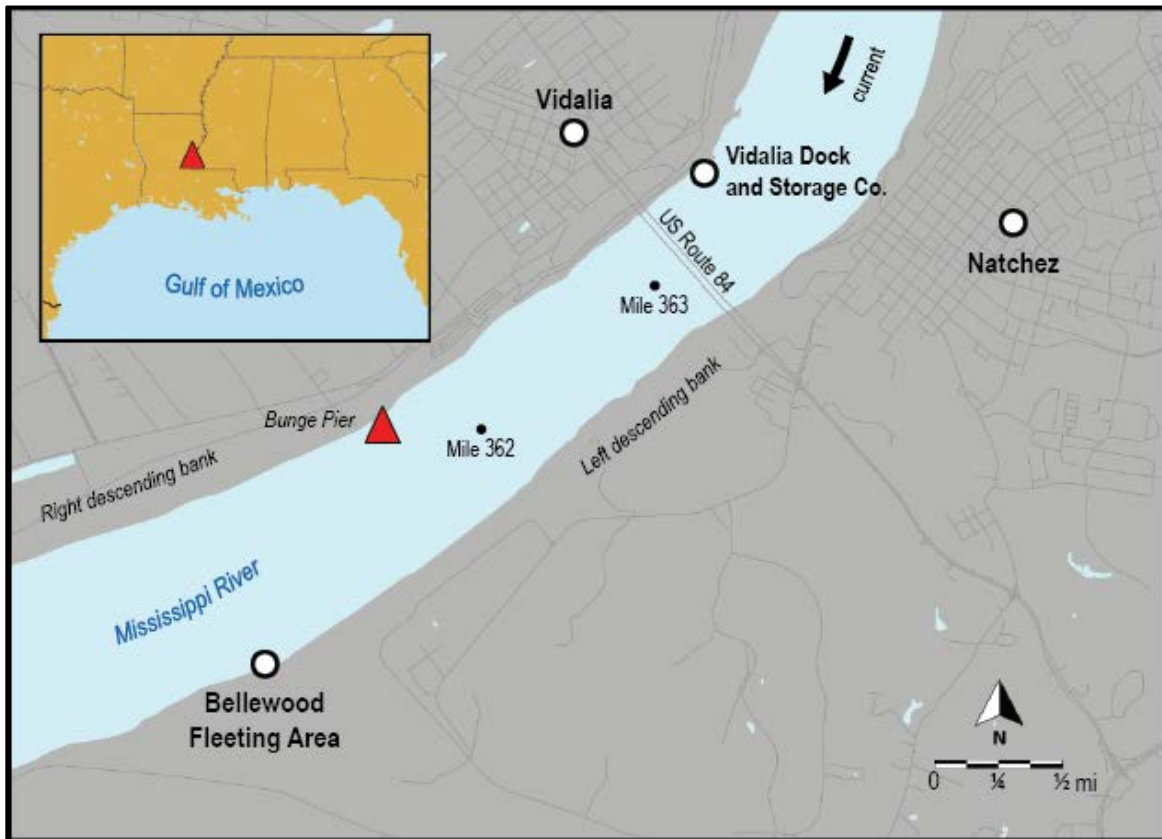
Area where the *Bettye M. Jenkins* tow contacted the Bunge pier and pilings as indicated by the red triangle. (Background Source: Google Maps)

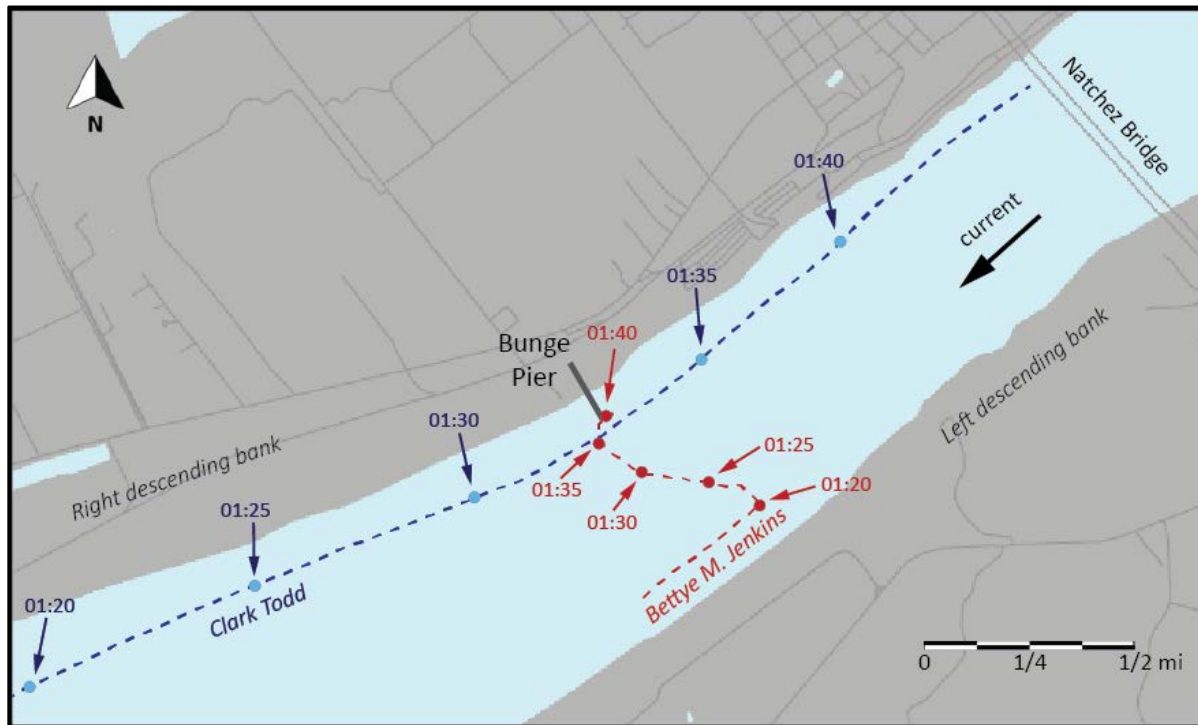
Select positions of the *Clark Todd* and the *Bettye M. Jenkins*. (Data source: US Coast Guard Navigation Center; background source: Google Maps)

According to the *Clark Todd*'s pilot, the *Bettye M. Jenkins* lingered in the middle of the river while crossing. After notifying the crew of the *Bettye M. Jenkins* by radio, the *Clark Todd* passed ahead of the *Bettye M. Jenkins* about 0136. The *Bettye M. Jenkins* was about 300–400 feet astern of the *Clark Todd* when they attempted to turn to starboard and head for the west span of the bridge. According to the captain, the *Bettye M. Jenkins* had difficulty making the turn upriver (to starboard) as it was against/into the high current and because the tow was in the *Clark Todd*'s wheelwash (reducing propeller thrust). As the vessel attempted the turn, the river current set the tow further downstream (to port). About 0140, the lead barge, T9353, struck the northernmost mooring piling at the Bunge facility, all lines parted between the two barges, and the lead barge broke free and drifted downstream inside the pilings and onto the vertical dolphins, damaging them. The pilot of the *Clark Todd* was not aware of the *Bettye M. Jenkins*' situation and continued upriver.

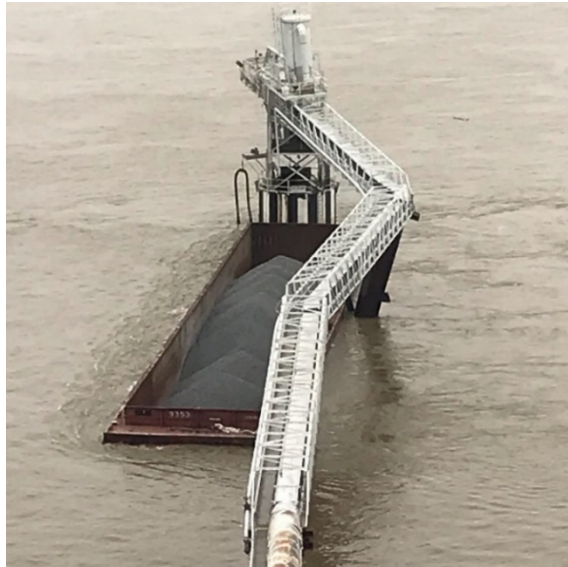
As a result of the contact, the two dolphins farthest from shore that supported the conveyor and trusses were deflected up to 15 feet. Three conveyor trusses were forced out of alignment as much as 3 feet. Bunge employees cut the conveyor belt to prevent the entire structure from being damaged. Due to the damage, Bunge had to transport cargo 7.4 miles across the river to the Adams County Port for loading on barges until repairs were completed on August 20, 2019.

**The damaged Bunge grain conveyor and barge T9353, four days after contact. (Source: Bunge Grain Facility)**
