National Transportation Safety Board

Contact of *Lindberg Crosby* Tow with Interstate 10 Bridge

Accident type	Contact	No. DCA19FM015
Vessel names	<i>Lindberg Crosby</i> and <i>Shawnee</i>	
Location	San Jacinto River, Channelview, Texas, at the Interstate 10 bridge 29°47.57' N, 95°3.73' W	
Date	February 11, 2019	
Time	1316 central standard time (coordinated universal time – 6 hours)	
Injuries	None	
Property damage	\$1.56 million in damage to bridge; \$26,279 to barge <i>Shawnee</i>	
Environmental damage	None	
Weather	Temperature 73°F, partly cloudy with winds from the south at 10 miles per hour, no precipitation	
Waterway information	The Interstate 10 bridge crosses the San Jacinto River about 16 miles east of Houston, Texas. ¹ The waterway connects to the Houston Ship Channel and is transited by towing vessels, barges, and other small craft.

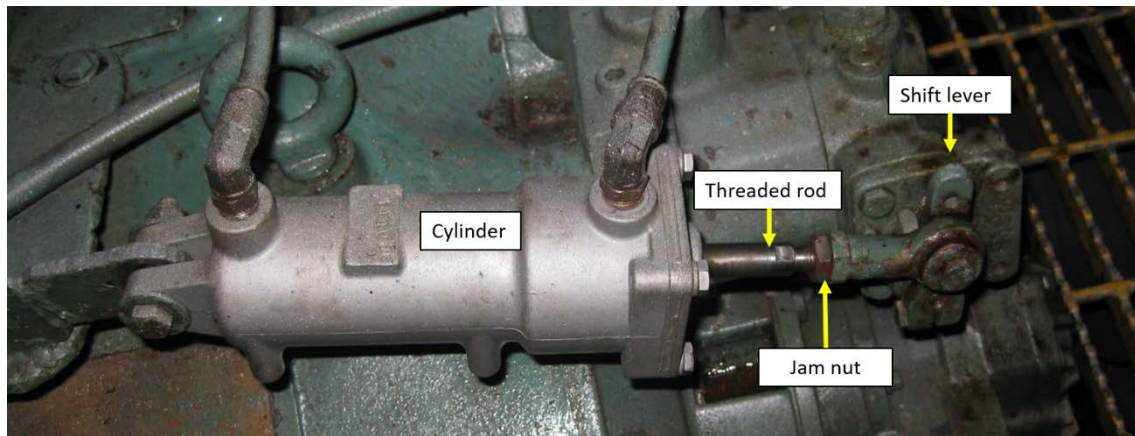
Pneumatically controlled actuator connected to transmission shift lever with threaded rod and jam nut.

When the captain examined the starboard engine following the accident, he found that the threaded rod of the actuating piston had disconnected from the connector affixed to the shifting lever. This prevented any direction changes from being transmitted from the wheelhouse throttle levers to the shifting lever on the transmission, resulting in the transmission remaining stuck in the ahead direction. With twin propulsion engines and no positive feedback system to alert the operator that shift commands were not followed, the captain did not immediately discern the loss of starboard engine control and discovered it only after observing wheelwash coming from behind the starboard propeller (indicating that it was still pushing ahead).

As a result of the postaccident tests, the NTSB believes that there was not a material failure of the pneumatic cylinder or its components; the cylinder operated as expected. The design of the piston within the cylinder allowed it to rotate to account for misalignment in various applications. Postaccident testing showed that during repeated operation, the piston rod rotated in a direction that would unscrew a threaded connection. To prevent cylinder shaft rotation as it was fitted on the vessel's transmission, a jam nut was provided to tighten down against the shift lever threaded connector. The most likely cause of the separation of the linkage between the cylinder and the transmission lever was the jam nut becoming loose over time, therefore allowing rotation of the piston rod, resulting in the rod unthreading from the shifting lever connector piece.

Many vessels use mechanical linkages to transmit control commands to critical machinery. Operators of vessels using adjustable linkages that include jam nuts, locking nuts, or other devices should frequently examine the position of the nuts on shafts to verify their security and develop procedures to effectively ensure critical control system components are included in preventative maintenance programs. Component and control system manufacturers should provide guidance/options for passively securing jam nuts, such as locking wire, locking washers, securing tabs, thread-locking insert materials, thread-locking fluid, or other means.

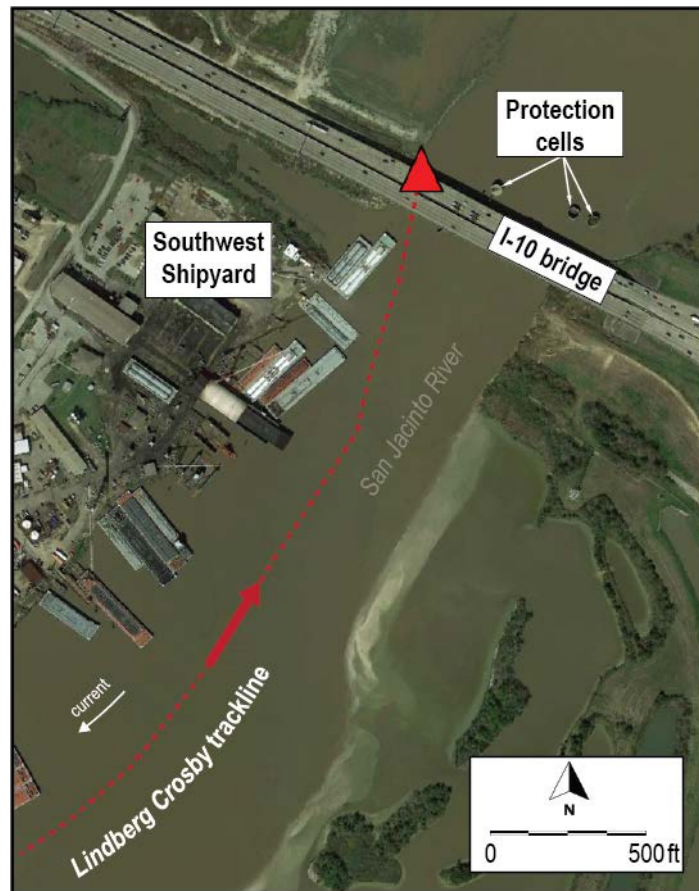
As the vessel approached its intended berth at a speed of 3.2 mph, the captain shifted the engines (port and starboard) from ahead propulsion to neutral, then attempted to slow the tow by shifting them both astern.

Trackline and location of the *Lindberg Crosby* when the tow struck the I-10 bridge (marked with red triangle). (Background source: Google Earth)

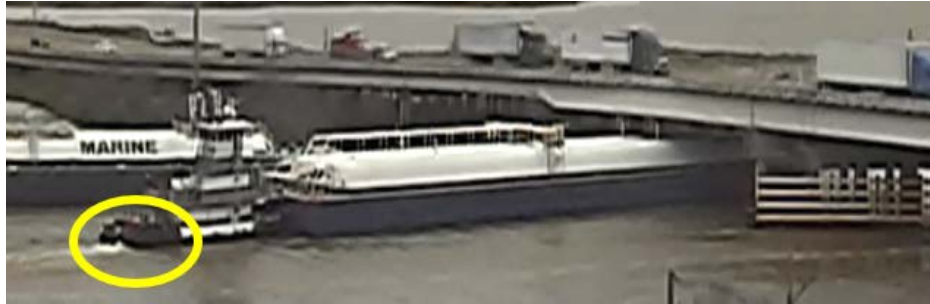
To further slow the tow as it neared the berth, the captain moved both throttle levers further in the astern direction; however, instead of slowing as the captain expected, the towboat and barge began veering to port. Realizing that there was a problem affecting control of the vessel, the captain attempted to steer the bow of the barge into the rocky shore to stop the tow and prevent the *Lindberg Crosby's* accommodation spaces from striking the bridge. Consequently, the barge (*Shawnee*) passed under the eastbound span, and at 1316, the bow of the barge contacted a westbound highway bridge pier column at a speed of 2.9 mph, bringing the tow to rest and damaging the pier column. Immediately after the tow stopped, the captain looked aft and saw wheelwash behind the starboard propeller. He realized that despite the fact that he put the starboard engine control in the astern direction, it was still “clutched in,” or stuck in, and providing propulsion in the forward direction.

Wheelwash from the *Lindberg Crosby's* starboard propeller, circled in yellow, after striking the I-10 bridge. (Source: Screenshot from Harris County Sheriff's Department video)

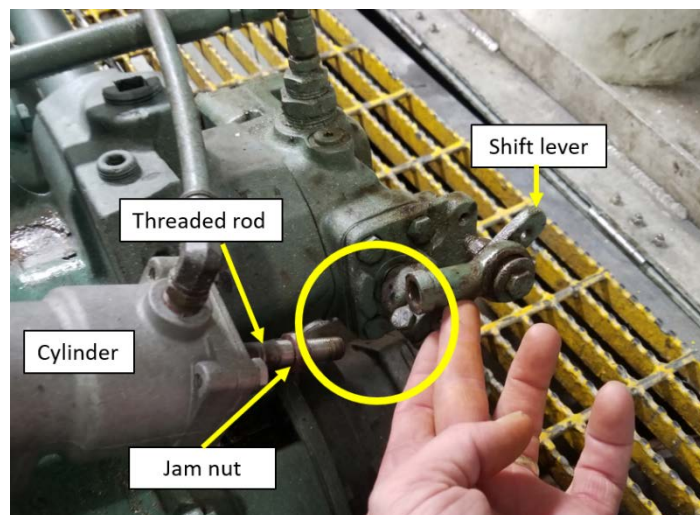
The captain stopped the starboard engine. He used the port engine to back the *Shawnee* out from under the bridge and moored the tow at the shipyard dock. He went to the engine room and found the transmission shifting lever of the starboard engine stuck in the ahead position because the threaded rod of the actuating piston had disconnected from the connector affixed to the shifting lever, preventing any shifting from the wheelhouse lever controls. Later that afternoon, representatives from the company's maintenance department reconnected the two pieces of the transmission shift linkage and tightened the jam nut. The control system was tested, and the cylinder and transmission appeared to function normally.

Starboard engine pneumatic gear clutch actuator linkage disconnected aboard the *Lindberg Crosby* as found after the accident. (Source: *Lindberg Crosby* captain)

The National Transportation Safety Board determines that the probable cause of the towing vessel *Lindberg Crosby* contacting a pier column of the Interstate 10 bridge was the undetected loss of starboard engine directional control due to a separation of the control system mechanical linkage to the pneumatic gear clutch, resulting in the engine not shifting in response to the operator's commands.

Following the accident, replacement pneumatic cylinders were installed on both engine transmissions, and the starboard cylinder was removed for testing.

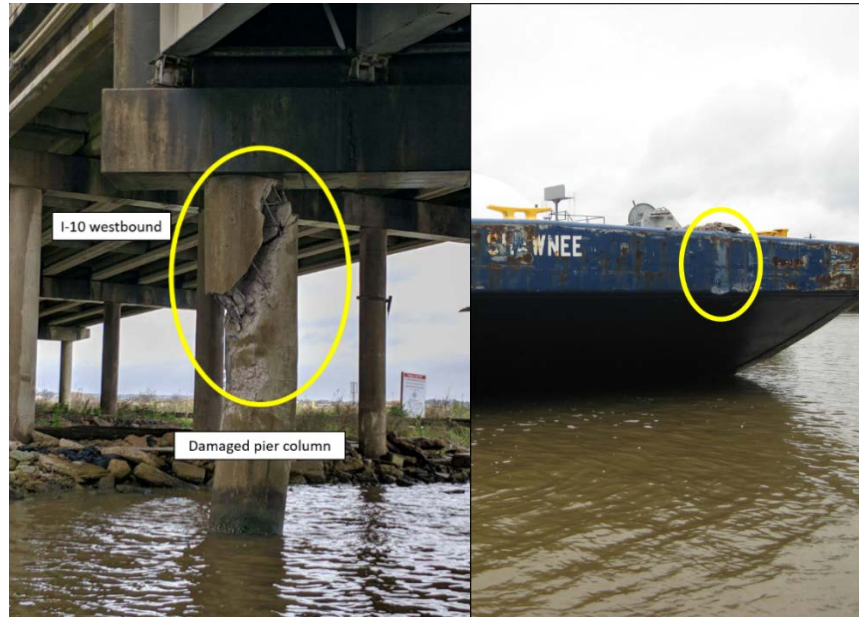
The westbound highway's southernmost concrete pier column, located approximately 15 feet from the west bank shoreline, showed an impact area approximately 8–10 feet above the waterline. The pier column was completely sheared above the impact area and no longer vertical. Damage to the barge consisted of a 3-inch inset to the bow; distorted internal components, such as vertical stiffeners, longitudinal angles, bulkheads; and a bent cargo tank relief stack. There was no damage to the *Lindberg Crosby*.

Left: Damaged section of pier column, circled in yellow, under westbound lanes of I-10 bridge. Right: Bow of barge *Shawnee* after the accident with damaged section circled in yellow.
