National Transportation Safety Board

Marine Accident Brief

Contact of Cruise Ship *Norwegian Epic* with San Juan Cruise Port Pier 3

Accident type	Contact	No. DCA19FM016
Vessel name	<i>Norwegian Epic</i>	
Location	Pier 3 east, Old San Juan Cruise Port, San Juan, Puerto Rico 18°27.58' N, 066°06.67' W	
Date	February 12, 2019	
Time	1724 Atlantic time (coordinated universal time – 4 hours)	
Injuries	None	
Property damage	\$3.7 million est.	
Environmental damage	None	
Weather	Visibility 10 miles, partly cloudy, winds easterly at 11 knots, gusts 21 knots; easterly waves at 2–3 feet, current setting west at 1 knot, air temperature 79°F, water temperature 78°F ¹	
Waterway information	San Juan harbor generally runs in an east to west direction after entering from the Atlantic. The cruise ship piers of Old San Juan are situated at the northern part of the harbor.

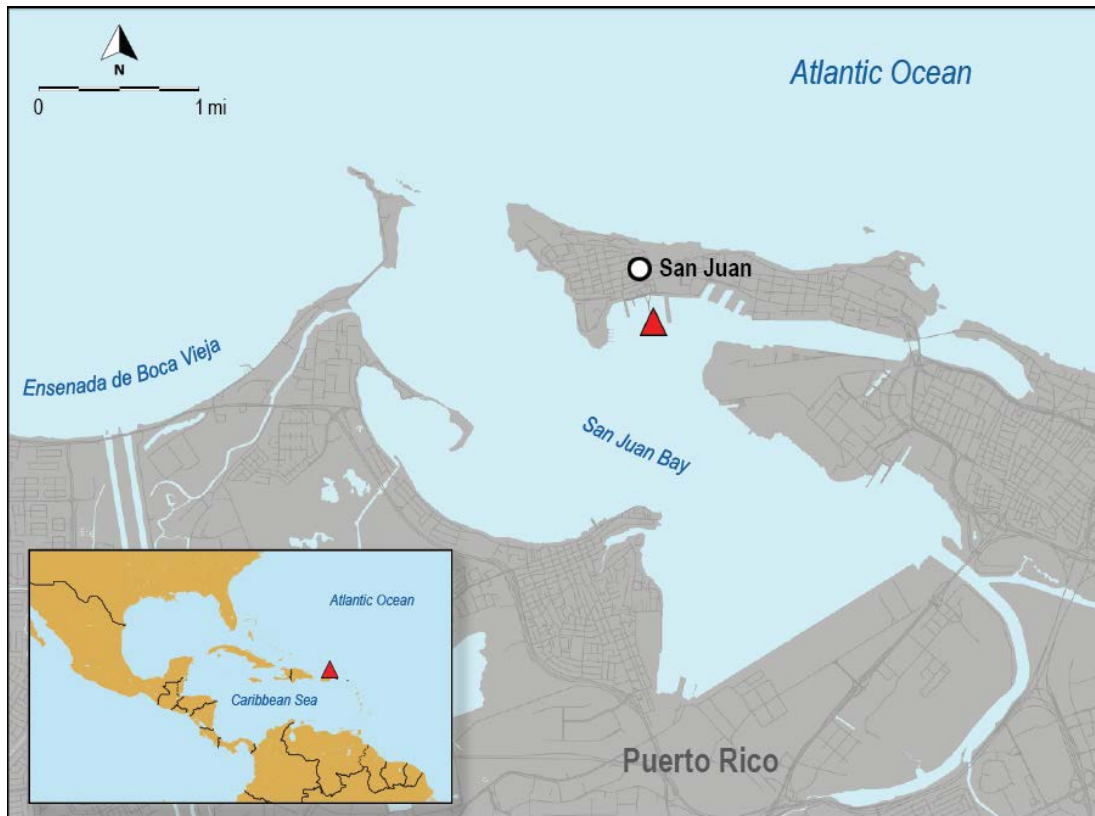
Area where the *Norwegian Epic* struck Pier 3, as indicated by the red triangle. (Background source: Google Maps)

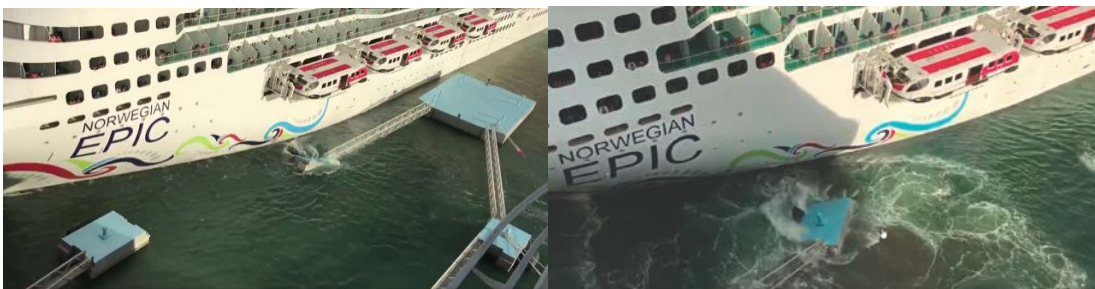
Left: Image of the *Norwegian Epic* as it struck the first mooring dolphin and catwalk, which collapsed. Right: Image of the second dolphin and catwalk as it collapsed after being struck. (Source: TweetsWithTito@dunard2)

About 1724, the master realized that the *Norwegian Epic* was going to “touch” the pier, and between 1724:00 and 1724:12, he increased bow thruster power towards the pier, and then from 1724:12 until the time of first impact at 1724:55, he went from 50% bow thruster power to port to 100% bow thruster power to starboard. After being struck, the dolphin and connecting catwalks collapsed into the harbor. A short time later, the *Epic* struck the dolphin that was closer to shore, and it also collapsed with its connecting catwalk.

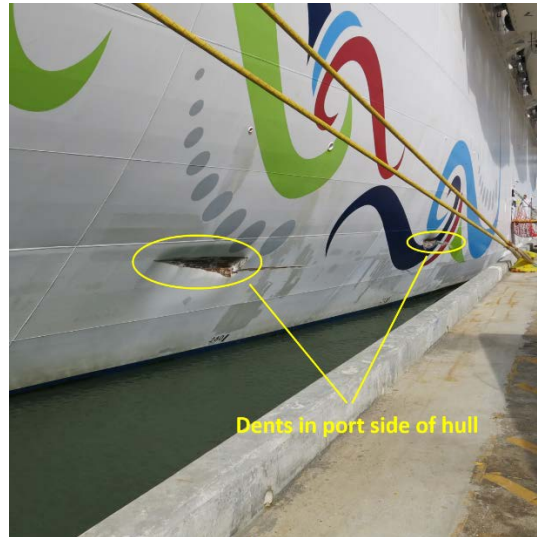
The ship then continued its docking evolution without further mishap and was all fast to the pier at 1814. The strikes to the dolphins left two indentations to the hull of the ship above the waterline that were each about 6 feet 4 inches long, 20 inches high, and 4–6 inches deep. No injuries or pollution were reported, and total damages to the ship and pier structure were estimated at \$3.7 million. Drug and alcohol test results for the relevant ship crewmembers and pilot were negative.

Damage to the *Norwegian Epic*'s hull.
