National Transportation Safety Board

Marine Accident Brief

Collision Between *Miss Dixie* Tow and *D. & R. Boney* Tow

Accident type	Collision	No. DCA19FM017
Vessel names	<i>Miss Dixie</i> , <i>D. & R. Boney</i> , and barges <i>AEP 7235</i> , <i>005024</i> , <i>005028</i> , <i>005492</i> , and <i>005495</i>	
Location	Lower Mississippi River, Mile 104, New Orleans, Louisiana 29°56.91' N, 90°8.44' W	
Date	February 13, 2019	
Time	1917 central standard time (coordinated universal time – 6 hours)	
Injuries	None	
Property damage	\$294,530 for barges <i>AEP 7235</i> , <i>005024</i> , <i>005028</i> , <i>005495</i>	
Environmental damage	None	
Weather	Visibility 15 miles, clear, winds from the south at 5 miles per hour (mph), air temperature 51°F	
Waterway information	Carrollton Bend at mile 104 near Nine Mile Point in the Lower Mississippi River, approximately 2 miles downriver from Huey P. Long Bridge. ¹ Current estimated at 4–5 mph. The Carrollton river gage was 13.6 feet.

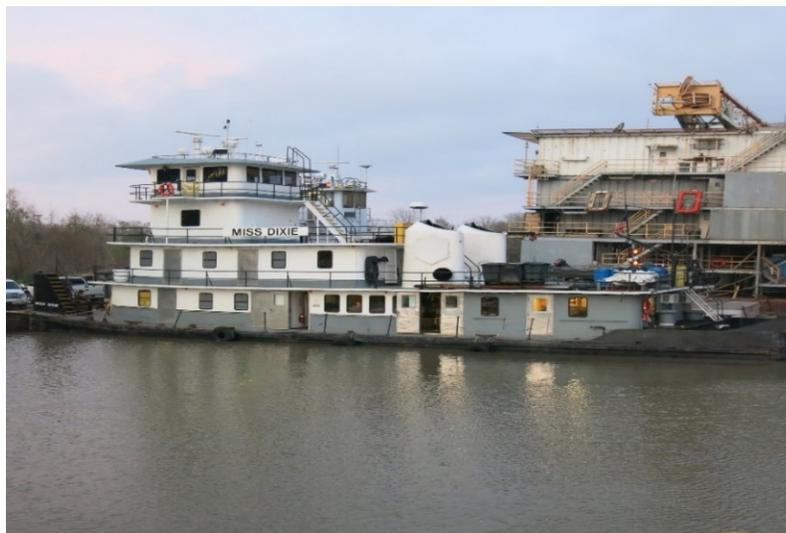
The towing vessel *Miss Dixie* docked in New Orleans after the accident.

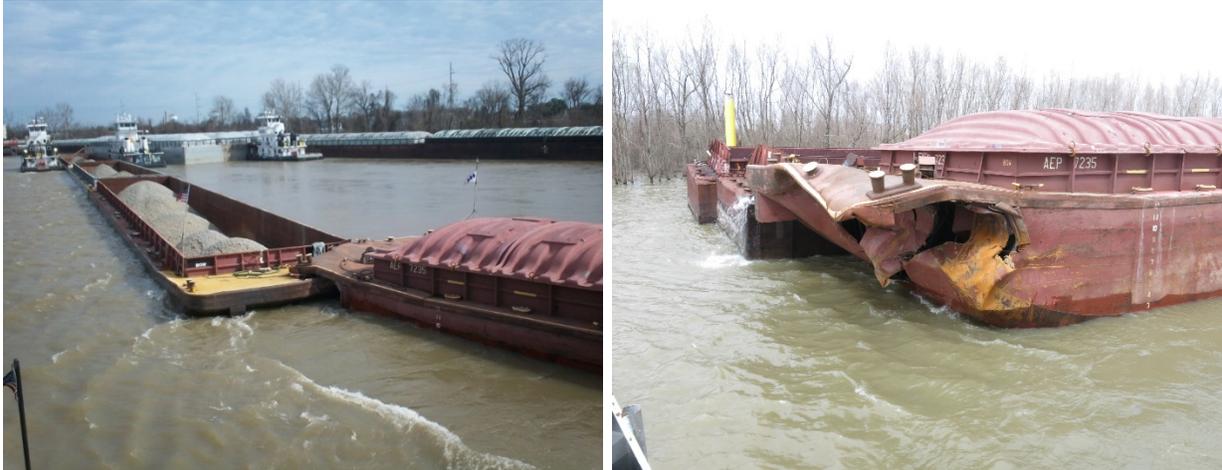
Left: The AEP 7235 laying across the 005492 after the collision. Right: Damage to port bow of the AEP 7235.

Four barges were damaged in the collision. As a result of the impact, the bow of *Miss Dixie*'s lead barge, 005492, was pinned under the damaged rake of the *D. & R. Boney*'s lead barge, AEP 7235 (the 005492 was dented, but not repaired). The hull of AEP 7235 was breached, creating a 20-by-20-foot hole in the bow void compartment, which resulted in flooding. Damage to three other barges in the *Miss Dixie*'s tow consisted of several areas of inset plating, framing, and side shell.

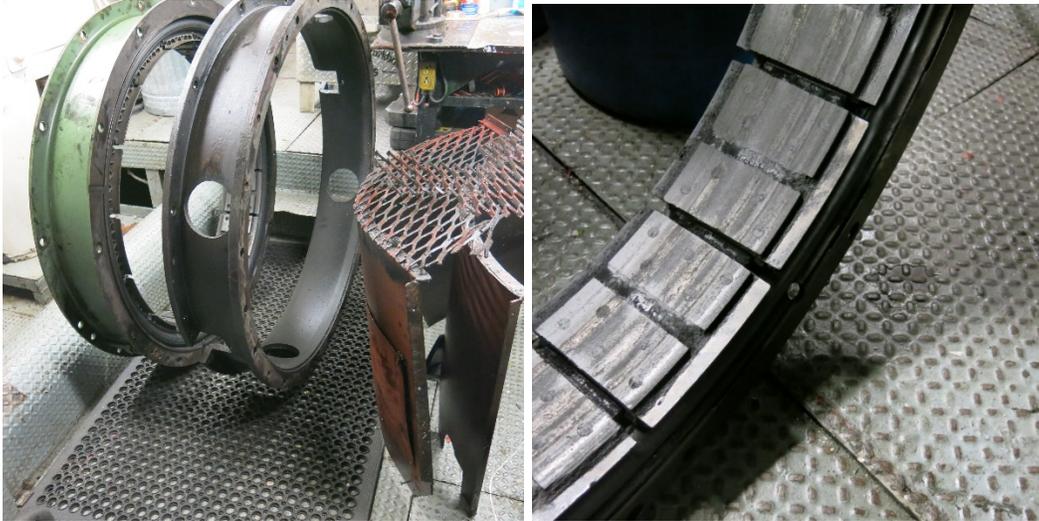
After the accident, a service representative specializing in marine industrial gears inspected the port clutch aboard the *Miss Dixie* and determined that the port clutch had “excessive wear” and

that the clutch would slip and was “40% operational.” The report also indicated that the bearings of the reduction gears were in satisfactory condition, and the gears had pitting and some sharp edges. Another service company inspected the pneumatic system for the clutch and reported that the control system was operating satisfactorily. After the accident, the port clutch was repaired.

Left: Port clutch assembly steel rings removed from the *Miss Dixie* after the collision during postaccident inspection. Right: Condition of the port engine clutch friction pads aboard the *Miss Dixie* after the accident.

Further, a postaccident inspection by a service representative found that the port clutch had excessive wear, would slip, and was only 40% operational. The air-actuated clutch was designed to transfer torque from the engine to the propeller by inflating a rubber air tube within a steel ring, forcing friction shoes onto the rotating assemblies, which would rotate the propeller at a proportional speed to the engine. Heat is generated by a slipping clutch, producing smoke from the overheating of components in the clutch system, such as the rubber tube, and results in a reduction of power being transferred to the propeller. Without records to show any previous maintenance or inspections of the clutches aboard the *Miss Dixie*, the condition of the units before, or at the time of, the accident is unknown.

The National Transportation Safety Board determines that the probable cause of the collision between the tows of the towing vessels *Miss Dixie* and *D. & R. Boney* was the lack of an effective maintenance program aboard the *Miss Dixie*, resulting in excessive and undetected wear of the port clutch, which compromised the vessel's maneuverability.

Owners and operators should ensure that all critical equipment associated with propulsion systems, such as clutches, are included in preventative maintenance systems and that they follow the manufacturer's maintenance and inspection interval recommendations.
