National Transportation Safety Board

Marine Accident Brief

Contact of Towing Vessel *Rivers Wilson* and Tow with Norfolk Southern Railway Bridge

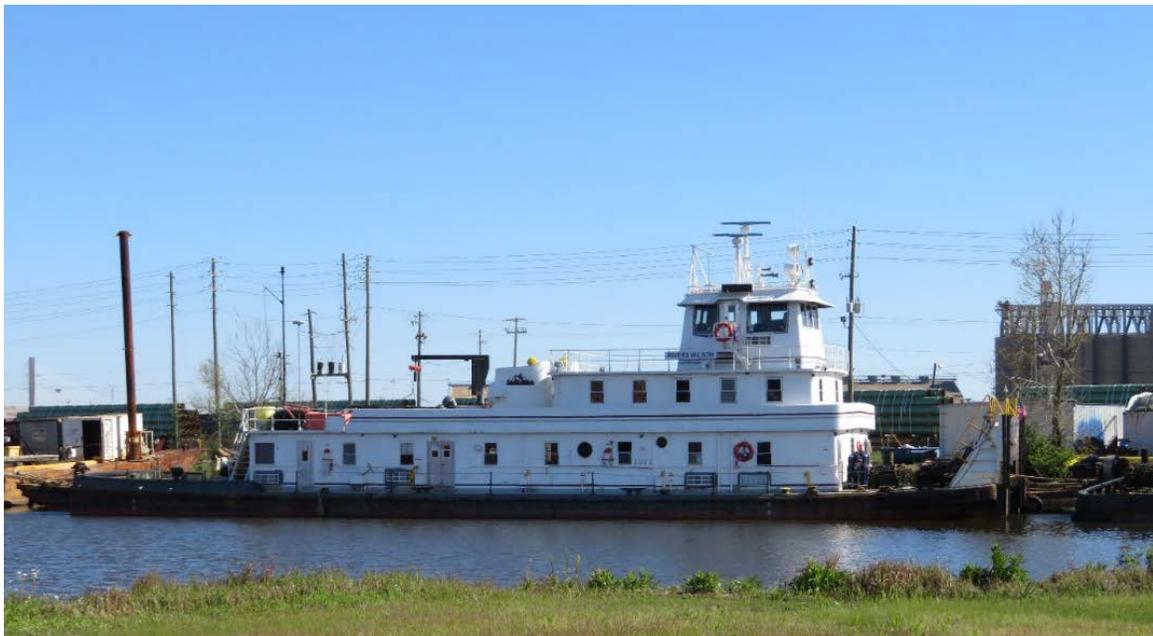
The *Rivers Wilson* moored in Mobile, Alabama, after the accident.

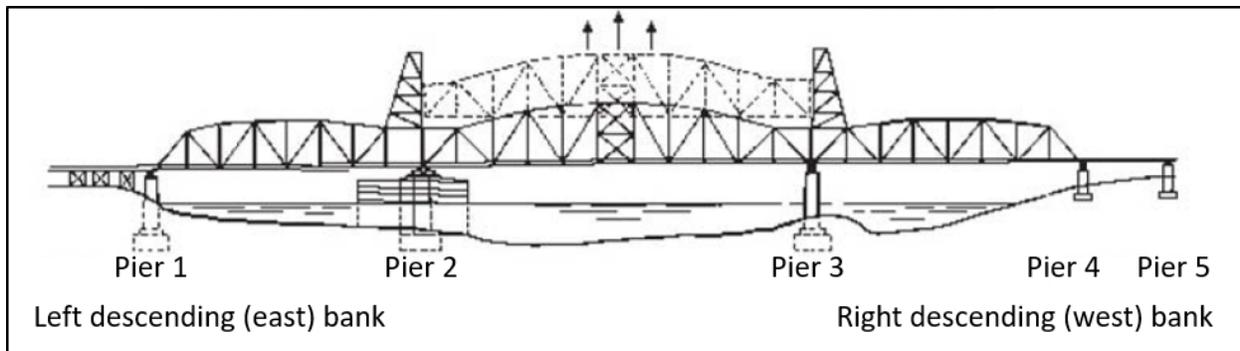
Diagram of the Norfolk Southern railway bridge at Jackson, viewed from upriver. (Source: US Army Corps of Engineers; annotated by the NTSB)

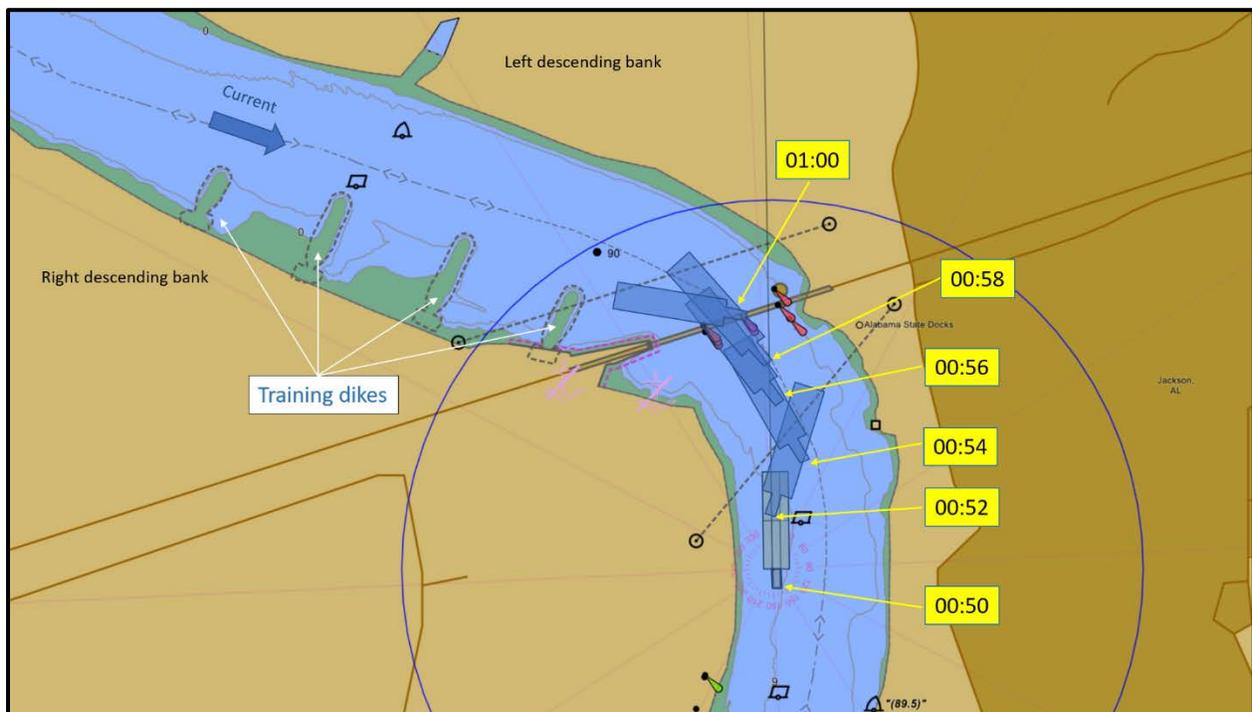
Select positions of the *Rivers Wilson* and barges on the Tombigbee River near mile 90 before the accident. Note the training dikes upriver of the bridge on the right descending bank (Background source: Corps of Engineers; vessel data: Graestone)

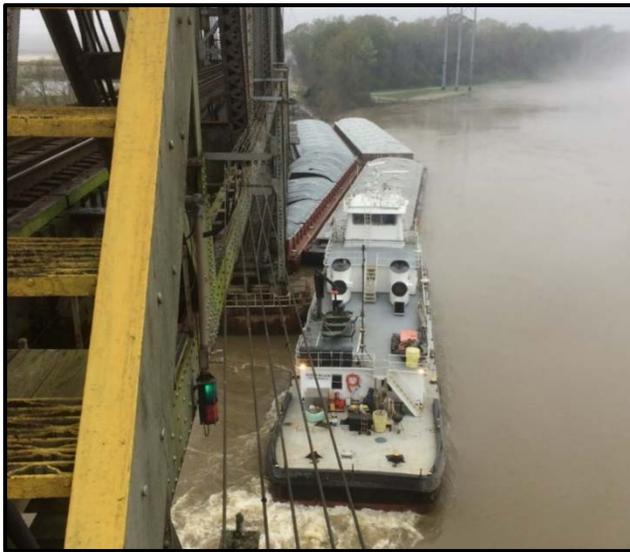
The *Rivers Wilson* and tow, on the north side of the bridge at sunrise on March 10, after the two starboard barges were recovered. (Source: Norfolk Southern)

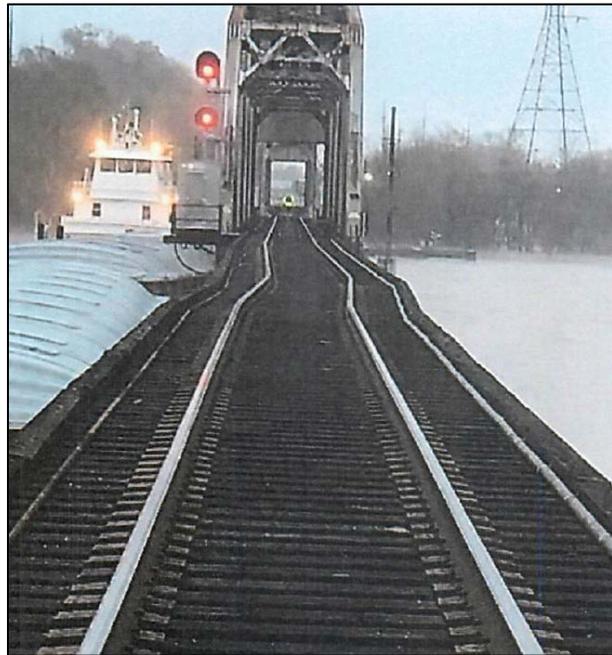
The captain called the Coast Guard by radio, as did the bridge tender by phone. The tender was able to lower the bridge at 1230; however, dislodged rail left the bridge out of service to train traffic. The initial repair estimate for the bridge and rail was \$4,842,500.

Rail displacement of the Norfolk Southern railway bridge, looking east, with the *Rivers Wilson* and two barges alongside. (Source: Coast Guard)
