National Transportation Safety Board

Marine Accident Brief

Contact of *Chad Pregracke* Tow with Old Highway 80 Bridge

Accident type	Contact	No. DCA19FM021
Vessel name	<i>Chad Pregracke</i> and barges <i>CC 5507B</i> , <i>CC 95523B</i> , <i>LTD 405</i> , and <i>MTC 852</i>	
Location	Lower Mississippi River, mile 435, near Vicksburg, Mississippi 32°18.79' N, 90°54.14' W	
Date	February 27, 2019	
Time	0704 central standard time (coordinated universal time – 6 hours)	
Injuries	None	
Property damage	\$800,000 est.	
Environmental damage	None	
Weather	Visibility 10 miles, cloudy, winds calm, current 4–5 knots, air temperature 54°F, morning twilight 0610, sunrise 0635	
Waterway information	The Lower Mississippi River near mile 435 was under an extreme high-water safety advisory. The river gage measured 48 feet of water at Vicksburg (flood stage is 43 feet).

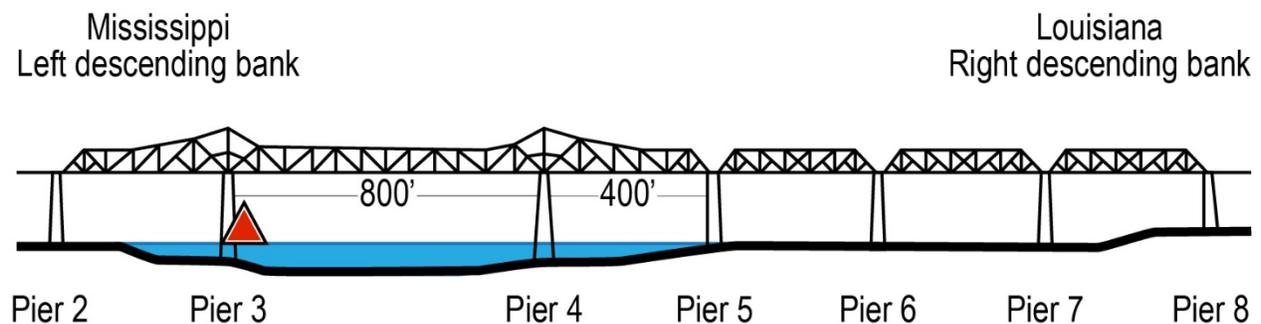
A drawing of the Old Highway 80 Bridge looking downriver. The red triangle indicates the location of the bridge strike.

800-foot width between piers 3 and 4. The pilot stated that as the tow moved downriver, the current set the tow to the left side of the river despite his efforts to head towards the right side of the span. The pilot told investigators that he experienced the set to the left earlier and harder than he anticipated. The tow, moving at 11.5 knots, was set down onto pier 3 at a 10° angle to the pier. The

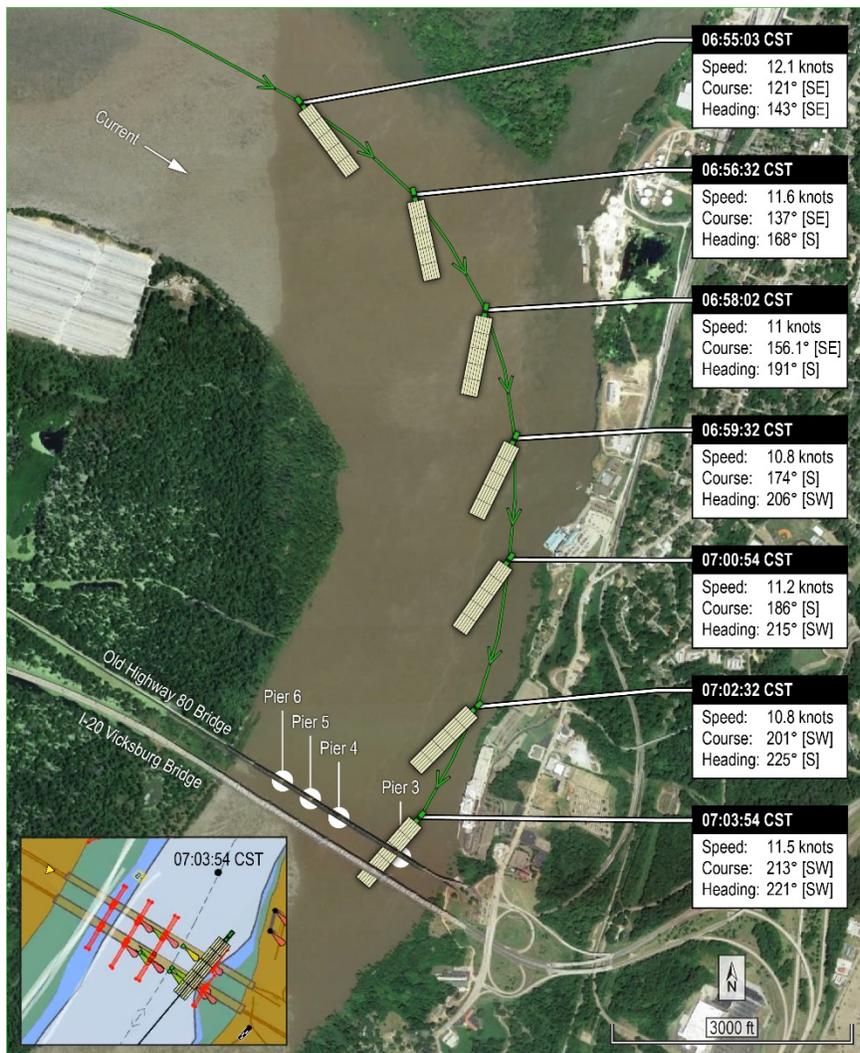
Trackline of the *Chad Pregracke* and its 30 barges over the last 9 minutes leading up to the bridge strike. (Background source: Google Earth). Inset: *Chad Pregracke* as recorded on RosePoint at 07:03:54 CST.

As the tow moved through the bend, the pilot had about a mile to line up the tow with the bridge. The pilot, anticipating a set to port, steered for pier 4 on the right side of the span, in order to line up to transit the

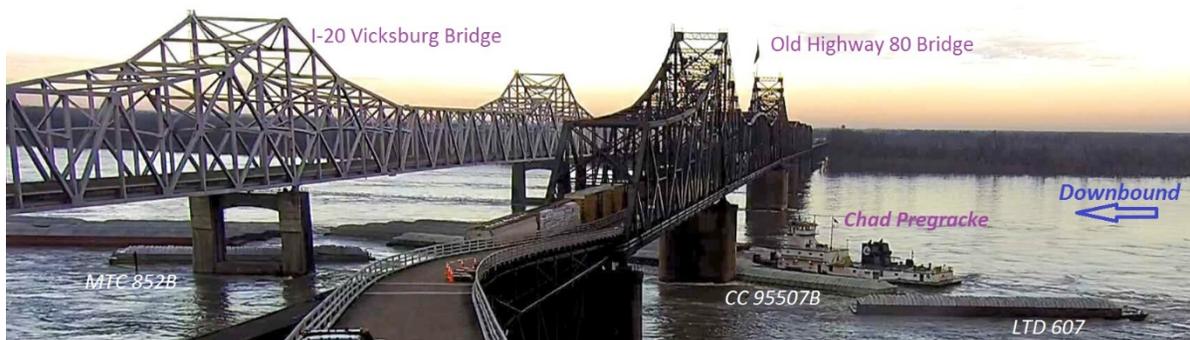
tow contacted the bridge between the third and fourth barges from the head of the tow on the port side, and the tow broke apart.

Four barges were damaged. The *CC 95507B* sank immediately, and the *LTD 405*'s bow was submerged. Two other barges were damaged but remained afloat. The Coast Guard closed the river to traffic. By 1450, the crew of the *Chad Pregracke*, with the help of other towing vessels, had retrieved the remaining barges, and, on March 1 at 1300, the crew had rebuilt the tow with the undamaged barges and continued the southbound transit. A total of 26 towboats and 354 barges were delayed until the morning of March 1, when the Coast Guard re-opened the area for vessel traffic. As of the publication of this report, barge *CC 95507B* has yet to be salvaged due to the high-water level. Salvors hope to recover the barge when the level recedes to 20 feet. The other three damaged barges were recovered, and each was towed to a shipyard in Vicksburg.

Barges broke away from the *Chad Pregracke* after the tow struck pier 3 of the Old Highway 80 bridge. (Photo: US Coast Guard)
