National Transportation Safety Board

Marine Accident Brief

Collision of *Dixie Vandal* Tow with Moored *Trinity* and Tow

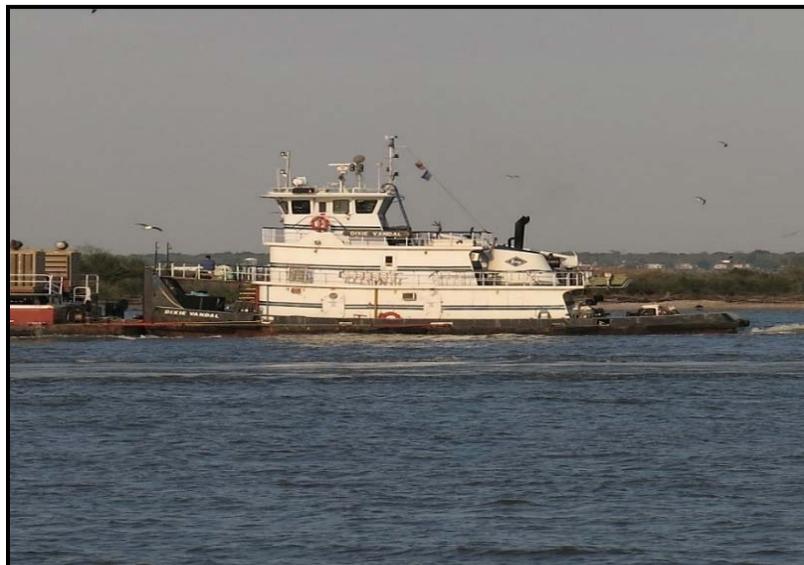
Towing vessel *Dixie Vandal* under way in Houston after the accident.

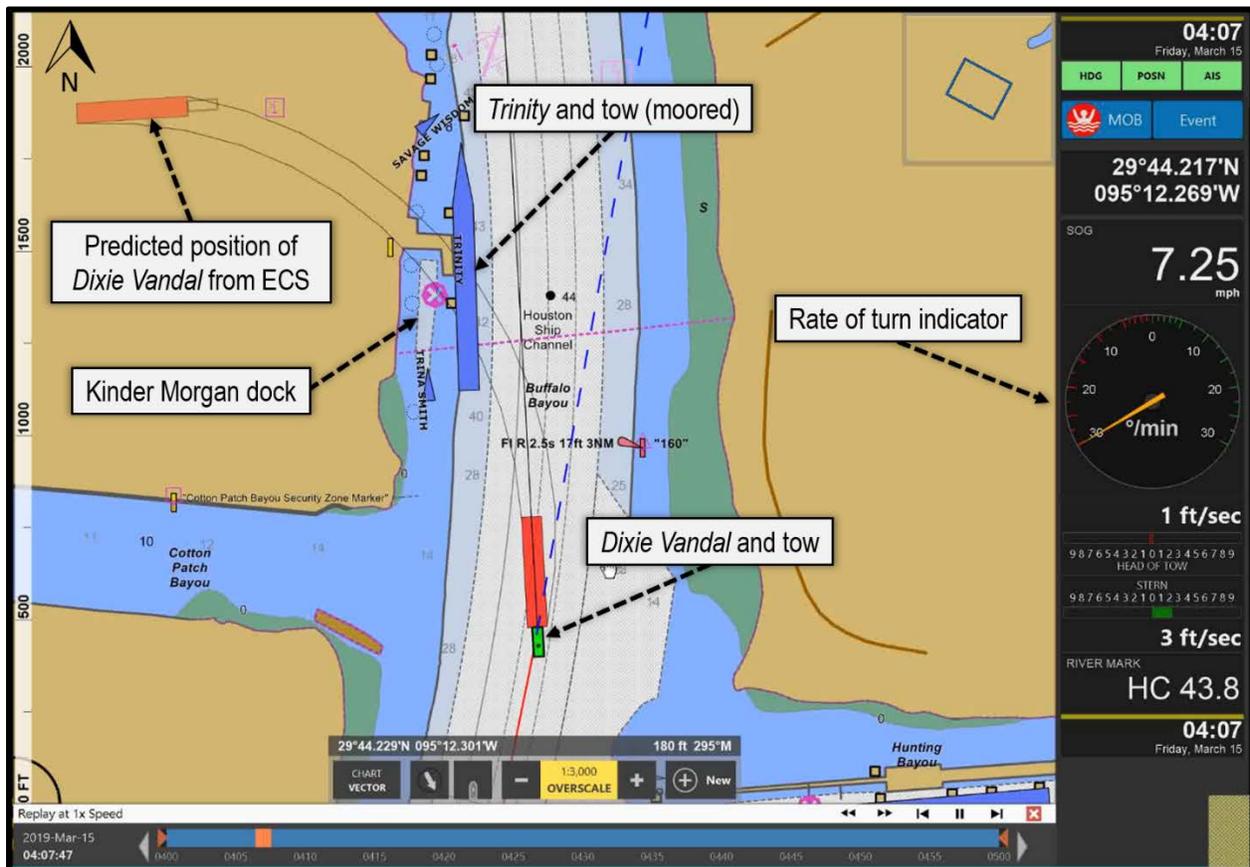
Playback from the *Dixie Vandal*'s electronic charting system (ECS) showed that about 04:07:30, as the *Dixie Vandal* and tow was proceeding around the left-hand turn by the basin, the tow began turning off course to port. At 04:07:47, the rate of turn indicator on the electronic charting system reached its maximum display of 30° to port. At 04:08:31, at a speed of about 6.5 mph, the forward port corner of the lead barge, *Kirby 29751*, contacted the starboard side of the *Trinity* and then struck the forward port corner of the barge *Kirby 29051*.

A screenshot captured at 04:07:47 from playback of the *Dixie Vandal*'s ECS shows the towing vessel as it approached the Kinder Morgan facility. (Source: Rose Point)

The *Dixie Vandal*’s ECS playback displayed a course change to port about 04:07:30, a maximum rate of turn to port at 04:07:47, and a significant drop in speed at 04:08:35, indicating contact occurred between the vessels just over a minute after the course change. The pilot did not recall making this sudden course change nor did he recall hearing the BNWAS alarm on the bridge;

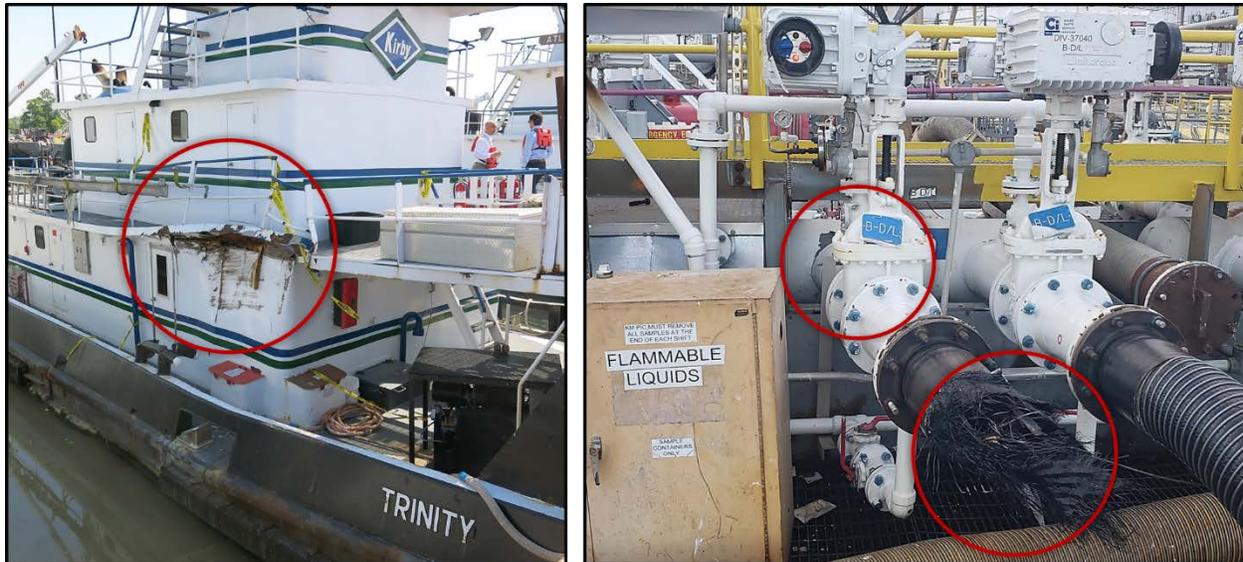
The impact caused the *Trinity* and its tow to shift about 100 feet along the dock, straining and subsequently parting all 12 mooring lines (6 per barge). Also, two cargo hoses that connected the tank barge *EBL 2997* to the facility's manifold parted. About a half-gallon of residual jet fuel inside the cargo hoses spilled into the channel.

The starboard side of the second deck on the *Trinity* was damaged, including the decking, handrail, and house structure. The vessel was sold "as is" postaccident; therefore, no repairs were made to it. Damage to tank barge *Kirby 29501* included indentation of the deck and hull's upper sheer strake and bow plating. Additionally, a stanchion on the deck was ripped from its weld due to the parted mooring lines. Tank barge *EBL 2997*'s 10-inch-diameter cargo liquid manifold piping was distorted. The facility reported damage to the pipeline, loading systems, dock, and two cranes that were supporting the cargo hoses. The *Dixie Vandal* was not damaged in the incident.

Left: Damage to the *Trinity's* starboard side from the impact of barge *Kirby 29751*. **Right:** Damaged shoreside cargo hose and deformed piping at the manifold at the Kinder Morgan facility. (Source: Kinder Morgan Pasadena Liquids Terminal)
