National Transportation Safety Board

Marine Accident Brief

Contact of Towing Vessel *DeJeanne Maria* with Submerged Dredge Pipe

Accident type	Contact	No. DCA19FM030
Vessel name	<i>DeJeanne Maria</i>	
Location	Lower Mississippi River, mile 0, Head of Passes, near Pilottown, Louisiana 29°09.26' N, 089°14.86' W	
Date	April 15, 2019	
Time	0044 central daylight time (coordinated universal time – 5 hours)	
Injuries	None	
Property damage	\$650,000 est.	
Environmental damage	Oil sheen (diesel oil, estimated volume released 70 gallons)	
Weather	Visibility 10 miles, clear, winds north at 10 knots; air temperature 56°F, water temperature 75°F	
Waterway information	Mississippi River close to where it empties into the Gulf of Mexico where the river splits into three larger passes: Southwest Pass, South Pass, and Pass A Loutre. This area of large and smaller passes, taken together, form the delta of the river.

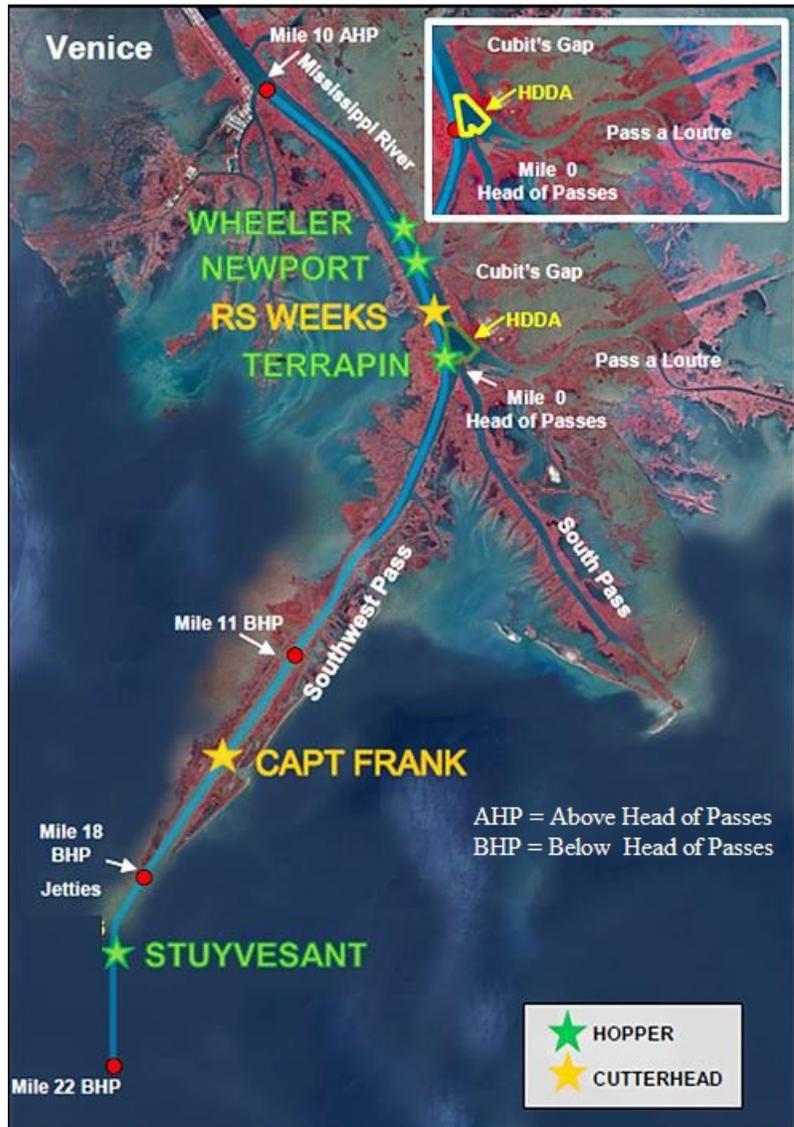
Dredging Activity on March 12, 2019, about a month before the accident, but similar to ongoing activity the day of the accident. (Source: Corps of Engineers)

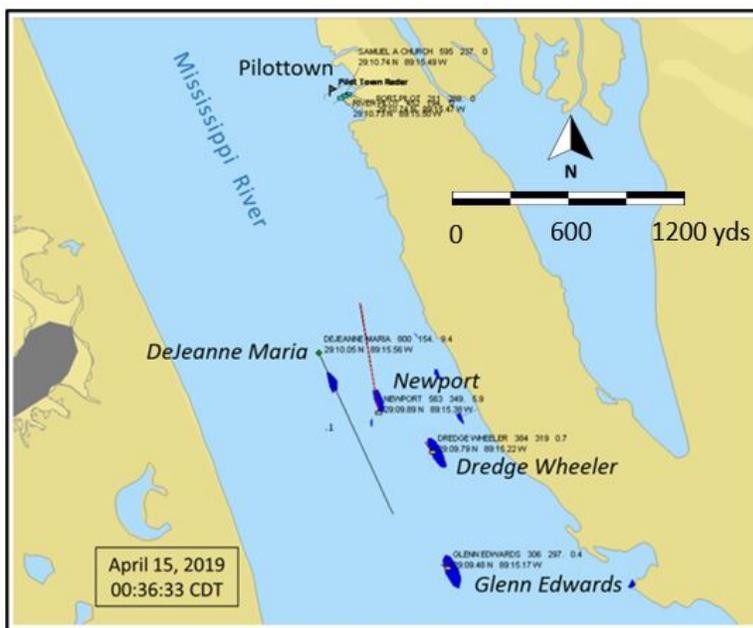
DeJeanne Maria passing dredges. (Source: US Coast Guard)

About 0037 on April 15, the *DeJeanne Maria* entered the project area and began passing three hopper dredges assigned to the project: the 265-foot-long *Newport*, the 384-foot *Dredge Wheeler*, and the 390-foot *Glenn Edwards*. As the tow neared the entrance to Pass A Loutre at 0043, the captain and the two deckhands were in the wheelhouse. The captain steered the tow close to a buoy line of “yellow, big drum-like buoys” that marked the pipeline previously used by the *R S Weeks* on his starboard side. He was familiar with the dredging operations in the vicinity of the Head of Passes, the notice to mariners, and had traveled through

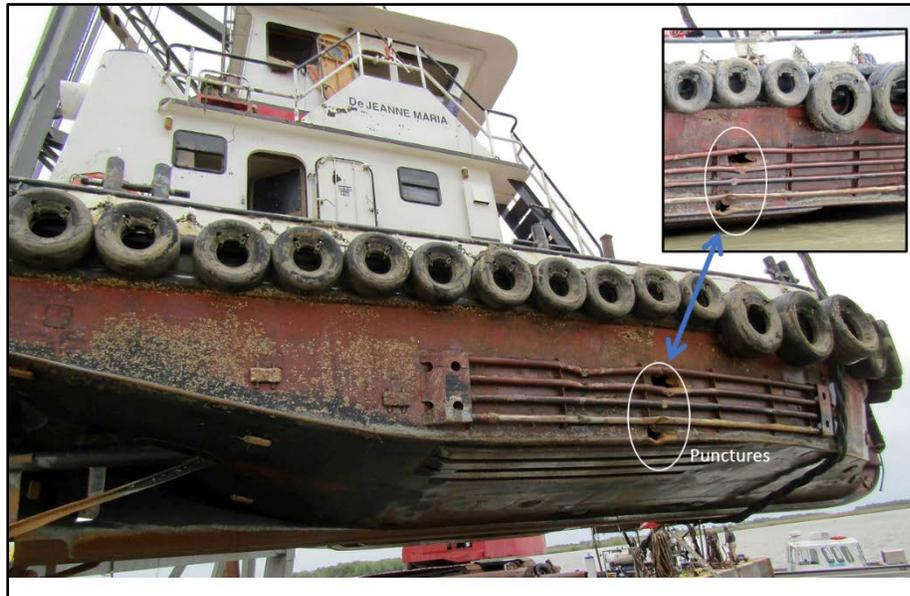
***DeJeanne Maria* during recovery. Punctures to the vessel's hull are shown circled in white. (Source: Central Maritime, L.L.C.)**

About two hours after the strike, the crew boat *Able Responder I* arrived to take the *DeJeanne Maria* crew ashore. About the same time, the towing vessel *Papa D*, also operated by Denet Towing Service Inc and working at a drilling rig nearby, disconnected the barges from the *DeJeanne Maria* and took them in tow. Both vessels had responded after receiving calls from the employee that the captain had called before abandoning the vessel. The *DeJeanne Maria* sank and remained on the bottom of Pass A Loutre until it was salvaged on April 25, 2019. The vessel incurred a 2-foot-by-7-inch hole in the starboard side shell plating of the engine room and starboard fuel tank, and a 10-by-7-inch hole in the lower starboard-side shell plating of the engine room.

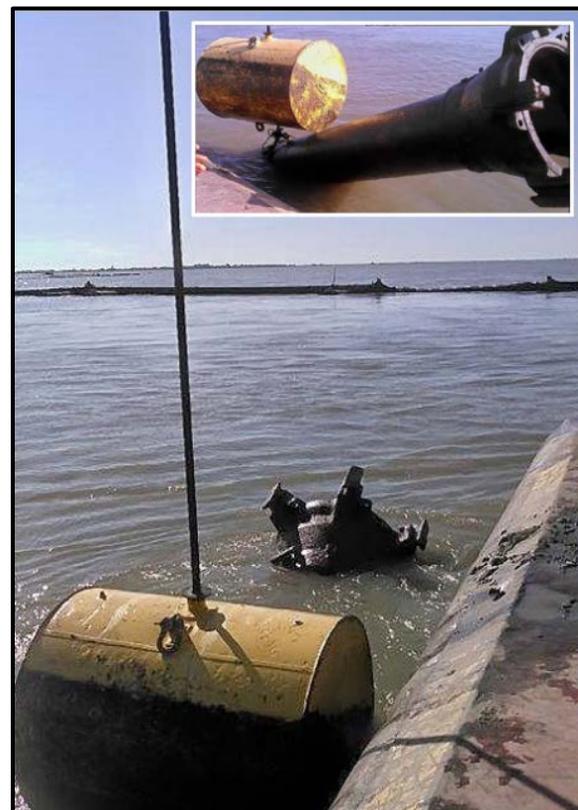
End of the submerged pipeline and its buoy. (Source: Weeks Marine)

HDDA, the 49-foot *Michael T*, struck what was identified a few hours later as the end of the submerged pipeline. The pipe measured 29 inches in diameter and nearly 48 inches in diameter at the bell end. The end of the pipe was located 5 feet beneath the river's surface and 1,035 feet from where the *DeJeanne Maria* was recovered from the bottom of the river. The buoy marking the end of the submerged pipe was floating 75 feet downstream from it.

The buoy that marked the end of the pipeline was secured to the pipe 15 feet from the bell end by a 90-foot-long cable, which was also used to lift the pipe end to the surface. The Department of the Army's Safety and Health Requirements Manual (EM 385-1-1) contained requirements for marking the end of the pipeline. The manual applied to Corps of Engineers elements and its contractors. Per the manual, the buoy marking the beginning (and end) of a submerged pipeline should include a flashing yellow light and be marked "DANGER SUBMERGED PIPELINE" (Section 19.G.03).

Even though the submerged pipeline's buoy markings had a white light and were therefore not fully compliant with standards (flashing yellow light), due to his experience in the area, the captain of the *DeJeanne Maria* was aware that the buoy and others marked a submerged pipeline. When the end of the pipe was discovered on May 6 due to a second vessel strike, its buoy was sighted 75 feet downriver. Buoys are often not located directly over what they mark; adequate scope in a down line is needed to prevent the river current from snapping the line, lifting the pipe off the bottom, or submerging a buoy. Based on calculations, when the pipe and the attached cable moved closer to the surface, the buoy scope would have increased from 4:1 to 15:1, but the buoy would have only moved about 3 feet further down river. The crew that surveyed the location on April 14 based the survey area on their best understanding of the location of the northern end of the submerged pipe in relation to the buoy marking it. While the survey results did find depths of less than 6.8 feet in the vicinity of the end of the pipeline, the survey vessel did not pass over and chart the end of the pipeline that was later found to be only 5 feet below the water surface.

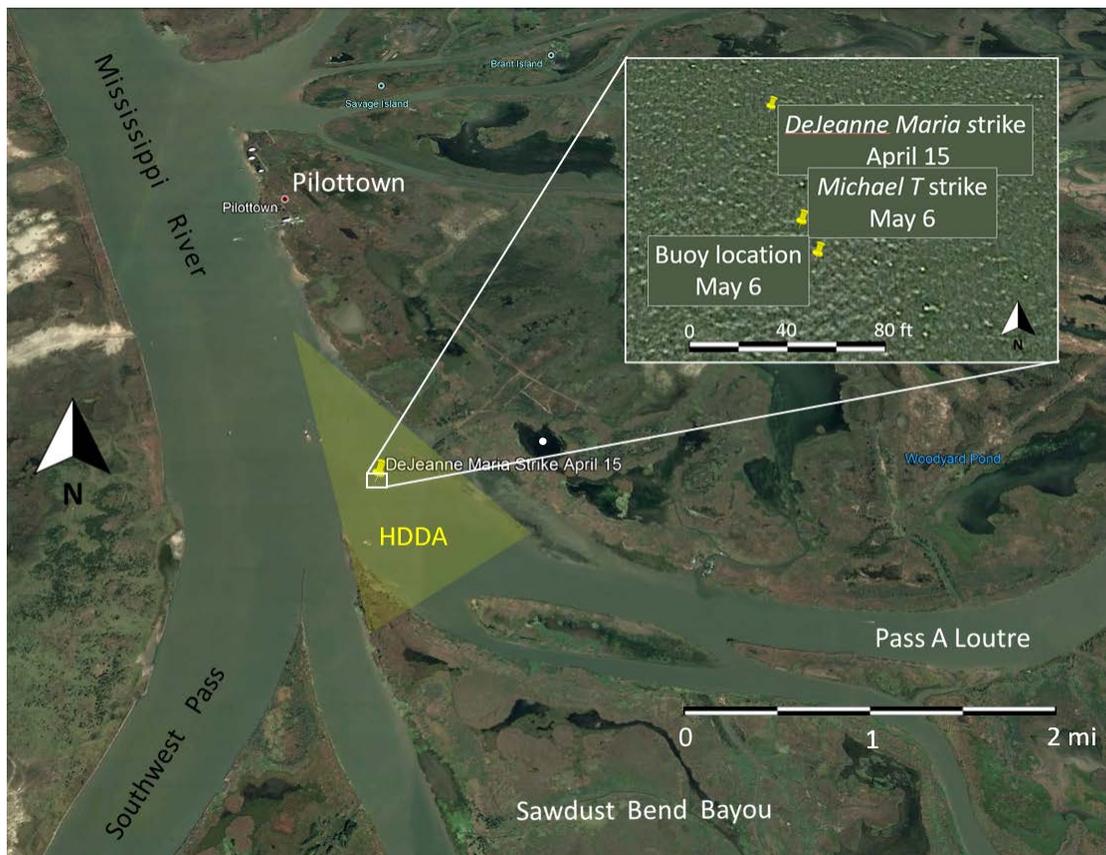
Area of the Mississippi River, Head of Passes, where the *Michael T* and *DeJeanne Maria* struck the submerged dredge pipe. Inset: Close-up view of accident location. (Background source: Google Earth).

When the *R S Weeks* disconnected from the pipeline in December 2018, the pipe sank to a depth of 24 feet, where it rested on the bottom, based on the depth survey conducted by the *Trinity*. Over the next few weeks, the hopper dredges continued to deposit sediment in the area, burying the pipeline. The pipe remained there until April 13, when the crane barge applied 70,000 pounds of lift 15 feet from the end of the 7-mile stretch of pipe. Though the pipe did not reach the surface, the lift likely raised the end of the pipe such that when the crane released it, the pipe dropped to or remained on top of the sediment. Although the area was surveyed the next day, the end of the pipeline was not identified. Three weeks after the *DeJeanne Maria* strike, the *Michael T* also struck the end of the submerged pipeline, based on the location of the pipeline's end and the vessel's damage.
