National Transportation Safety Board

Marine Accident Brief

Grounding and Sinking of Recreational Vessel *Silver Lining*

| Accident type | Grounding | No. DCA19FM044 |

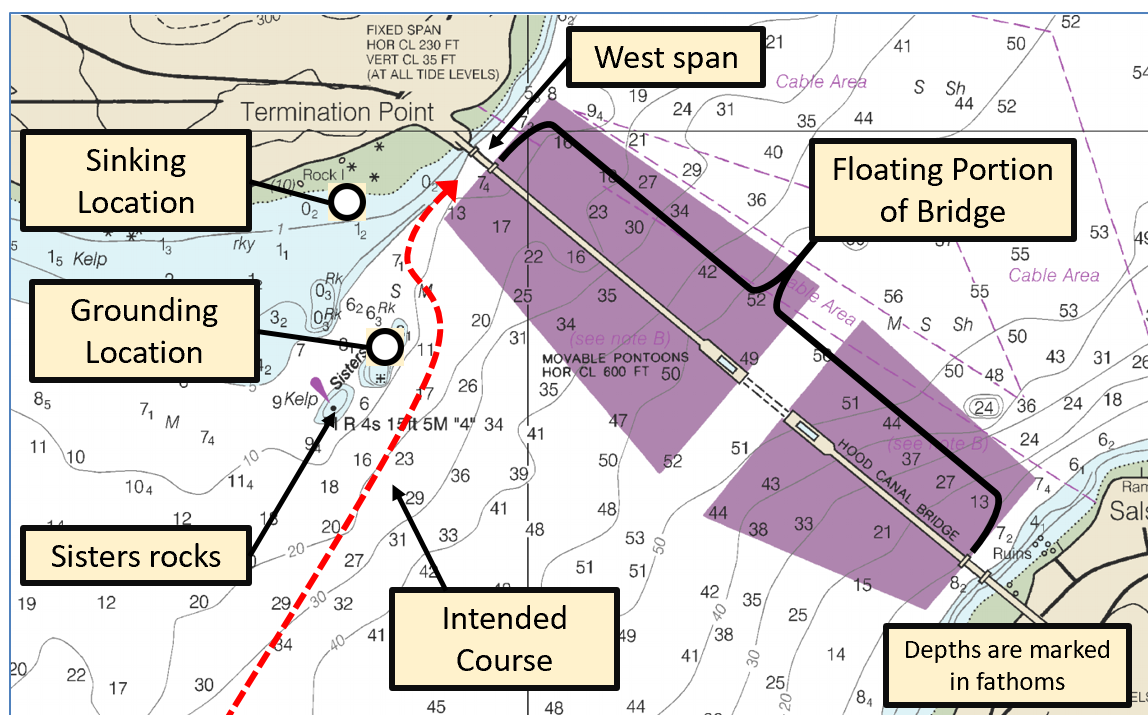
Map of the Hood Canal Bridge, including an estimated trackline of the *Silver Lining*'s intended course. (Source: National Oceanographic and Atmospheric Administration [NOAA] Chart No. 18476, annotated by NTSB)

The owner of the *Silver Lining*, who was at the helm of the vessel on the flying bridge, stated in the interview that he used dead reckoning when the vessel was approaching the Hood Canal Bridge. There was no GPS unit on the flying bridge, and he had a paper navigation chart for reference. He used the dinghy that was being towed astern as a reference point to verify that the *Silver Lining* had passed the Sisters rocks. After he saw that the dinghy had passed the number 4 navigation aid marker, he thought it was safe to turn to port to line the vessel up to pass under the west side of the Hood Canal Bridge. However, the 100-foot tow line, in addition to the location of the flying bridge where he was driving the vessel, put the owner approximately 140 feet away from the 12-foot dinghy. Therefore, based on the charts of the Sisters, when the owner turned the vessel after the dinghy passed the navigation marker, the *Silver Lining* had not yet completely passed the southern Sister, and the northern section of the Sisters was still ahead of the vessel to the port side. Per the *US Coast Pilot*, he would have needed to advance 600 feet (an additional 460 feet) to pass both rock pinnacles.

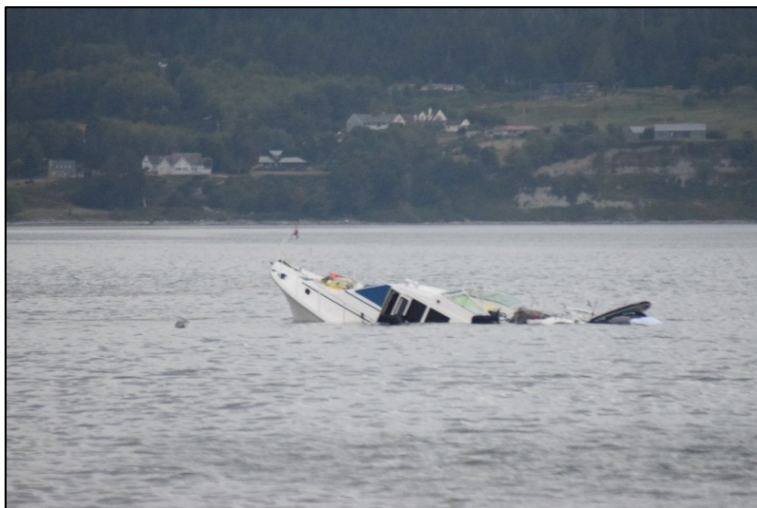
***Silver Lining* following the accident. (Source: US Coast Guard)**

About 1700, about 2 hours after the vessel started taking on water, it sank with just the bow still visible above the surface and still adrift. A salvage company arrived approximately 1800 and moved the vessel to a shallower area of water closer to shore by Rock Island so that it could be salvaged and refloated.

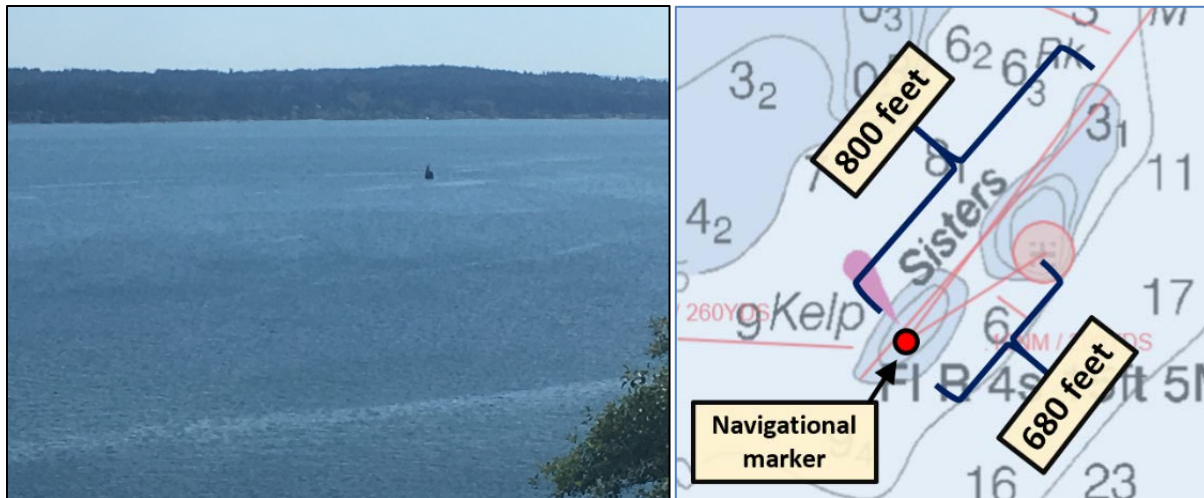
Aids to navigation marker for the Sisters rocks from Termination Point (left). Close-up chart of the Sisters formation (right). (Source: NOAA Chart No. 18476, annotated by NTSB)

The Sisters, identified on NOAA chart 18476, are located 0.57 miles southwest of the Hood Canal Bridge. Two separate pinnacle rock formations make up the Sisters: the northern Sister and the southern Sister. The southern Sister rock is marked with a fixed day board and a flashing red navigation light maintained by the Coast Guard. Both rock formations were marked on nautical charts. The water around the Sisters was between 11 and 18 fathoms (66 and 108 feet).²

The total length of both Sisters rocks is approximately 0.2 miles: The distance between the navigational aid of the southern Sister and the center of the shallow part of the northern sister is approximately 680 feet, and the distance from the navigational aid of the southern Sister to the northern edge of the rock is approximately 800 feet. The water in the shallow area immediately around the Sisters has a depth between 0.5 and 6 feet depending upon the tidal and weather conditions.

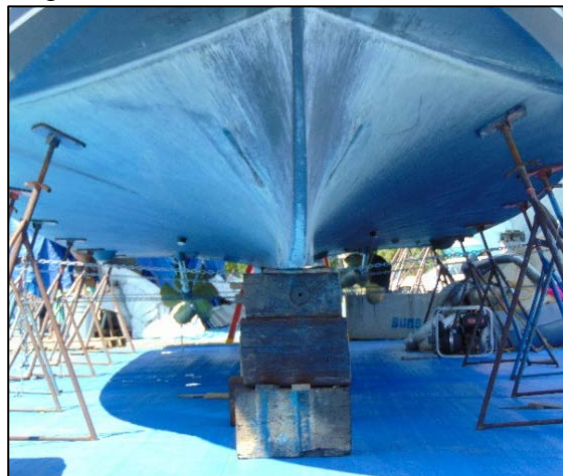
Vessel Damage. Three days after the accident, the *Silver Lining* was refloated and drydocked at a local marina. Investigators attended the vessel in drydock on July 29, 2019, and examined the hull and interior spaces. The bow and the forward part of the hull showed no indication of hull damage from a collision or grounding; however, the vessel had significant damage to the aft section of the keel and hull. The rudders and propellers were also extensively damaged. The

Photo of the bow of the *Silver Lining* following the accident.

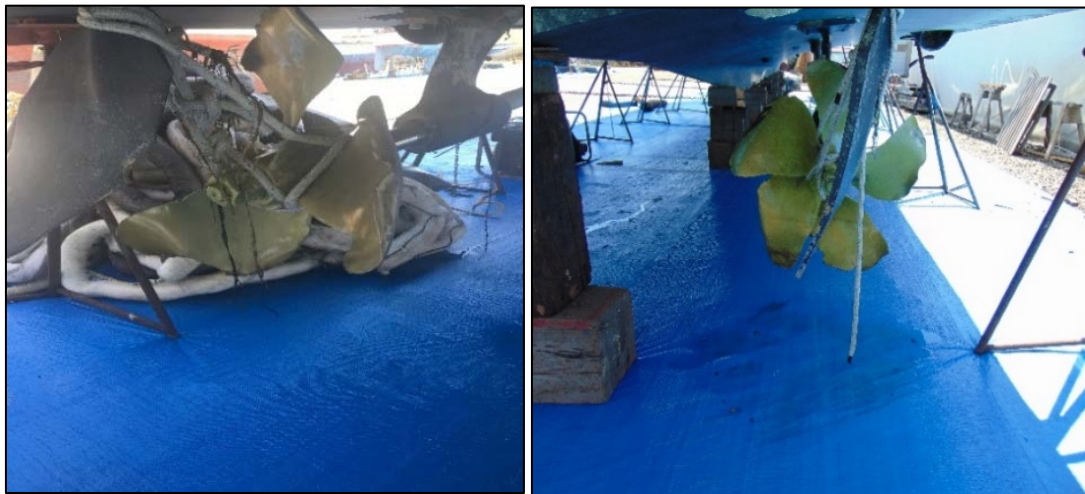
Damage sustained to the port propeller and rudder (left) and starboard propeller and rudder (right) of the *Silver Lining* following the accident.

The vessel had a listed draft of 5.5 feet, which was the maximum estimated depth of the area it grounded in at the time, accounting for the tide. Investigators found that the damage to the propellers and rudder was consistent with the vessel grounding. They also found that the propeller contact caused the shafts and the external strut bearings to be pushed into the hull, causing hull damage that would have allowed water to enter the vessel, in addition to the flooding from hull damage.

Based on the owner's interview and the propeller damage, it is most likely that the *Silver Lining* turned between the southern and northern Sisters, and that its starboard propeller first came into contact with the northern Sister rocks, which shut down the starboard engine. As the vessel proceeded, the keel from midships to the stern came in contact with the rocks at least three times, causing the vessel to rapidly slow down and the damaged hull to start taking on water. At the same moment, the port propeller also contacted the rocks, causing additional damage and shutting down the port engine.

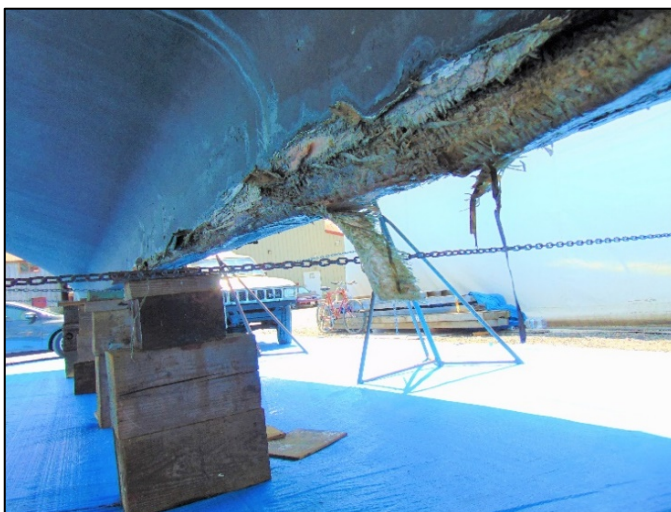
The keel, with a draft of 5.5 feet, was approximately 12 inches deeper in the water than the rest of the vessel, excluding the propeller and rudder. The damage to the keel started just aft of the vessel's midships and continued aft to its termination forward of the propellers. The keel damage was determined to have compromised the watertight integrity of the hull and would have allowed water to enter the vessel.

Damage to the keel of the *Silver Lining* postaccident.
