National Transportation Safety Board

Marine Accident Brief

Contact of *Dewey R* Tow with CSX Railroad Bridge Protection Cell

Accident type	Contact	No. DCA19FM031
Vessel name	<i>Dewey R</i> and <i>ATC 3404</i>	
Location	Chicago Sanitary and Ship Canal, CSX Railroad Bridge, mile 312.3, Summit, Illinois 41°46.98' N; 87°49.58' W	
Date	April 13, 2019	
Time	0123 central daylight time (coordinated universal time – 5 hours)	
Injuries	None	
Property damage	\$162,104 to barge <i>ATC 3404</i> , est. \$813,980 in damage to bridge protection cell	
Environmental damage	None	
Weather	Temperature 38°F, winds from the northwest about 25 mph, clear visibility	
Waterway information	The Chicago Sanitary and Ship Canal is a waterway linking the south branch of the Chicago River with the Des Planes River at Lockport, Illinois. The canal is 30 miles long and has a minimum width of 160 feet, a minimum depth of 9 feet, and 2 locks.

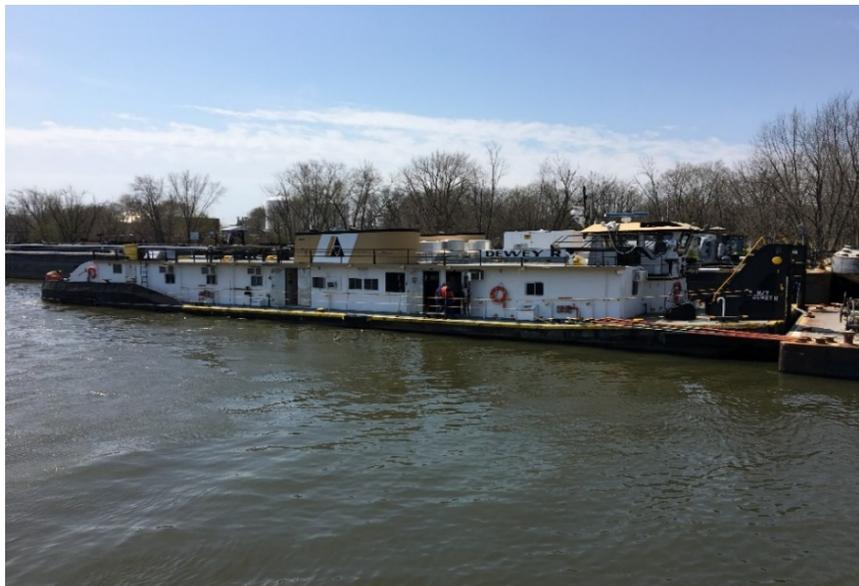
Towing vessel *Dewey R* docked after the accident, with the wheelhouse in the lowered position.

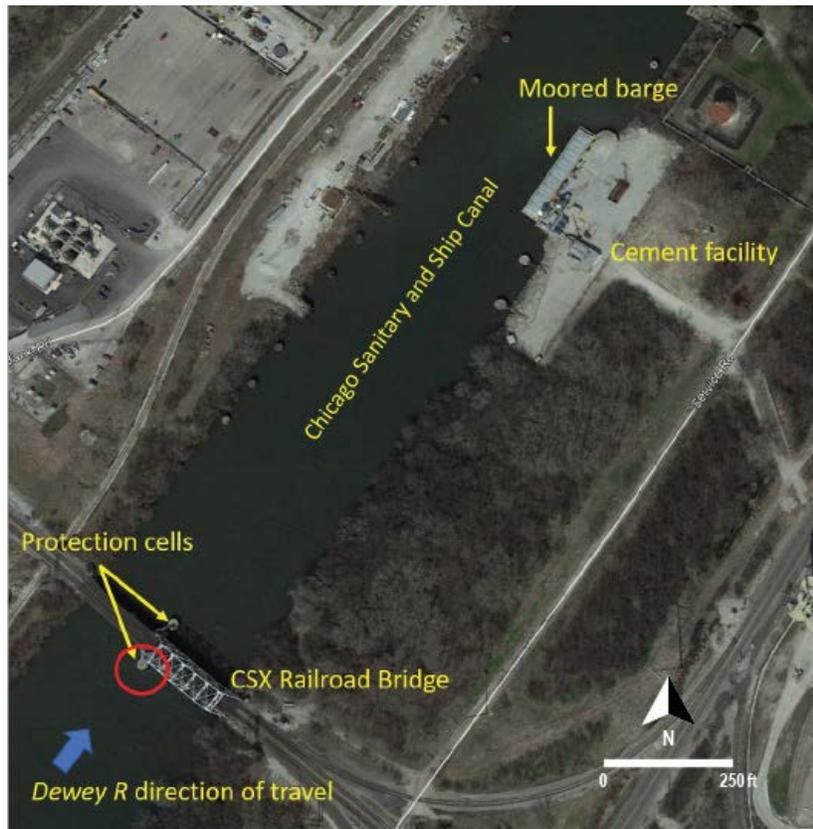
Location of the Chicago Sanitary and Ship Canal where the *Dewey R* and tow attempted to pass through the CSX Railroad Bridge, and location of a barge moored at the cement facility, similar to the barge that was moored at the time of the accident. The protection cell that was struck is circled in red. (Background source: Google Maps)

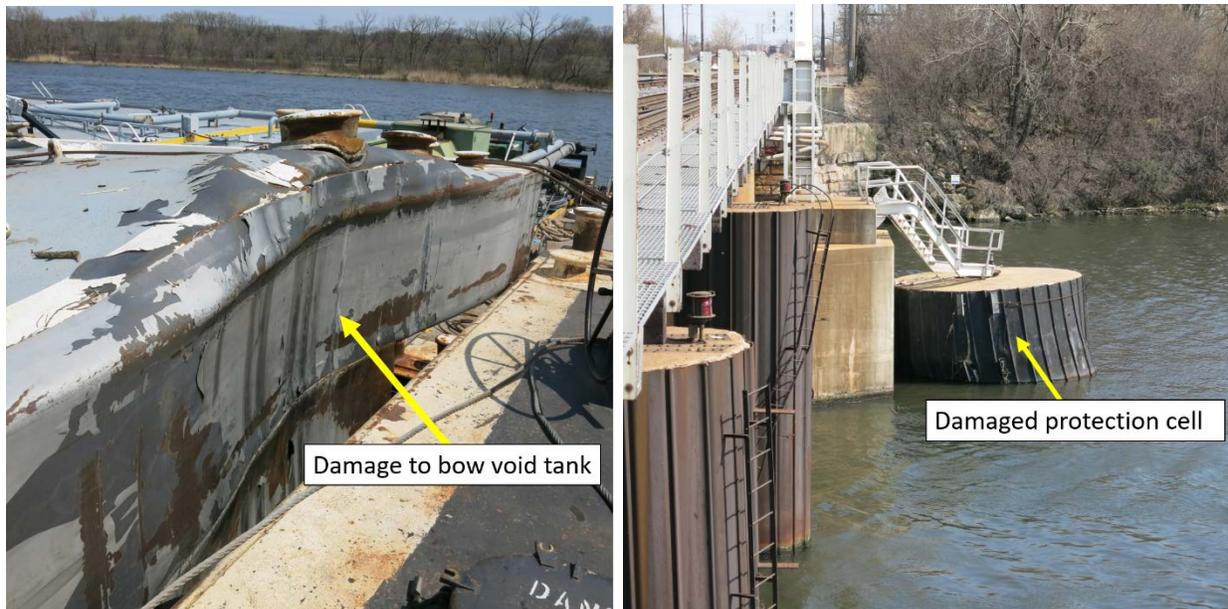
As a result of the collision, a 1.5-foot by 12-foot wide section of the port side of the *ATC 3404*'s bow void tank was inset, and several components of the barge's internal structure in the bow void tank were damaged. The southern protection cell was displaced over 4 feet in the direction of the pier. An engineering firm determined the protection cell to be extensively damaged with a fractured sheet pile that split opened and exposed the concrete within the cell. Also, several pieces of its fendering system had been dislodged and were no longer in place. The south corner of the bridge's concrete pier was also damaged, with an approximate 12-square-foot shallow concrete spall adjacent to the displaced protection cell, buckled vertical posts, and damaged fenders.

Postaccident images of the *ATC 3404* (left) and the south side of the CSX Railroad Bridge (right).
