National Transportation Safety Board

Marine Accident Brief

Contact of *Leviticus* Tow with Plaquemine Point Shipyard

Accident type	Contact	No. DCA19FM023
Vessel name	<i>Leviticus</i> , Kirby 27781, and Kirby 27754	
Location	Lower Mississippi River, mile 208.5; near Sunshine, Louisiana ¹ 30°17.63' N, 091°13.62' W	
Date	March 7, 2019	
Time	1020 central standard time (coordinated universal time – 6 hours)	
Injuries	10 minor	
Property damage	\$539,500 est.	
Environmental damage	None	
Weather	Visibility 10 miles, partly cloudy skies, winds easterly 10 knots; air temperature 52°F, water temperature 46°F	
Waterway information	The river at the accident site was at major flood stage, based on the gage at Baton Rouge, Louisiana (mile 228.4). The mean current velocity was estimated at 4.1 mph with a maximum of 8.7 mph.

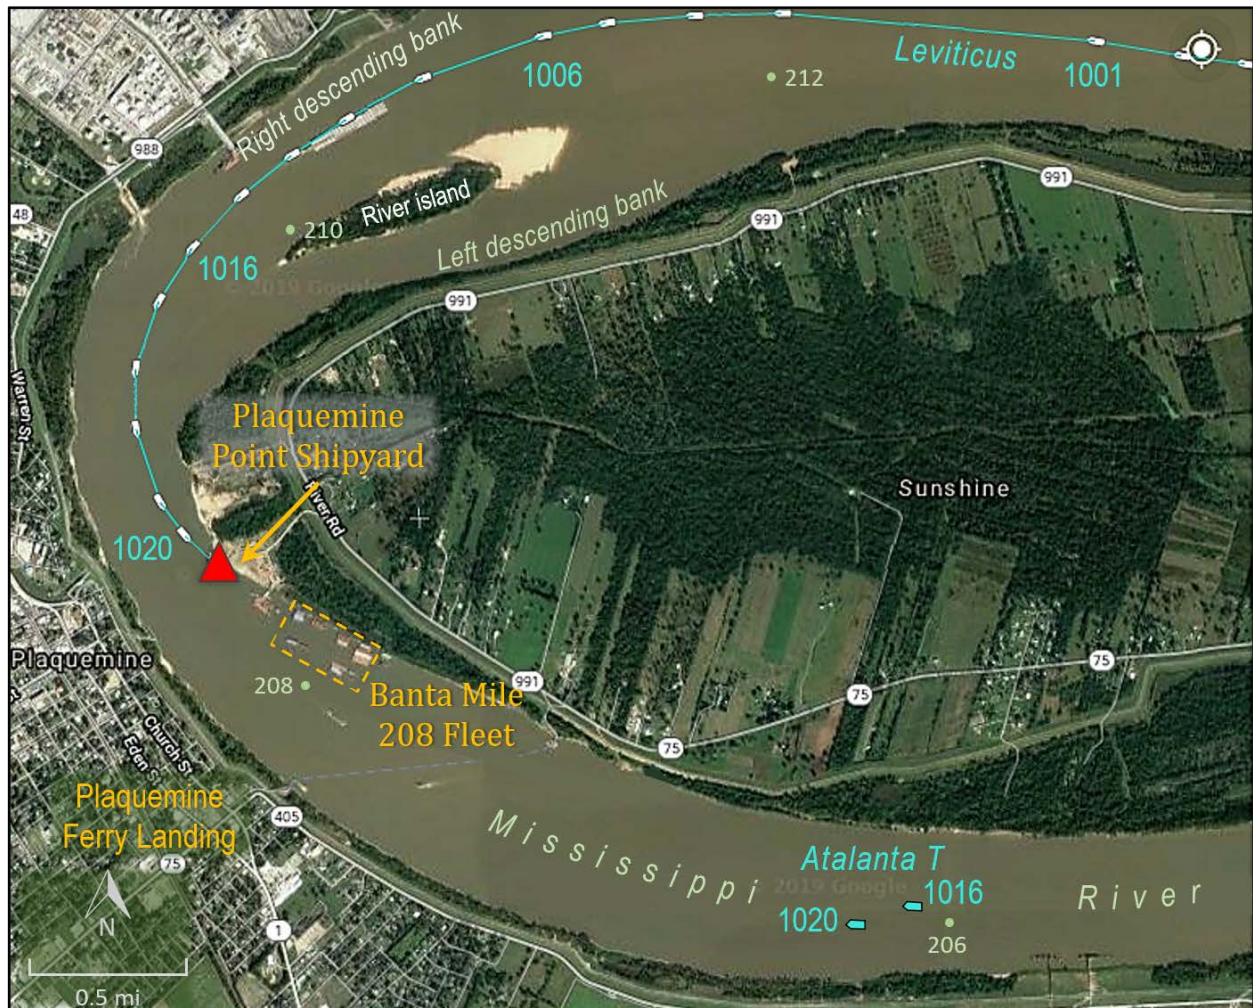
Trackline of the *Leviticus* tow during the last 20 minutes leading up to the contact with the barges moored at the Plaquemine Point Shipyard, based on the vessel's AIS data. According to the passing arrangement, Plaquemine Ferry Landing is where the tow would have met the *Atalanta T*. (Source: Marine Traffic; Google Earth)

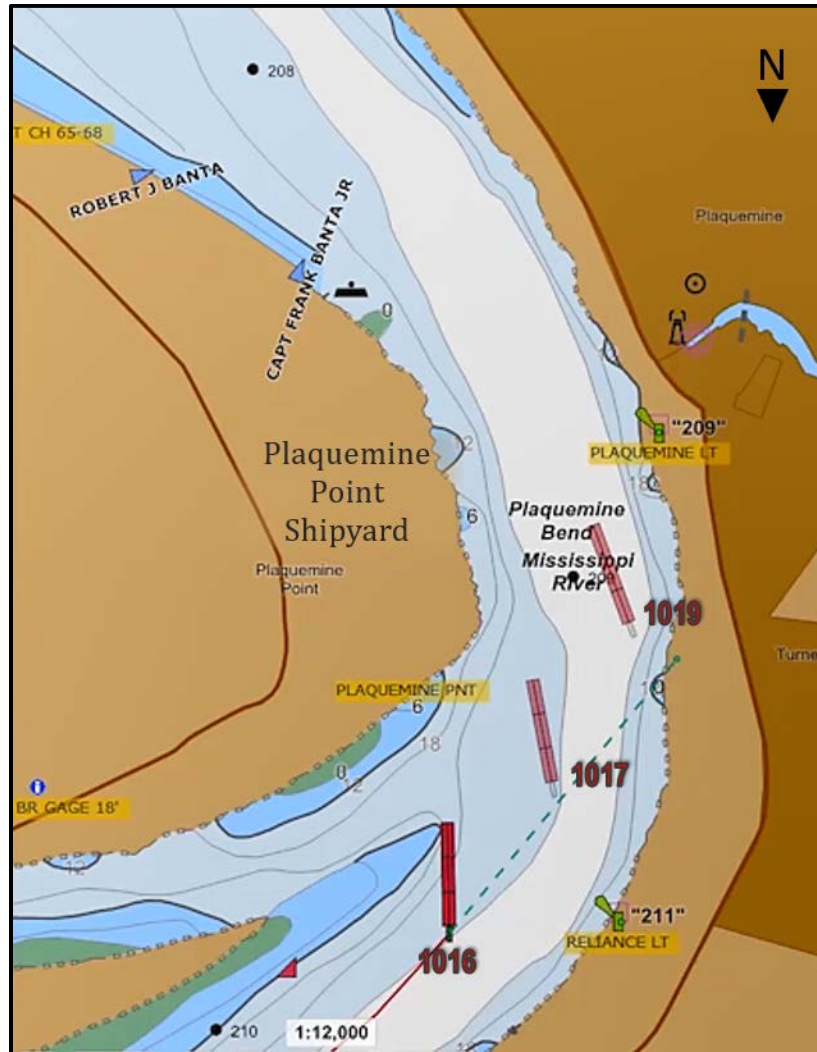
Screen capture from playback of *Leviticus*' navigation system at 1016 shows tow length and predicted positions as the vessel rounds the bend. Position times have been superimposed. (Source: Kirby Inland Marine)

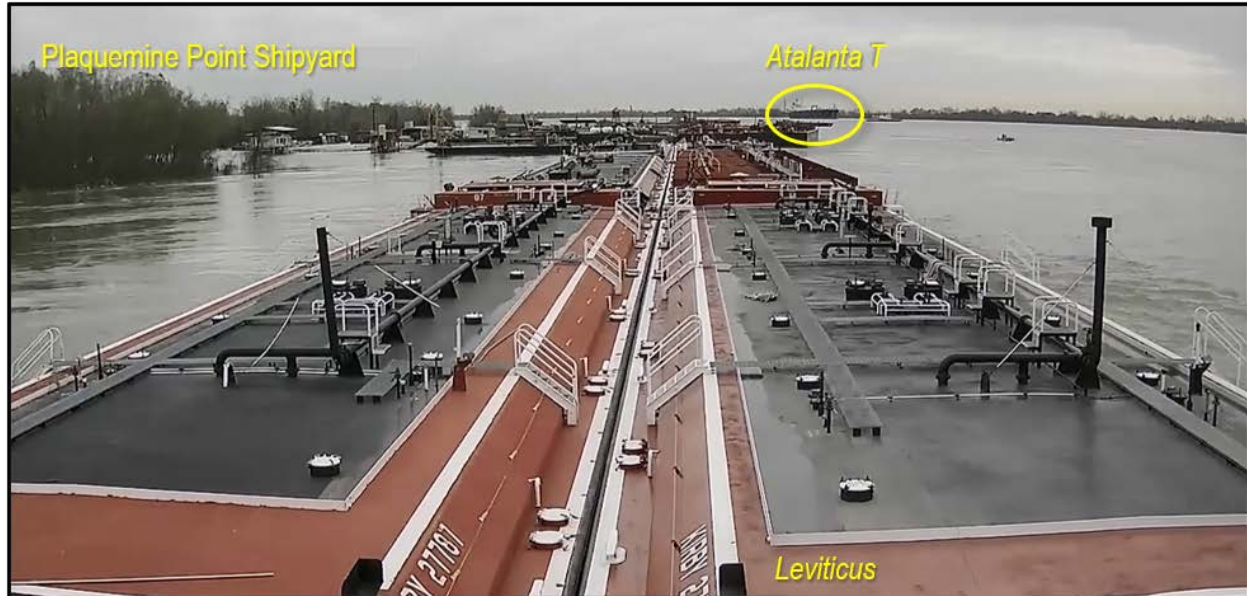
At 1020, the port lead barge of the *Leviticus* tow, *Kirby 27781*, with a SOG of 9.4 mph, struck a barge at the cleaning plant. Less than a minute later, the tow's starboard lead barge, *Kirby 27754*, struck an empty red-flag barge. As a result, all six of the cleaning plant barges were knocked free from their moorings, and the tow continued to push them downriver in the direction of the repair yard.

Screen capture from the *Leviticus*' video recorder at 1020 looking forward shows initial impact with the moored barges at the shipyard's cleaning plant. (Source: Kirby Inland Marine)

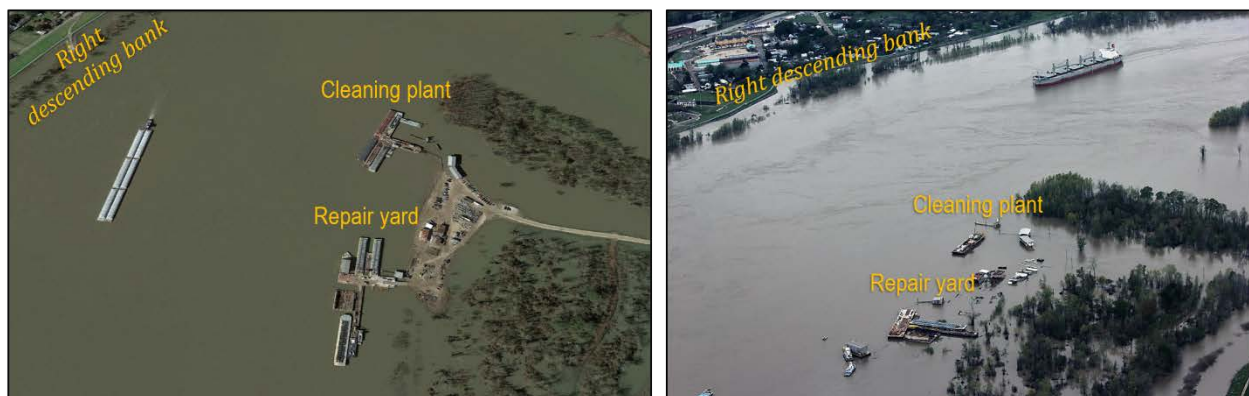
Damage to the Plaquemine Point Shipyard barges ranged from a 20-foot-by-12-foot hole to dents and deformations on the barges' hulls. In addition, anchors were lost. The shipyard was closed and reopened in August 2019, five months following the accident, after high-river conditions subsided.

Plaquemine Point Shipyard in January 2019 (left) and immediately after the accident during major flood stage (right). (Source: Google Earth Pro [left]; Coast Guard [right])
