# National Transportation Safety Board

## Marine Accident Brief

### Capsizing and Sinking of Workboat *MSRC 8-1*

<b>Accident Type</b>	Capsizing	<b>No.</b> DCA19PM014
<b>Vessel names</b>	<i>MSRC 8-1</i>	
<b>Location</b>	Boothville Anchorage, Lower Mississippi River, mile 18, near Boothville, Louisiana 29°21.06' N, 089°25.33' W	
<b>Date</b>	January 16, 2019	
<b>Time</b>	1038 central standard time (coordinated universal time – 6 hours)	
<b>Injuries</b>	Two fatal	
<b>Property damage</b>	\$250,000 est.	
<b>Environmental damage</b>	Oil sheen on water	
<b>Weather</b>	Visibility 10 miles, clear skies, winds northeast 6–8 knots, rippled river surface conditions, air temperature 51°F, water temperature 43°F <sup>1</sup>	
<b>Waterway information</b>	The Boothville Anchorage is an area about 5 miles long where deep-draft vessels anchor in the Lower Mississippi River. The river was near flood stage on the accident date, and the current was estimated at 3–4 knots.

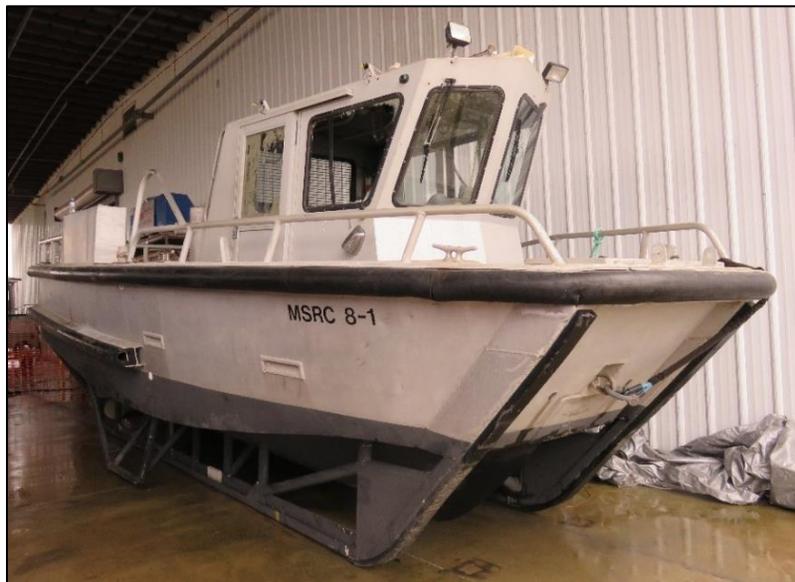
***MSRC 8-1* after salvage postaccident.**

***MSRC 8-1 Examination.*** The *MSRC 8-1* was salvaged on January 18 and transported to an MSRC facility in Lake Charles, Louisiana. Upon initial examination, Coast Guard investigators found the port and starboard sliding doors to the cabin in the closed position (although the port sliding door was last seen open before the vessel capsized), and the port side sliding window was in the open position. All other windows were found in the closed position. None of the cabin windows were broken at the time of recovery. At the control console inside the cabin, the port engine propulsion control lever was found in the full astern position while the starboard control lever was in the engaged astern position (dead slow astern). Both rudders were deflected to about 10 degrees to starboard. Steering gear and linkages were visually inspected and showed no signs of damage. There was no evidence of any propeller fouling or underwater hull damage.

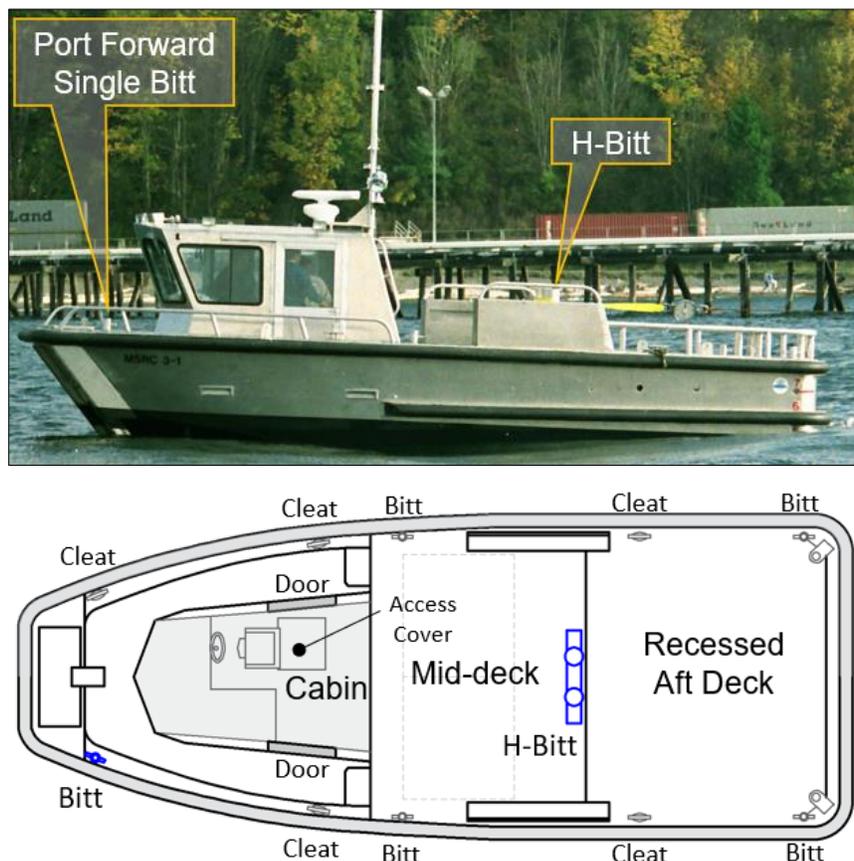
**32-foot aluminum workboat similar to the *MSRC 8-1*. The port forward single bitt and midship H-bitt used during the accident are shown in blue. (Photo source: Munson Manufacturing, Inc)**

A tow post (also called an H-bitt because of its shape) was located on the midships deck of the *MSRC 8-1*. The operations manual for the boat cautioned that if the boat was towing using a line to the H-bitt, the operator was not to let the line tend more than 5–10 degrees off centerline directly astern. A towline tending more than 5–10 degrees risked capsizing the boat. Although the text of the caution note was capitalized and bolded in the manual, the warning was not posted anywhere in the vessel.

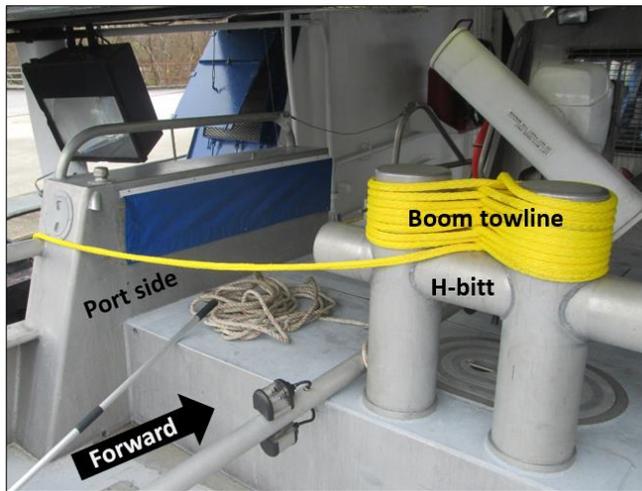
The H-bitt on a workboat of same design as *MSRC 8-1*, with towline secured to the bitt.

The H-bitt on the *MSRC 8-1* was located just aft of midship above the vessel's center of gravity, and the boom towline was made up to the top of the bitt. Once the *MSRC 8-1* was perpendicular to the current, the boom towline was tending directly off the boat's port side from the H-bitt with tension on it. The vessel's operating manual noted that the vessel was at risk of

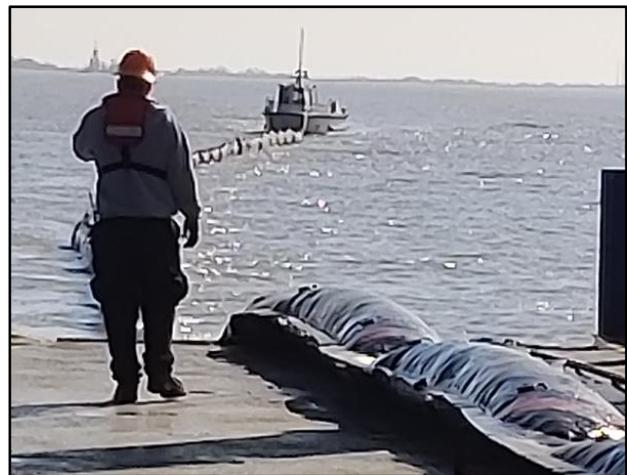
*MSRC 8-1* at 1031, downriver from the *Louisiana Responder* with the boom in tow. (Source: BSEE)

The *MSRC 8-1* began to move directly forward, thus slackening the boom towline. The deckhand then untied the towline from the bitt on the port bow and started walking the line back to the stern of the boat down the port side. Both the master and chief mate, who were observing the exercise from the *Louisiana Responder* wheelhouse, saw the *MSRC 8-1* turn “a few degrees to port”—in the same direction of the boom towline—which was unexpected. Then, seconds later, about 1038, they saw the *MSRC 8-1* come to starboard at a fast rate of turn, which put the boat perpendicular to the current.

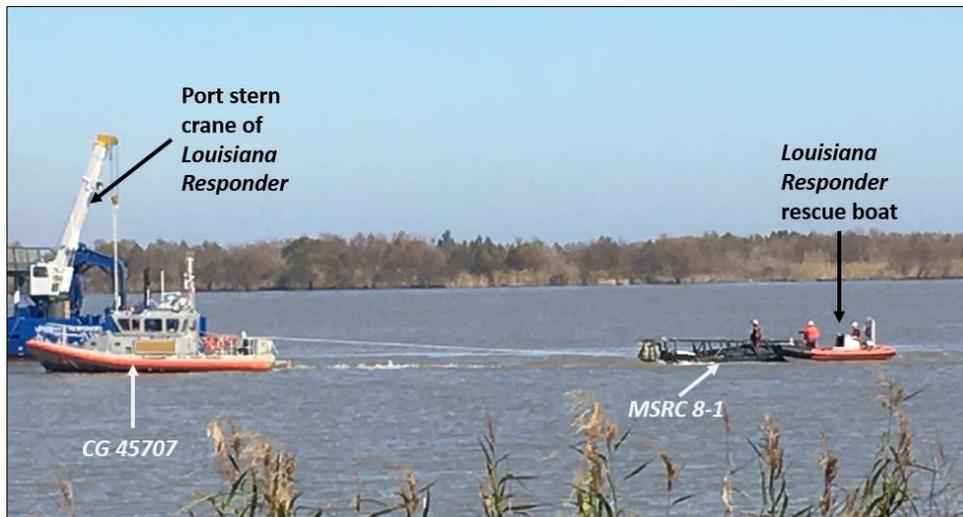
Overtaken *MSRC 8-1* under tow by the boom line from the *Louisiana Responder's* hydraulic reel and by *CG 45707*. The *Louisiana Responder* rescue boat is alongside the *MSRC 8-1*. (Source: rescue operation witness)

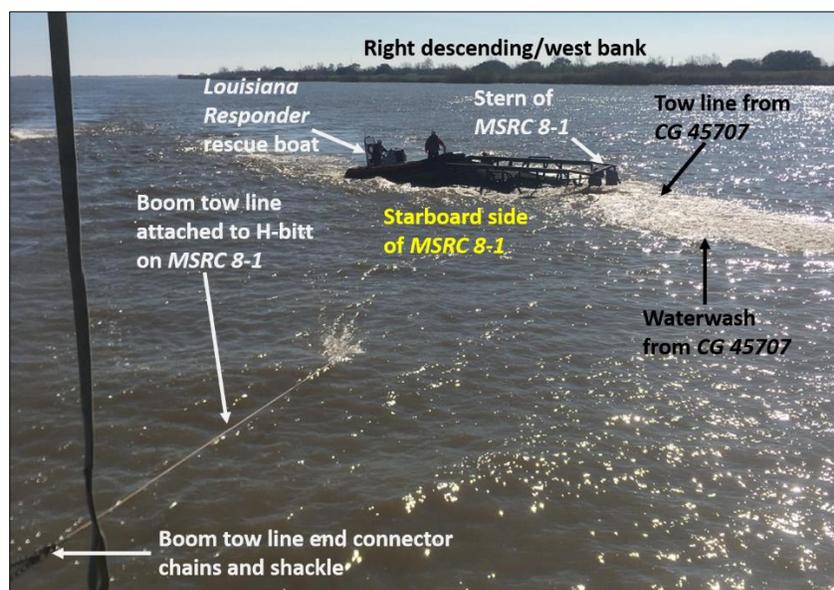
Photo taken at 1119 from the cab of the crane on the port stern of the *Louisiana Responder*. Note the waterwash from *CG 45707* and the combined current flow over the stern of the *MSRC 8-1*. (Source: *MSRC* crewmember)

Witness accounts and photos indicate that waterwash from *CG 45707*'s water propulsion system caused water to enter and flow over the overturned hull. After extending the tow and maintaining the minimum power possible, the coxswain determined that the towing effort was not effective. He recommended to the master of the *Louisiana Responder* that another means of getting the *MSRC 8-1* closer to the ship be determined, but by that time the *MSRC 8-1* had begun to exhibit unpredictable movements. As previously noted, the boom towline ultimately released from the *MSRC 8-1*, and the vessel sank. When examined after the accident, the boom towline showed no damage. Therefore, the efforts of the crew of the *CG 45707* to assist in the attempted rescue of the crew of the *MSRC 8-1* in dynamic and difficult conditions were reasonable and appropriate.

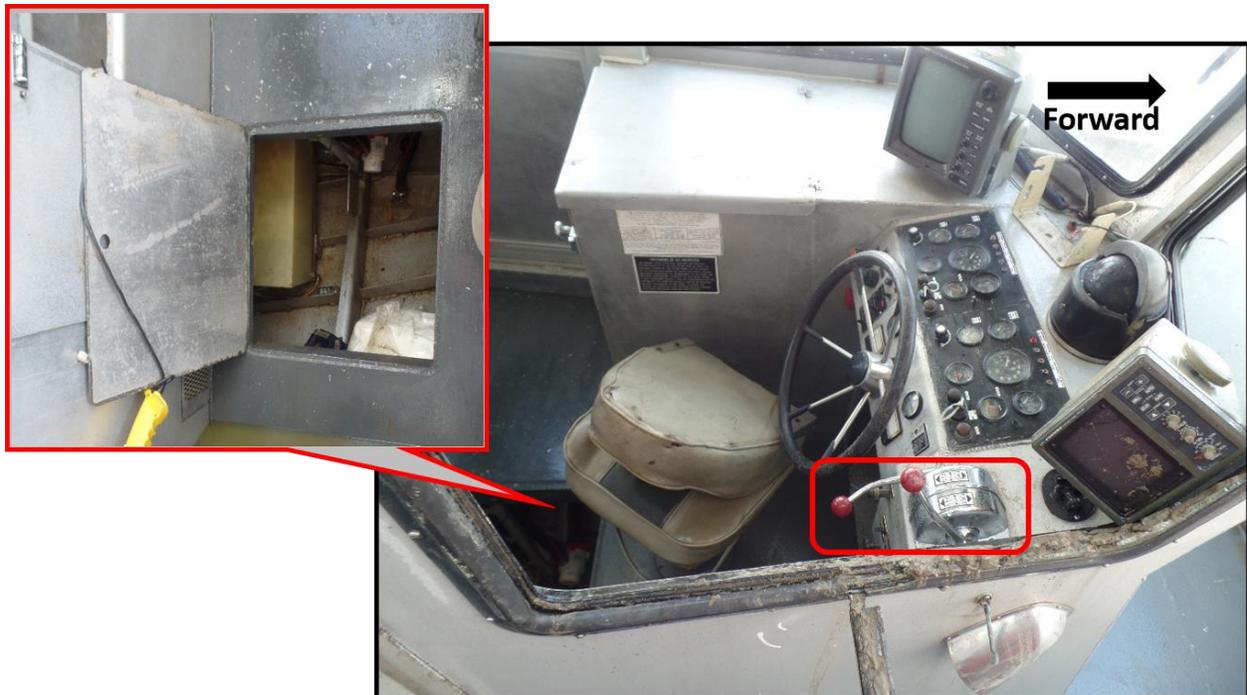
Inside the main cabin, there was no appearance of any anomalies or damage related to controls for engine or rudder. Switches and levers were examined and found to be in the configuration for normal operation. The starboard side sliding door, once cleared of debris and mud, operated properly, as did the port side door.

Cabin and control console of the *MSRC 8-1* postaccident. The red rectangle indicates the position of the propulsion control levers at the time the vessel was recovered: full astern on the port engine and engaged astern on the starboard. The inset shows the crawl space below the cabin where the operator was later found, as viewed through the opened access cover directly behind the helm chair. (Source: Coast Guard)

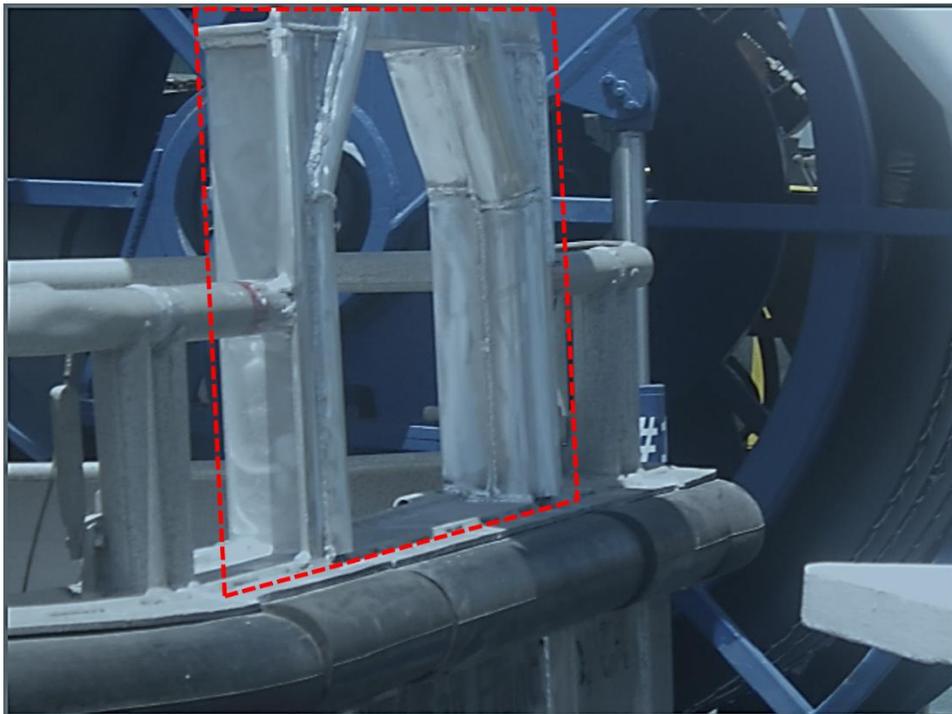
Towline guide, as outlined in red, installed on a *MSRC Munson* workboat's transom following the accident. (Source: *MSRC*)

**Company Actions Since Accident.** Following the accident, MSRC conducted an analysis to determine lessons learned and any necessary changes to procedures or to the equipment configuration. The company determined that the “taut towline while workboat was broadside to the current tripped and capsized the boat.” (Tripping is the effect when the force acted on the vessel by its tow overcomes the buoyant forces acting on the vessel.) As a result of the analysis, the company began modifying each of its Munson boats by installing a towline guide on the stern and a buoyancy collar at the waterline. The towline guide is a deck fitting that the towline is passed

through before being secured to the H-bitt. It reduces the capsizing hazard by moving the pivot point of the tow force aft, which allows the vessel to swing away if caught in a current. The guide also provides the operator a visual indication (the sides of the guide) when the towline is near the recommended limits for the angle of the tow relative to dead astern. The buoyancy collar is designed to limit heeling when an athwartships force is applied, improving the vessel's ability to right itself while increasing time for the vessel to swing. In addition to these workboat modifications, the company stated that it is conducting risk assessments of its field operations, enhancing procedures, and training and documenting the enhanced procedures in its safety management systems. Further, the company is sharing its lessons learned with other industry participants who perform similar operations. Full implementation of the safety enhancements is expected to be completed in mid-2020.

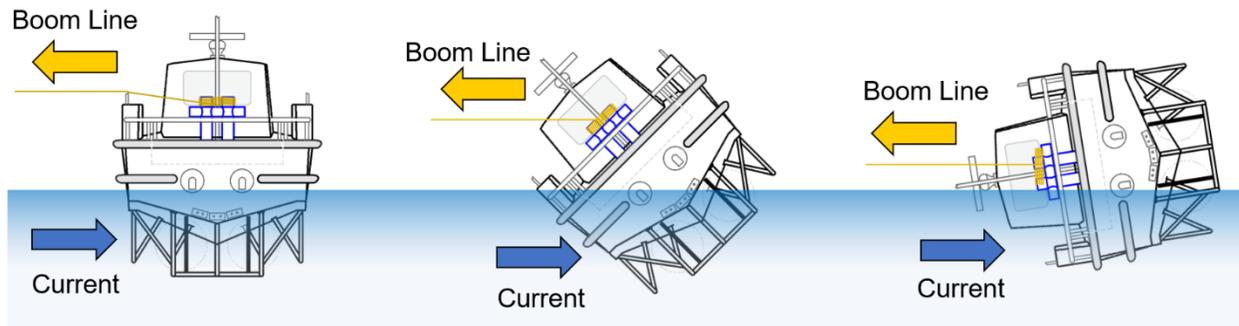
capsizing with a towline tending as little as 10 degrees off centerline dead astern. By comparison, during the accident, the boom towline was tending about 90 degrees off centerline. The static force that the boom towline exerted on the H-bitt, combined with the force of the current broadside to the *MSRC 8-1*'s underwater hull, attached framework, and large rudders, created a heeling moment, which rolled the boat to port quickly, overcoming its inherent stability and capsizing it. Although the boom towline was rigged for ease of release, the speed of the capsizing and the tension on the line likely prevented the crew from releasing it.

**The forces of the current and boom towline acting to capsize the *MSRC 8-1*.**
