National Transportation Safety Board

Marine Accident Brief

Contact of Crane Barge *Mr Ervin*, Pushed by Towing Vessel *Kristin Alexis*, with Sunshine Bridge

Accident type	Contact	No. DCA19FM003
Vessel name	<i>Kristin Alexis</i>	
Location	Lower Mississippi River, mile 167.4, St. James Parish, about 30 miles downriver of Baton Rouge, Louisiana ¹ 30°05.86' N, 90°54.81' W	
Date	October 12, 2018	
Time	0141 central daylight time (coordinated universal time – 5 hours)	
Injuries	None	
Property damage	\$7 million est.	
Environmental damage	None	
Weather	Clear skies with visibility at 10 miles, winds north-northeast at 6 mph; air temperature 62°F, water temperature 77.5°F	
Waterway information	The Mississippi River at the Sunshine Bridge is about 2,550 feet wide, bank to bank. At the time of the accident, the river gage at Donaldsonville was at 18.37 feet, and the current was about 3 mph. (Flood stage was in effect at 27 feet.)

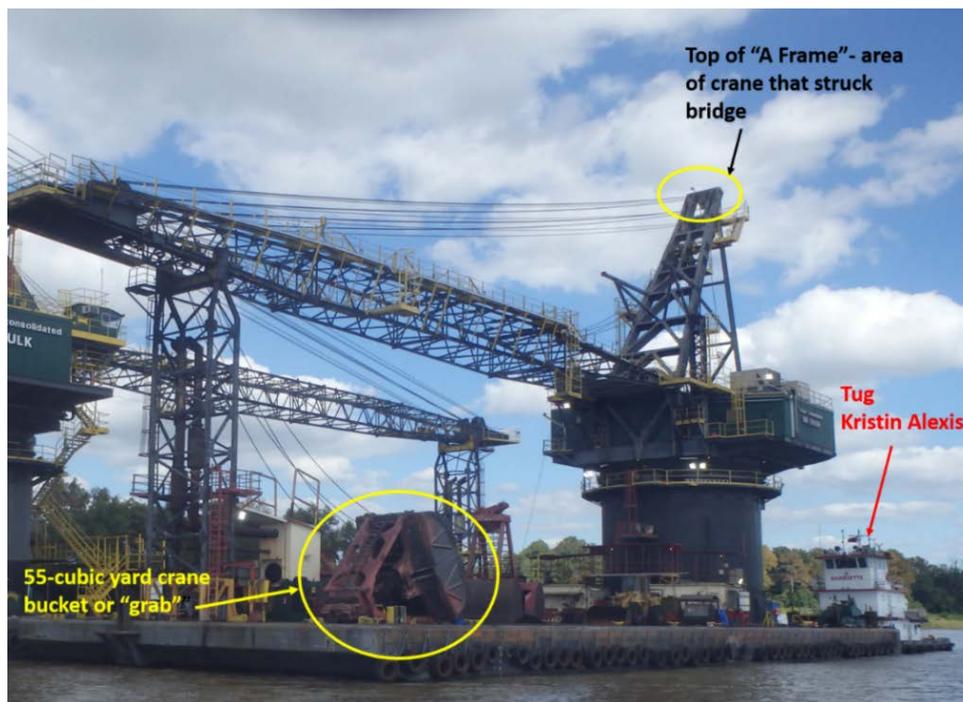
Figure 3. Photo of crane barge *Mr Ervin* faced up to the *Kristin Alexis*. (Source: Coast Guard)

⁶ According to Cooper Consolidated, the crane stood 128.25 feet high above the deck, and as such, would have had an air draft of around 135.75 feet high. Postaccident measurements by Coast Guard investigators determined the air draft to be 136 feet.

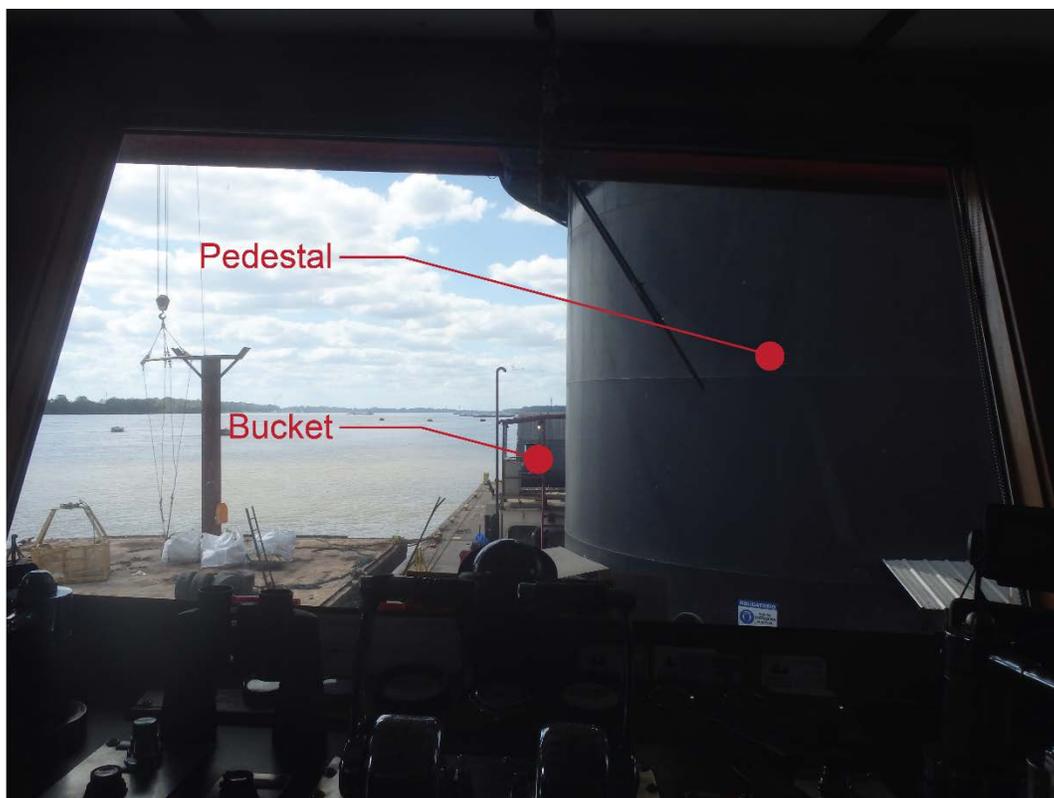
Figure 4. Forward view from the *Kristin Alexis*’ wheelhouse. The crane’s pedestal blocks most of the starboard view, while the crane bucket blocks a portion of the forward view ahead. (Source: Coast Guard)

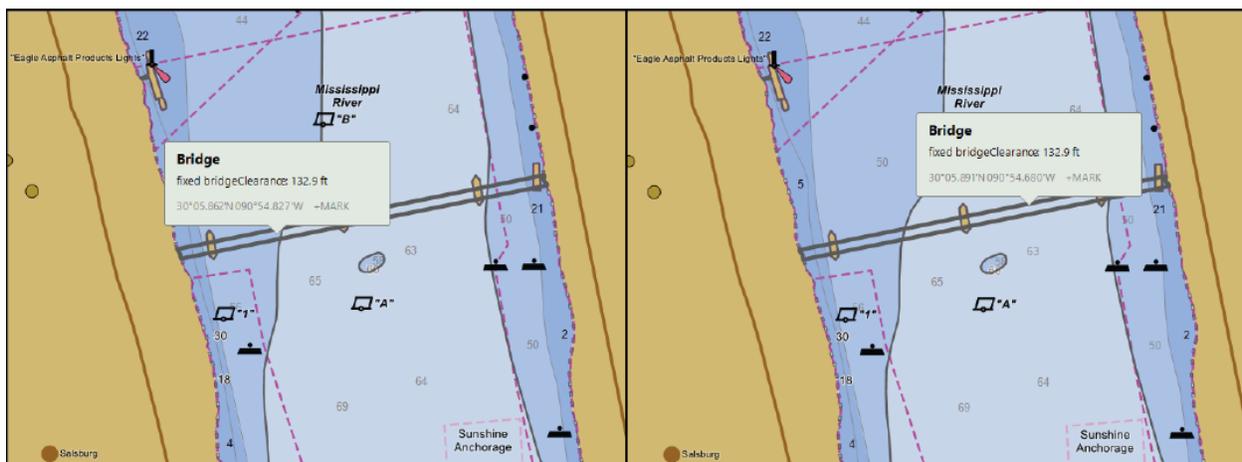
Figure 5. Vertical clearance of the Sunshine Bridge's west (left) and channel (right) spans, as indicated postaccident by the Rose Point display on board the *Kristin Alexis*, which showed the same clearance for each span (132.9 feet).

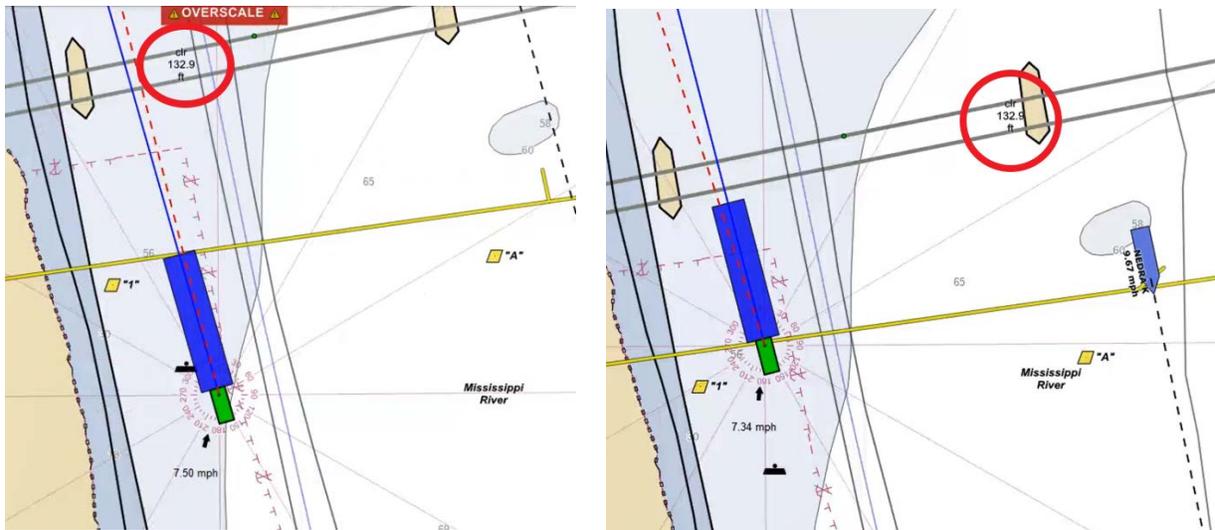
Figure 6. Screenshots of the *Kristin Alexis*' Rose Point at 0139 (left) and 0140 (right). The vertical clearance for the Sunshine Bridge is circled in red.

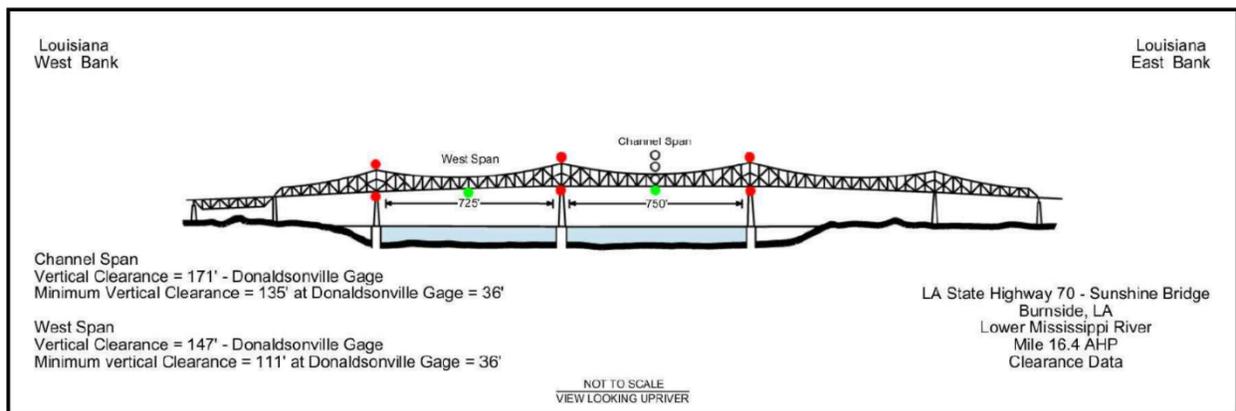
Figure 7. Sunshine Bridge span vertical clearances. The right descending bank is the west bank, and the left descending bank is the east bank. (Source: Corps of Engineers)

According to the Corps of Engineers map book, the channel span had a maximum vertical clearance of 171 feet (minus the Donaldsonville gage), and the west span had a maximum vertical clearance of 147 feet (minus the Donaldsonville gage) (see figure 7). The pilot stated that he was not using the map book.

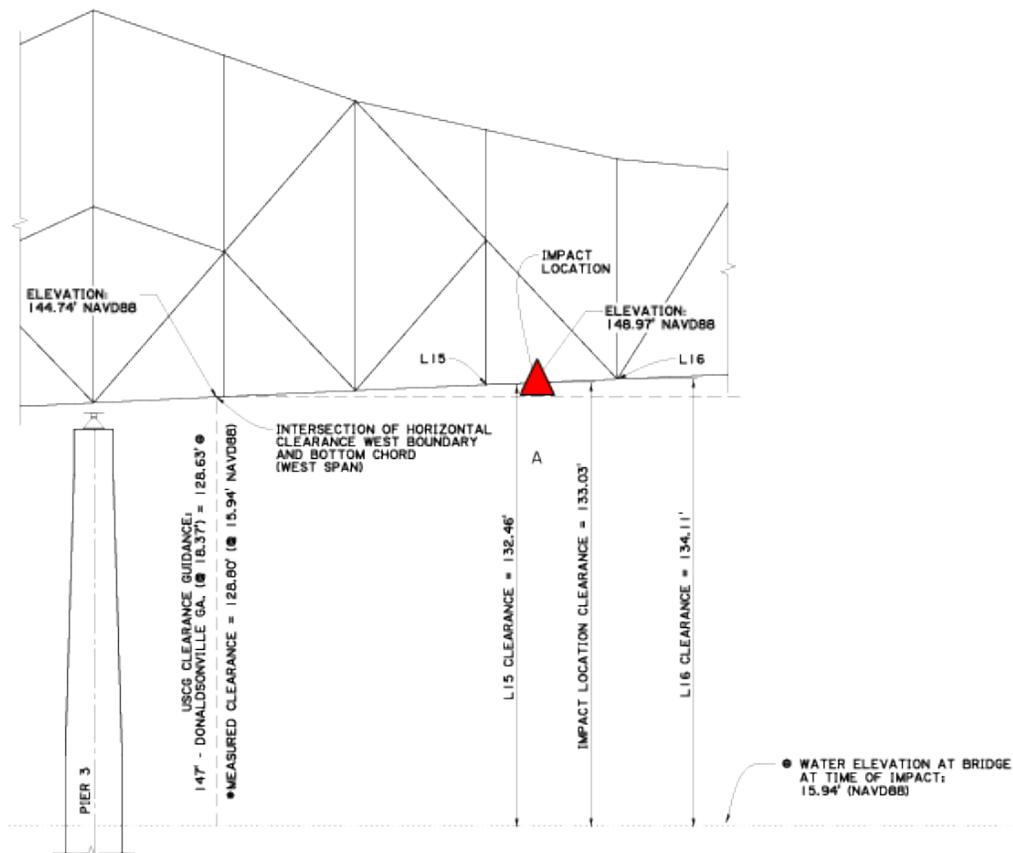
point of minimum vertical clearance for the channel span to be 16.88 feet, and for the west span to be (-)7.12 feet. As depicted in figure 10 (from the survey), the 5-percent bridge grade across the west span offered an increasing vertical clearance towards the center of the Mississippi River. At the point of impact, the survey-based vertical clearance was calculated to be 133.03 feet, indicating an actual estimated overhead clearance for the *Mr Ervin* of (-)2.72 feet.

Figure 10. Vertical clearances of the Sunshine Bridge's west span measured shortly after the accident. The impact location is marked with a red triangle. (Source: Forte and Tablada, annotated by NTSB)
