# National Transportation Safety Board

## Marine Accident Brief

### Collision between Bulk Carrier *Century Queen* and Towing Vessel *Kaytlin Marie*

<b>Accident type</b>	Collision	<b>No.</b> DCA19FM038
<b>Vessel names</b>	<i>Century Queen</i> and <i>Kaytlin Marie</i>	
<b>Location</b>	Lower Mississippi River, mile 126, near Hahnville, Louisiana <sup>1</sup> 29°59.47'N, 090°25.17'W	
<b>Date</b>	June 8, 2019	
<b>Time</b>	1215 central daylight-saving time (coordinated universal time – 5 hours)	
<b>Injuries</b>	Two minor, one serious	
<b>Property damage</b>	\$1,375,198	
<b>Environmental damage</b>	About 8,954 gallons of diesel fuel released	
<b>Weather</b>	Visibility 10 miles, winds north-northwest 4 mph, air temperature 88°F	
<b>Waterway information</b>	The Mississippi River at the accident site is approximately half a mile wide. The nearest river gage (mile 126.9) was 20.95 feet and rising.

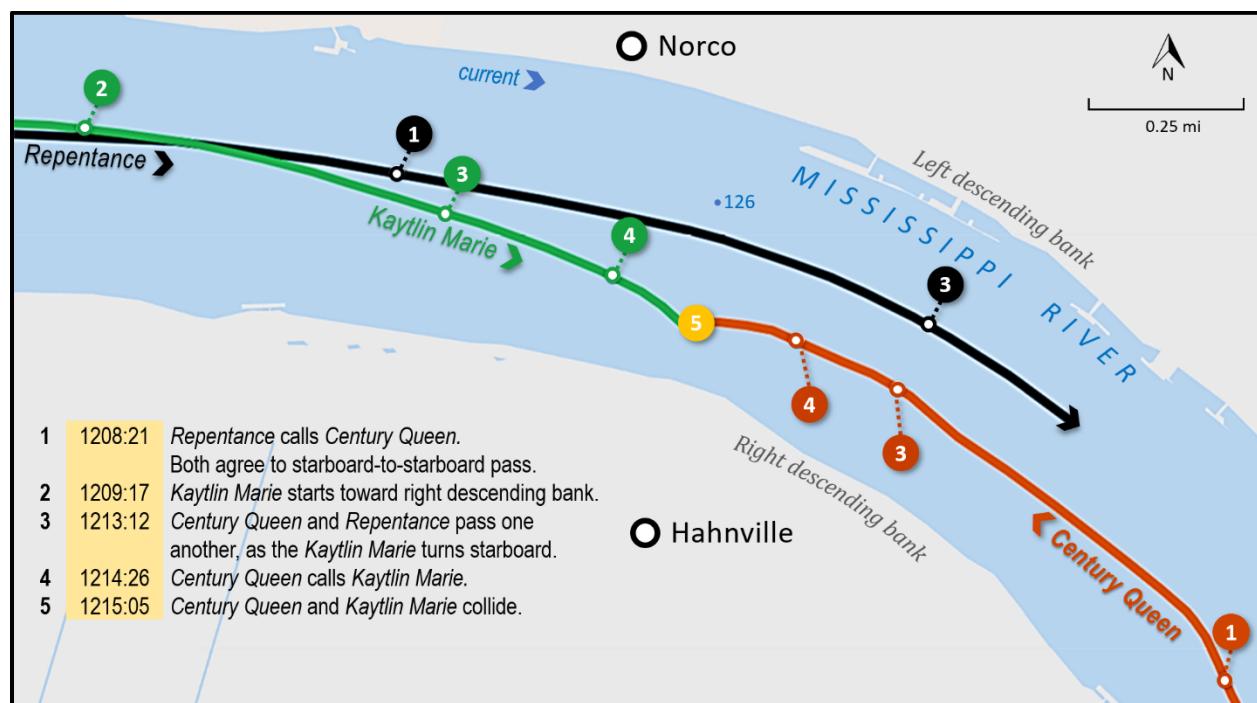
**Tracklines of the vessels during the last 7 minutes prior to the collision. The *Century Queen* is represented in red, the *Kaytlin Marie* in green, and the *Repentance* in black. (Background source: Google Maps)**

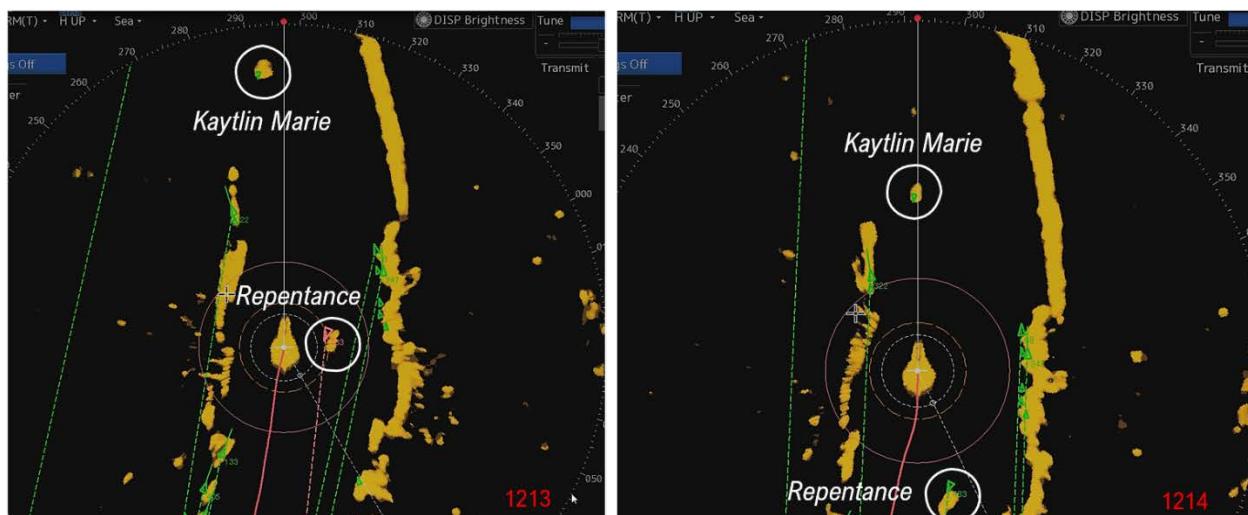
After passing the *Repentance*, the bulk carrier continued to make incremental course changes to port. At 1213:40, the pilot on the *Century Queen* ordered the rudder to port 5°. The *Kaytlin Marie* had altered course to starboard another 10° in the previous minute, toward the right descending bank, as the towboat and bulk carrier headed almost directly toward each other.

Screenshots of the *Century Queen*'s radar on a 0.75 nautical mile scale on a head-up display. The *Kaytlin Marie* is shown fine-to-port at 1213 (left) and dead ahead with a port bow aspect at 1214 (right). The *Repentance*'s position is also identified.

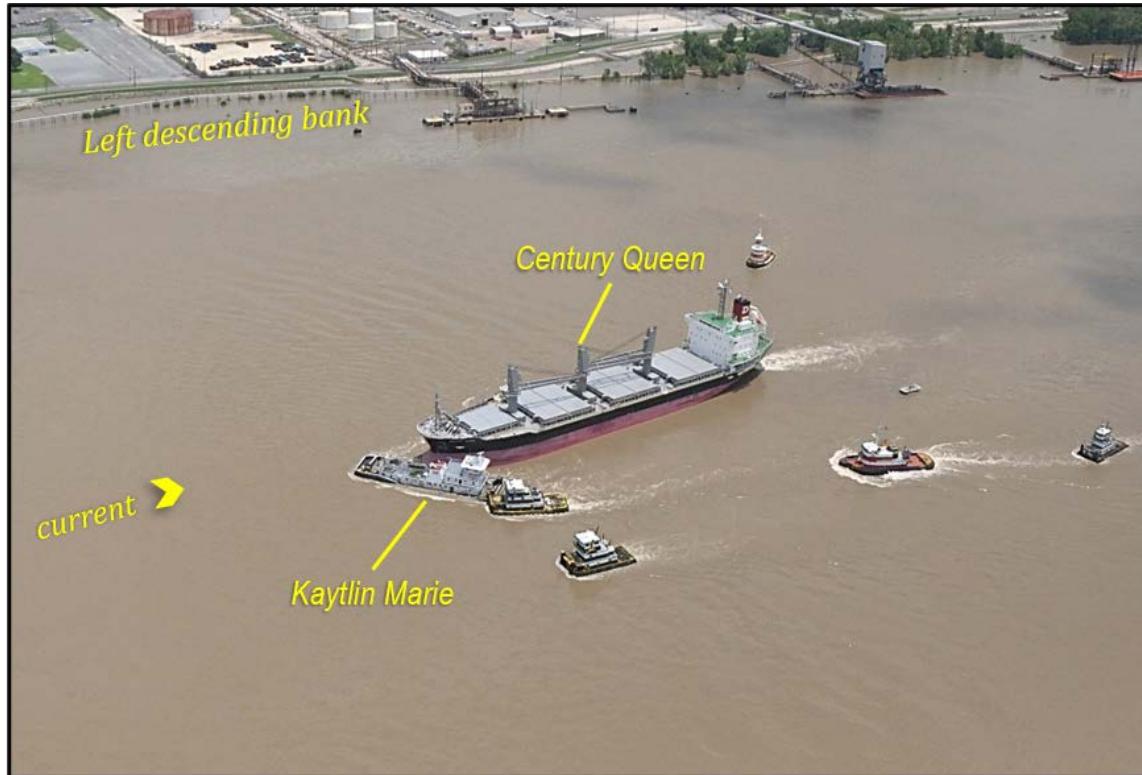
At 1215:08, the *Century Queen*'s bulbous bow struck the *Kaytlin Marie* amidships at about a 90° angle. The towboat's number 4 and 5 port fuel tanks outboard of the engine room were holed. Eventually, an estimated 8,954 gallons of marine diesel oil were released into the river. The cover to the port aft slop tank was dislodged; an unknown amount of waste oil was released as well. The engine room, whose windows were shattered, was at risk of flooding through an open starboard (up-current) door. A cleat on the port side that had caught on the damaged bow of the bulk carrier prevented the towboat from capsizing, as the *Kaytlin Marie* was pushed sideways up-current until both vessels came to a stop. The *Century Queen*'s bulbous bow was torn open for approximately 6 feet, and the void space was filled with river water and the released diesel fuel.

Both vessels shortly after the collision (Source: US Coast Guard)

At the time of the accident, the pilot on board the *Kaytlin Marie* was alone in the wheelhouse and became pinned by furniture that had come loose. Four refrigerators in the galley broke free from the port bulkhead, slid across the mess deck, and pinned two deckhands, one of whom suffered internal injuries. The other had a minor injury.

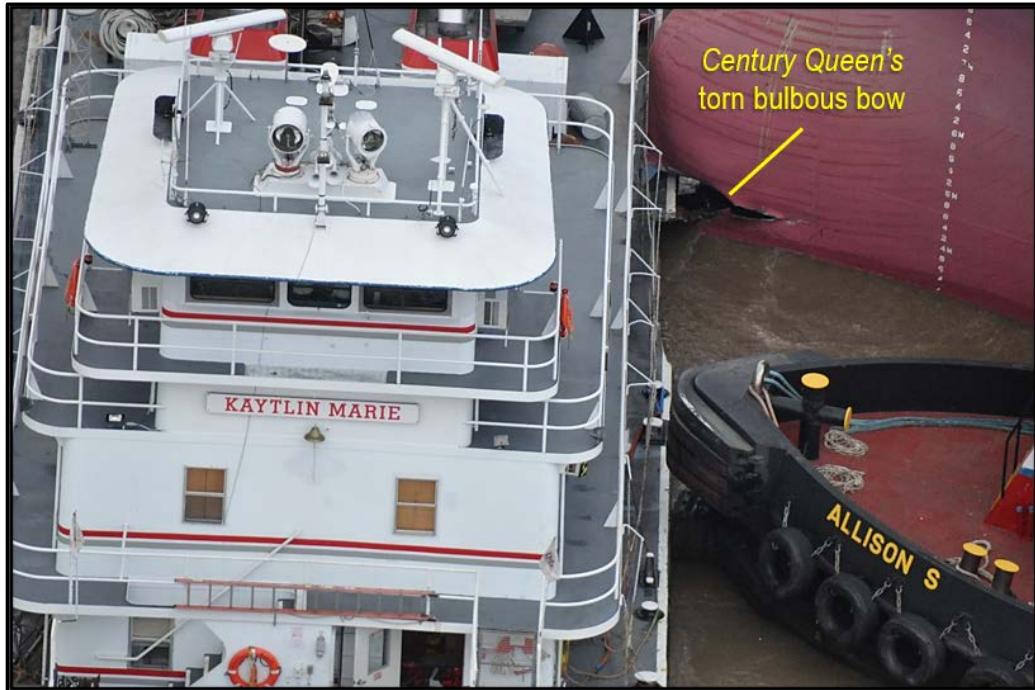
*Kaytlin Marie* embedded in the *Century Queen*'s bulbous bow. (Source: Coast Guard)

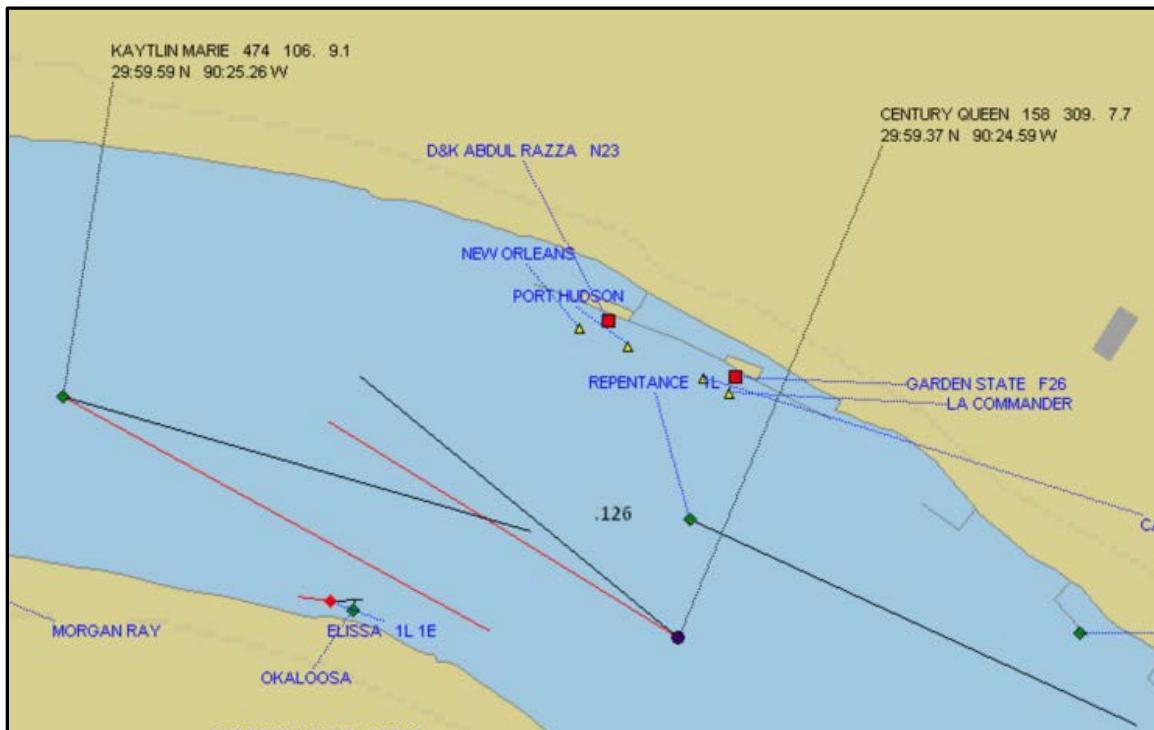
Screenshot of the VTS Ports and Waterways Safety System (PAWSS) tracking the *Century Queen* and *Kaytlin Marie* at 1213. Red vectors indicate the vessels' heading, and black vectors indicate their course over ground.

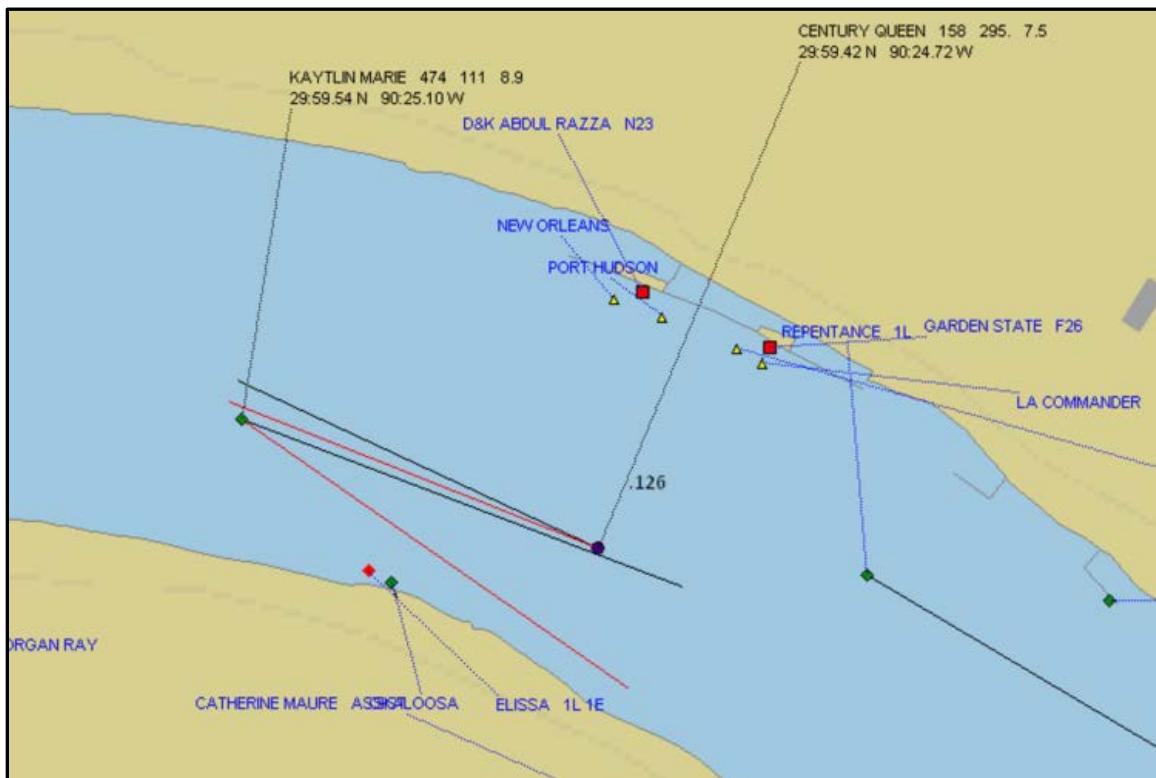
Screenshot of VTS' PAWSS at 1214. The *Century Queen* had altered course 14° towards port in the previous minute.
