National Transportation Safety Board

Marine Accident Brief

Flooding and Sinking of Towing Vessel *Mangilao* Towed by *Chamorro*

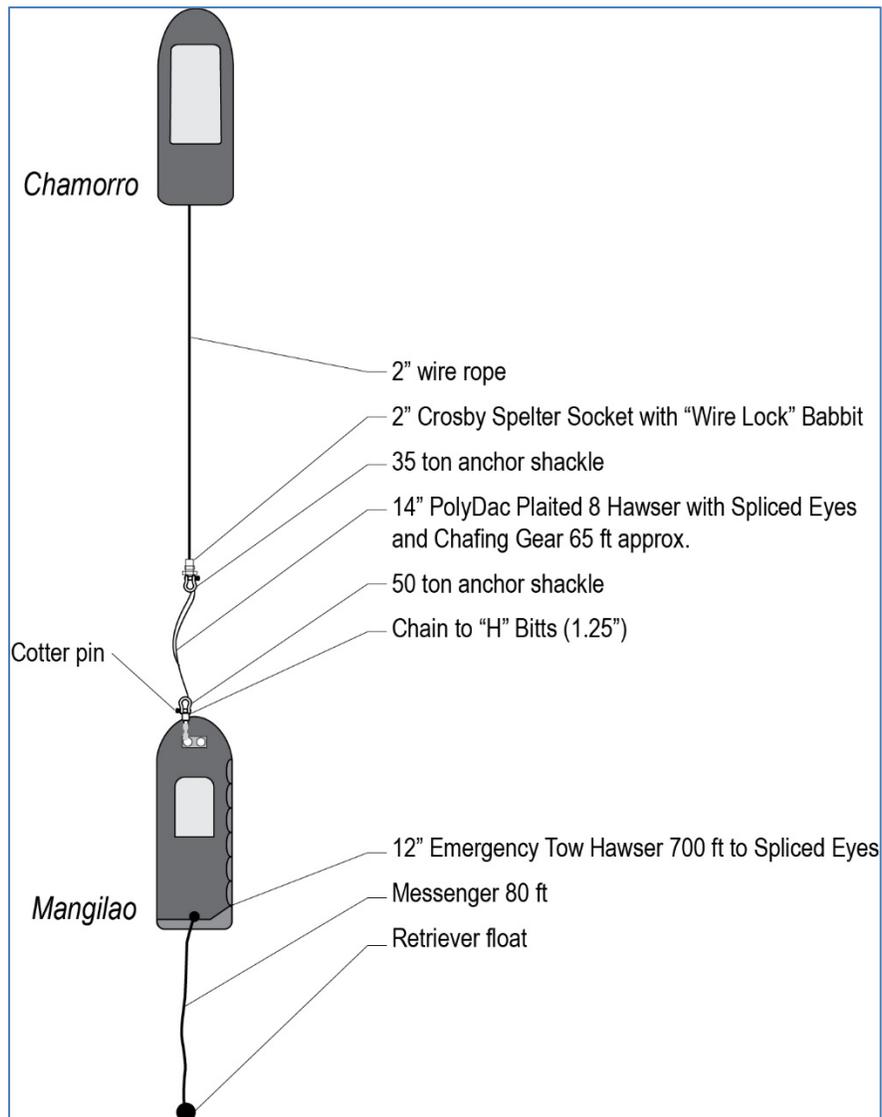
The *Mangilao* was towed astern of the *Chamorro* on a 2-inch wire rope with approximately 1,000 feet extended; a 14-inch-diameter-by-60-foot PolyDac plaited 8-strand hawser; a 1.25-inch chain terminal; and two anchor-type shackles connecting each part—one 35-ton shackle closest to the *Chamorro* and one 50-ton shackle to the 1.25-inch chain closest to the *Mangilao*. The 50-ton shackle had a bolt-type shackle pin fitted through smooth bore ears, and, as described by the tow captain, “we put a pin of the correct size in. We bent it over a significant amount so it couldn’t fall out.” The captain indicated the shackle had one-quarter-inch nylon rope around it for “cushion,”

as there was no thimble (on the 14-inch hawser) connected to the shackle bow. He recalled that the chain went through the *Mangilao*'s foredeck closed-bitt chock and was about 6 feet long, placing the shackle above the *Mangilao*'s bow fender. He stated that under tow, the shackle had a horizontal orientation and was about 8–12 inches above the fender. While under tow, the *Mangilao* displayed port, starboard, and stern running lights. The original navigation lights had been replaced with solar electric-eye LED lights, which turned on when dark.

Representation of tow plan based on interview with *Chamorro* captain.

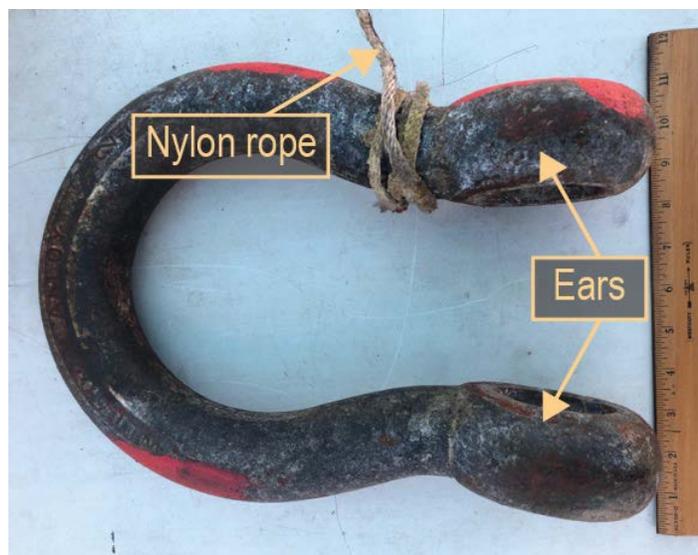
The captain told investigators that when they retrieved the towing gear, it all came on board except for the shackle pin that was secured to the 50-ton shackle closest to the *Mangilao*. He stated that “apparently, the chain was not of sufficient length to clear the fendering and it [the shackle pin] worked, it worked itself loose. Because we had it cotteder [fastened using the pin] and we had it safety shackled.” Although he could not physically see the shackle pin working loose, he “imagined” that the “vertical movement of this fender placed it in contact with the pin.” He recalled wondering if the chain was long enough on the first day they got into larger seas (when the pitching motion of the *Mangilao* increased).

Recovered 50-ton shackle with nylon rope, bent ear, and missing pin. (Source: Coast Guard, annotated by NTSB)

It is likely that the chain from the bitt on the foredeck of the *Mangilao* was not long enough for the attached shackle to clear the fendering on the bow. In heavy seas, as the vessel pitched and the bow of the vessel lifted up over the waves, the shackle likely made repeated contact with the fendering. Around 0400 on August 5, the towline's 50-ton shackle (closer to the *Mangilao*) opened, causing the towline to drop from the *Mangilao*. Crew statements and the recovered shackle indicated that at some point, the shackle's securing cotter pin broke or worked loose, thereby likely allowing the shackle bolt's securing nut to work loose. The bend in the recovered shackle indicated the load was uneven for a time, which could have occurred when the pin was partially retained in only one ear, bending the ear with the pin remaining inserted. Once the pin worked out, or snapped off, the *Chamorro* became immediately disconnected from the *Mangilao*. Had the chain been longer and the shackle extended out beyond the bow fender, the chain, rather than the shackle, would have contacted the bow. This likely would have prevented the shackle pin securing mechanism (cotter pin) from failing, and the tow would have remained connected.
