National Transportation Safety Board

Marine Accident Brief

Contact of the Barge *YD 71* with the James T. Wilson Fishing Pier

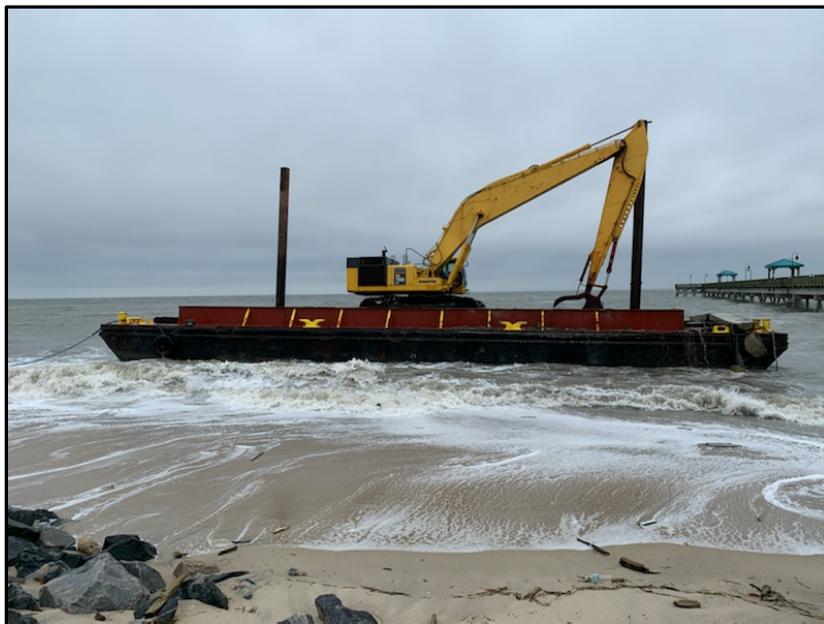
The *YD71* aground after breaking free from its mooring and prior to striking the pier. (Source: U.S. Coast Guard)

Sometime before sunrise on Sunday, November 17, the *YD 71* slipped its mooring and drifted south and downwind. It contacted and damaged an entertainment pier 1,200 feet north of the fishing pier. It then grounded on the rip rap erosion dike at Buckroe Beach, then on the sandy beach just north of the fishing pier sometime before 0541 when the fire department was alerted. Responders and public works staff were not equipped to stop the *YD 71*'s movement down the beach, and the barge contacted the fishing pier about 0904.

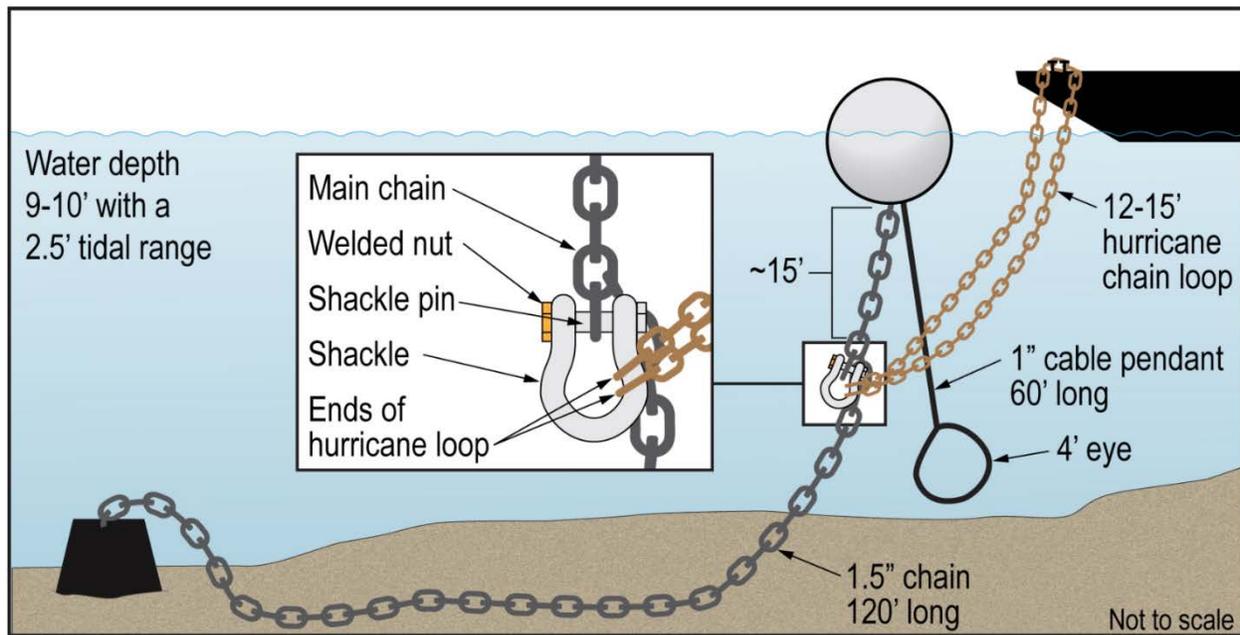
The hurricane loop was shackled to the bottom chain 15 feet below the mooring ball. The shackle's crown was passed through each bitter end of the hurricane loop. The shackle pin was passed through a link at the bottom chain with the center stud removed and held in place with a nut. The nut was welded to the shackle pin, all the way around to keep it from backing out.

A representation of the arrangement of the YD 71's mooring at the time of the accident.

The captain of the *Capt Dale* stated the 1.5-inch cable was sufficient for 52-knot winds, and that he only elected to use the hurricane loop due to a kink in the cable pendant wire, not because of weather warnings. Following the accident, the hurricane loop was found still secured to the barge's bitt, but the shackle (and its pin) that connected both ends of the hurricane loop to the bottom chain were not attached.

The mooring's chain and hurricane loop were found intact. Neither the shackle nor its pin connecting the hurricane loop to the chain were found. Therefore, the barge could only slip its mooring if the shackle failed, or if the pin backed out after the weld attaching the nut to the pin failed. It's more likely the weld failed than material failure of the shackle bow or pin. This likely would have occurred over a period of time, with the strain of the four-foot storm wave action, near gale winds, and/or high tide breaking it free.

The National Transportation Safety Board determines that the probable cause of the contact between the barge *YD 71* and the James T. Wilson Fishing Pier was a shackle pin in the mooring arrangement working itself free in heavy weather, leading to the barge's uncontrolled drift.

Moorings for vessels can be single-point failures that can lead to losses for both vessels and nearby infrastructure. Operators should identify failure modes of mooring arrangements and implement controls, including more frequent inspections if necessary, to avoid accidents.

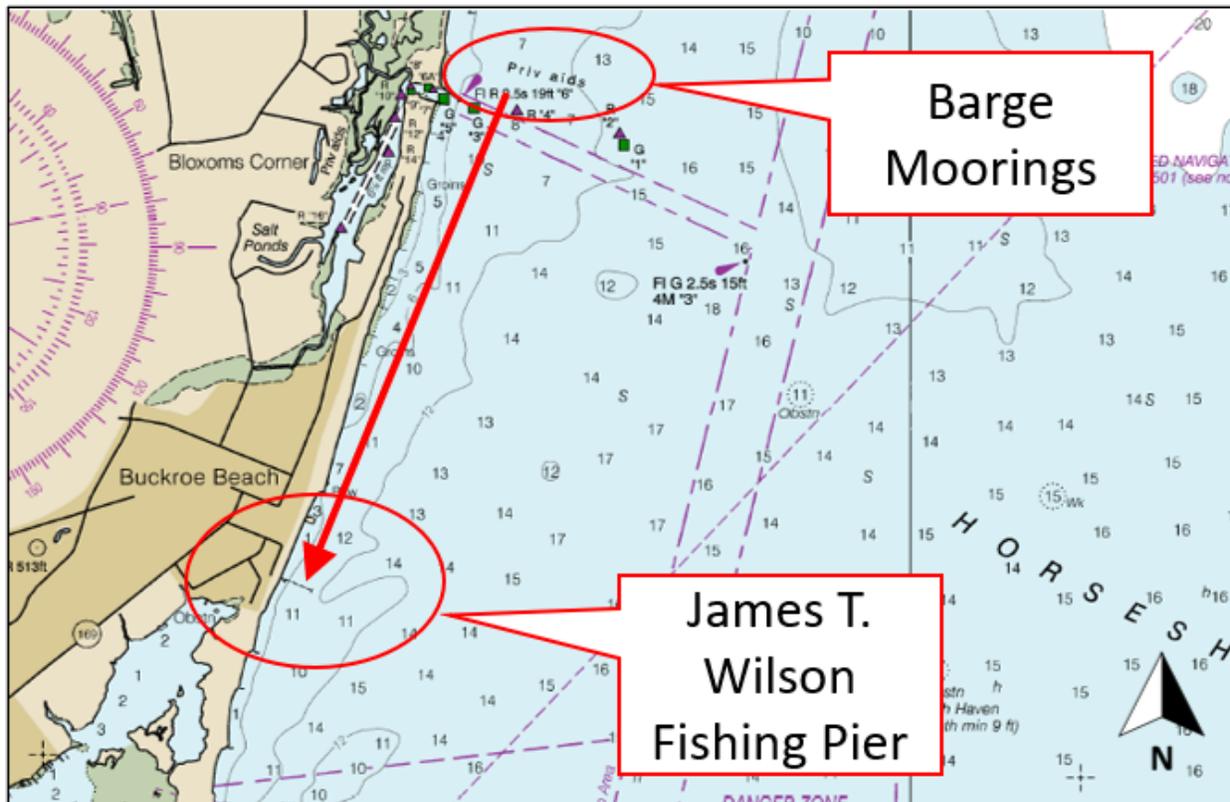
Extract of Chart 12222, with red arrow showing the assumed path barge YD71 took from its mooring to the James T. Wilson Fishing Pier. (Background source: NOAA annotated by NTSB)

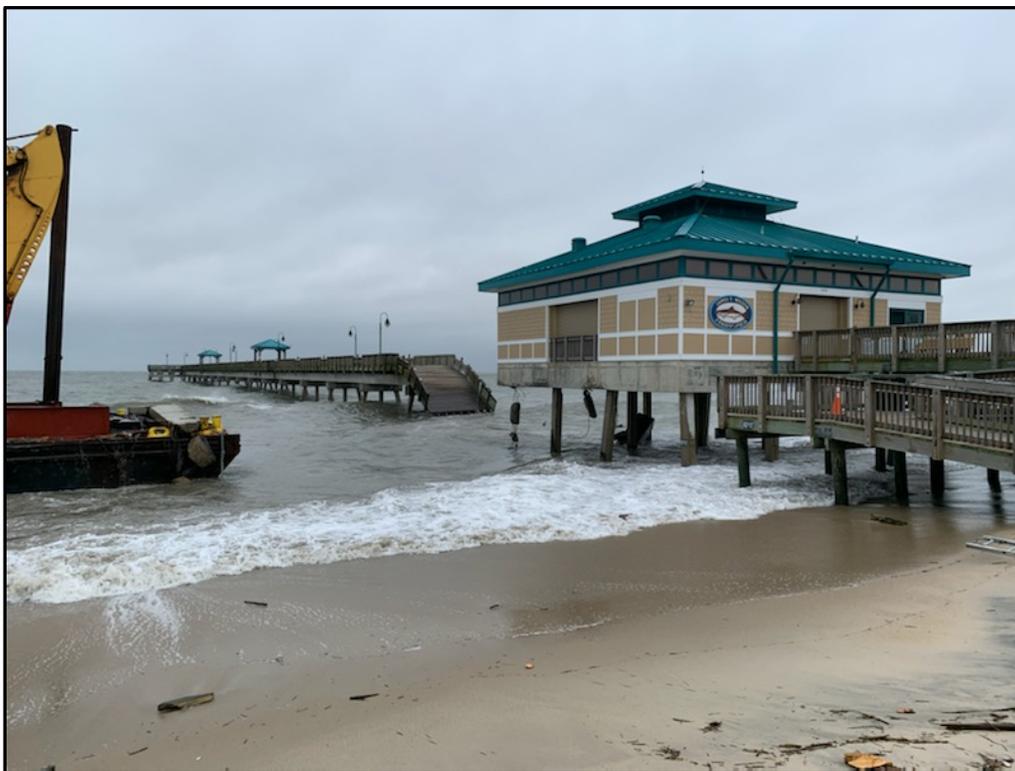
The damaged fishing pier with debris on the deck of the YD 71. (Source: Coast Guard)

Two pilings supporting the first and second 40-foot spans of the fishing pier nearest the beach were destroyed, and the spans collapsed into the water. Three pilings supporting the east edge of the pier house were also damaged. The pier was closed for repairs for almost a year, reopening on October 17, 2020.
