National Transportation Safety Board

Marine Accident Brief

Contact of Tugboat *G.M. McAllister* with NGL Energy Partners Berth

Accident type	Contact	No. DCA19FM053
Vessel name	<i>G.M. McAllister</i>	
Location	St. Juliens Creek Turning Basin, Elizabeth River Southern Branch, Chesapeake, Virginia 36°46.69' N, 076°18.57' W	
Date	September 23, 2019	
Time	About 0657 eastern daylight time (coordinated universal time – 4 hours)	
Injuries	None	
Property damage	\$1.47 million est.	
Environmental damage	None	
Weather	Visibility 10 miles, clear, winds south-southwest at 4 knots; air temperature 63°F, water temperature 77°F, daylight/dawn conditions, begin civil twilight 0628, sunrise 0654. ¹	
Waterway information	The Southern Branch of the Elizabeth River has a controlling channel depth of 36.6 feet, and the channel width from the St. Juliens Creek Turning Basin to Money Point is 780 feet; there was a 0.3 knot ebb current at the time of the accident.

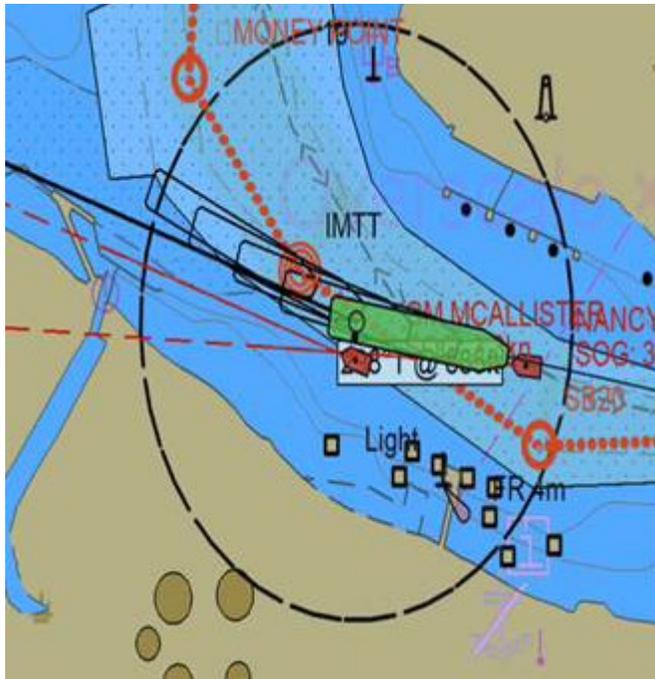
Screen capture from the state pilot's portable pilot unit, based on automated identification system (AIS) input, showing approximate positions of the tugs and *Ijssel Confidence* at 0653.

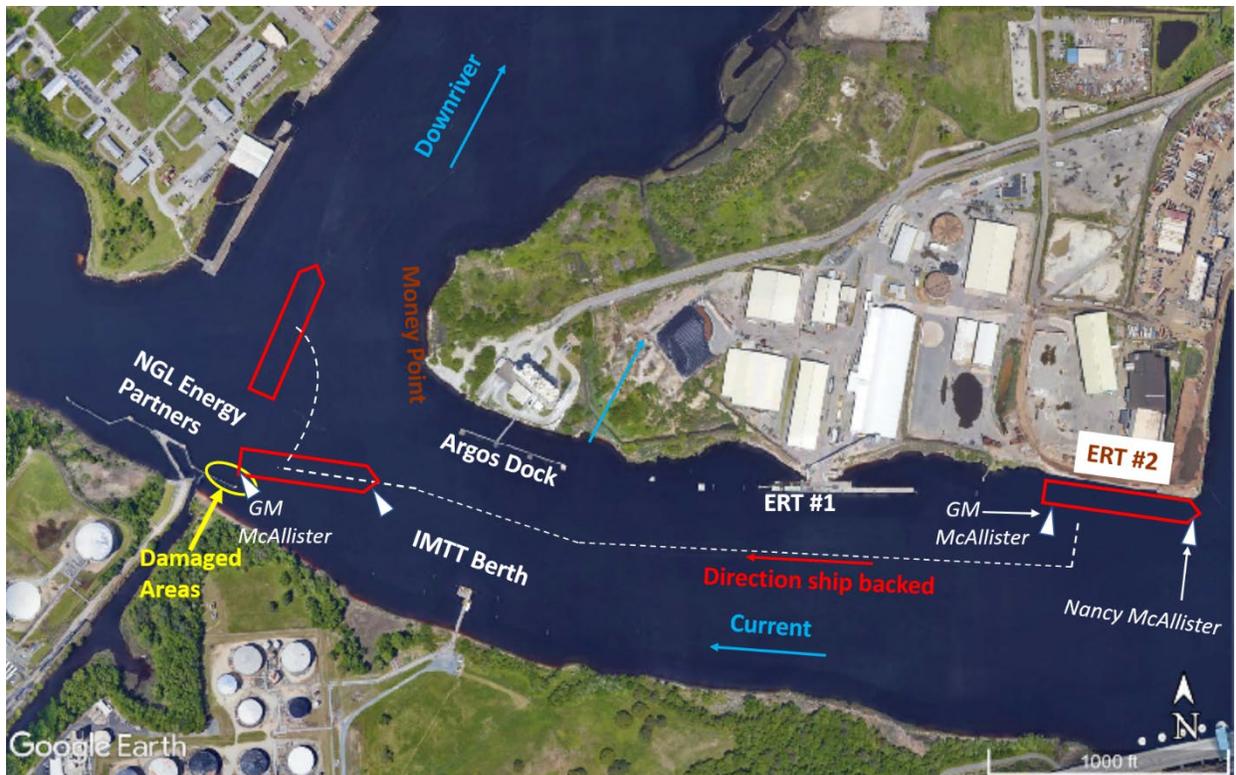
Detailed satellite image of the area where the *G.M. McAllister* contacted the NGL Energy Partners wharf. (Background source: Google Earth, annotated by NTSB)

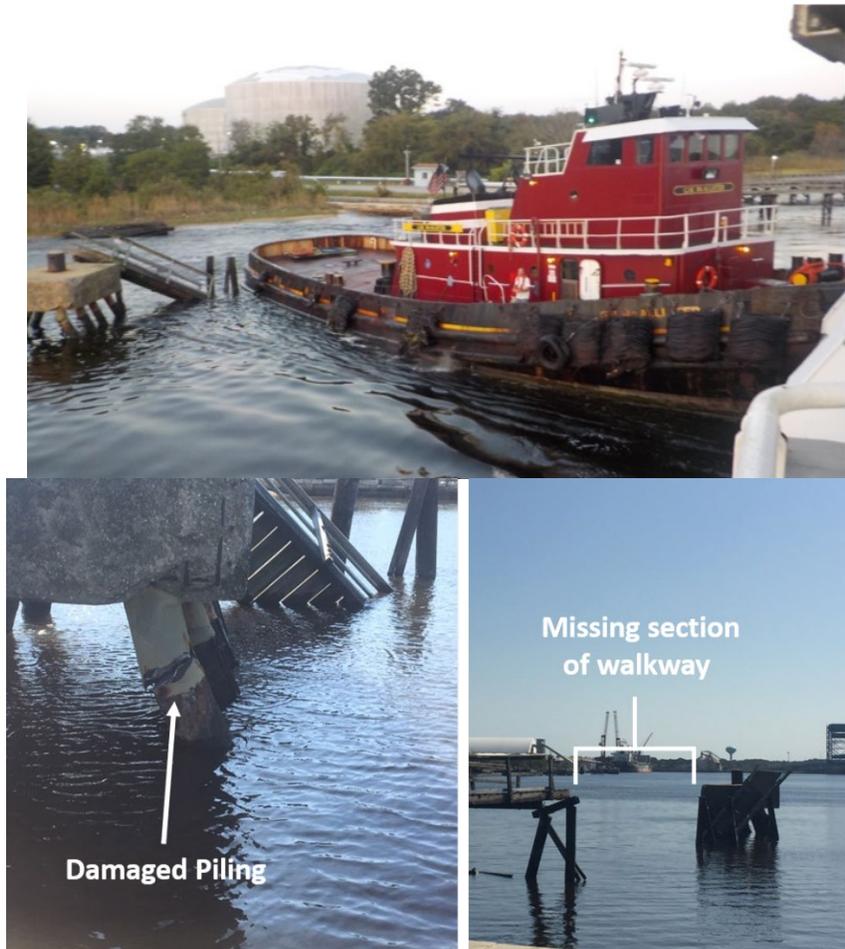
According to the *G.M. McAllister*'s captain, he was keeping the tug alongside and parallel to the ship by twisting the tug, but as the ship approached the berth structure, his tug's port quarter first hit the piling of the easternmost mooring dolphin and then, when the tug came ahead, struck the walkway between the easternmost mooring dolphin and the next dolphin to the west. Damage to the tug was negligible, but estimated damage to the NGLEP berth was \$1.47 million.

Top: *G.M. McAllister* at the NGL Energy Partners berth immediately after the accident (Source: Master, *Ijssel Confidence*). Bottom left and bottom right: Damaged NGL Energy Partners berth after the accident (Source of right photo: US Coast Guard).

Investigators also viewed video taken from a camera at NGLEP and noted the positioning of the *G.M. McAllister*, the thrust from the ship, and the 2 movements of the berth about 10 seconds apart. The first movement, which investigators believe was caused by the mooring dolphin strike, occurred just prior to the *G.M. McAllister* coming into the picture, as the tugboat was alongside the hull of the ship. This is consistent with the *G.M. McAllister* captain's statement that he was twisting the tugboat alongside the *Ijssel Confidence* just prior to striking the mooring dolphin. After the apparent strike, increasing slack in the *G.M. McAllister*'s headline indicated that the tugboat did move forward. The *G.M. McAllister* struck the walkway after the ship had placed the tugboat in such a position that the tugboat was caught between the dock and the side of the ship.
