# National Transportation Safety Board

## Marine Accident Brief

### Contact of Tanker *American Liberty* with Multiple Vessels

<b>Accident type</b>	Contact	<b>No.</b> DCA19FM034
<b>Vessel name</b>	<i>American Liberty, Don D, African Griffon, Ever Grace, and multiple hopper barges</i>	
<b>Location</b>	Lower Mississippi River, mile 139.5 near Reserve, Louisiana 30°03.19' N, 090°34.98' W	
<b>Date</b>	May 16, 2019	
<b>Time</b>	2042 central daylight time (coordinated universal time – 5 hours)	
<b>Injuries</b>	1 serious and 3 minor	
<b>Property damage</b>	\$40.5 million	
<b>Environmental damage</b>	None	
<b>Weather</b>	Visibility 10 miles, clear skies, calm conditions; air temperature 75°F, water temperature 69°F, moonrise 1743 (96% of visible disk illuminated), sunset 1949	
<b>Waterway information</b>	The river was at major flood stage at Baton Rouge (mile 230); the channel was about 84 feet deep and 1,848 feet wide in the vicinity of the accident.

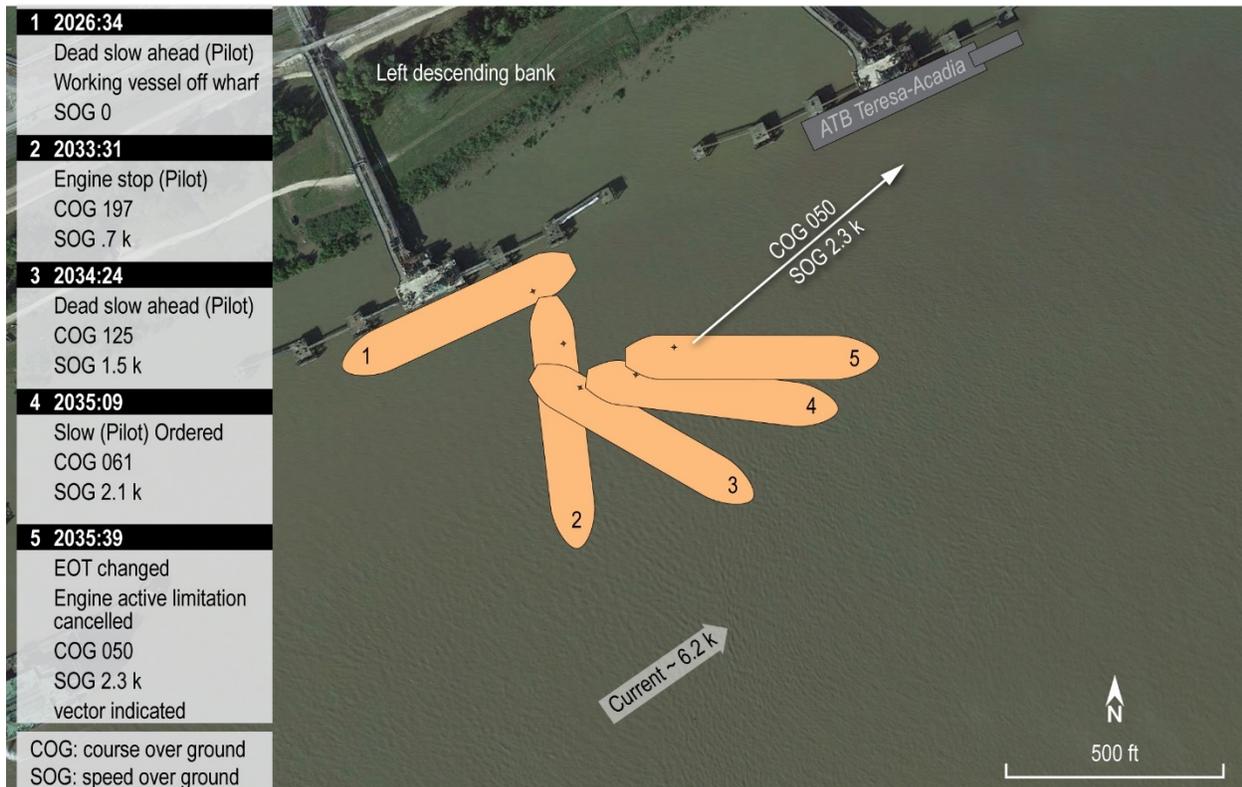
The *American Liberty*'s positions as it came off the dock and its vector at 2035:39, based on the vessel's ECDIS data and AIS data.

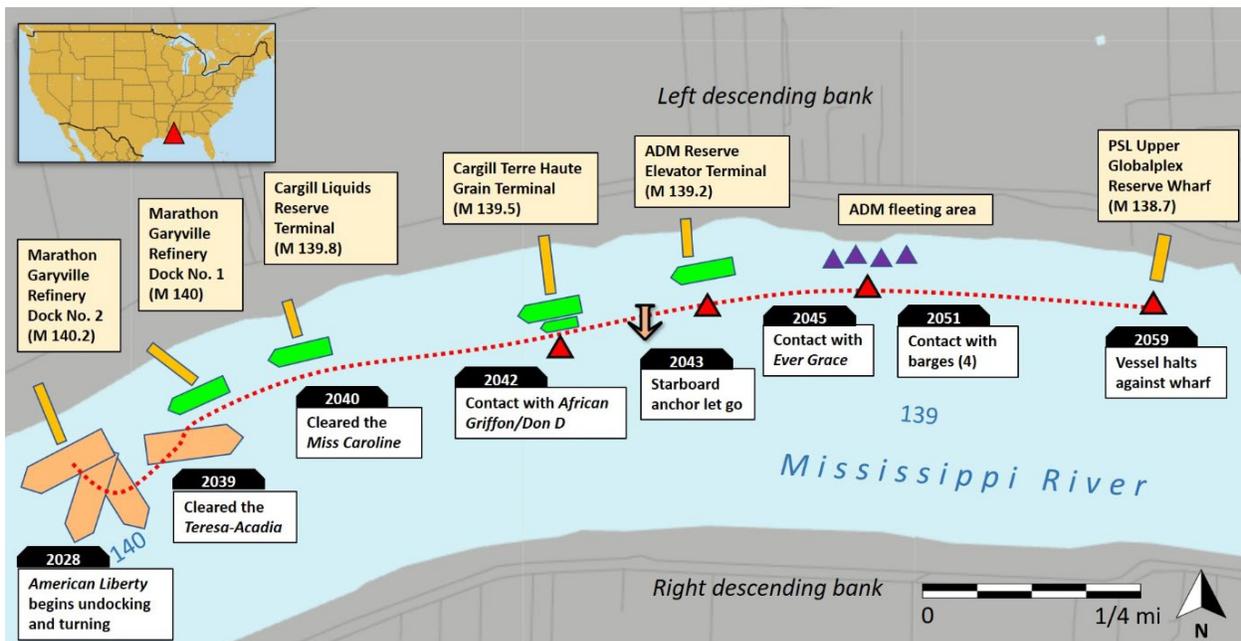
From where the *American Liberty* was moored, there were five wharfs on the left descending bank downriver. All vessels were moored starboard-side-to, bow pointed upriver. Shown is the vessel’s AIS track (red dots) getting underway, turning counterclockwise, moving bow first downriver, and contacting vessels and wharfs along the left descending bank, as indicated by the red triangles. Not to scale. (Background Source: Google Maps)

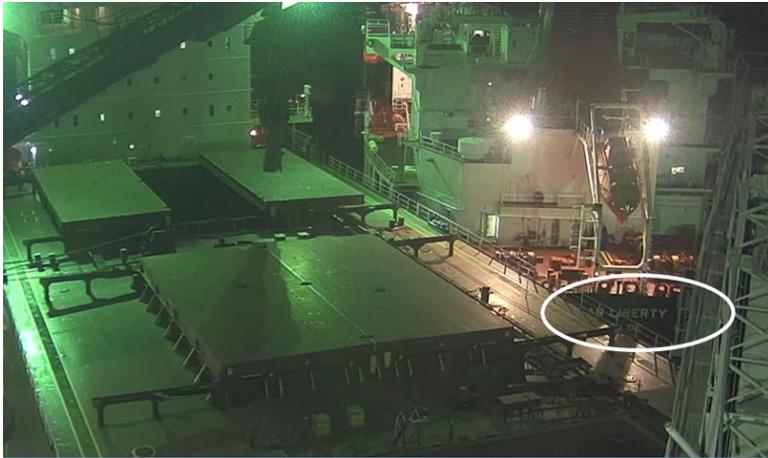
The *American Liberty* (name on the stern is circled), as it drifted down the port side of the *Ever Grace* at ADM Reserve Elevator Terminal. (Source: ADM)

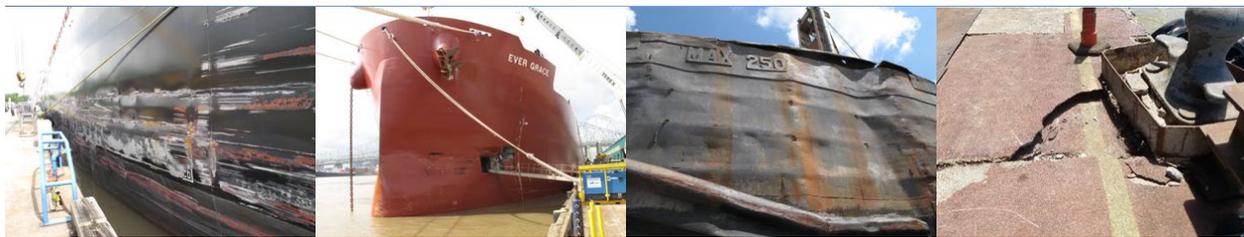
**Damage.** The *American Liberty* suffered \$1,704,934 in damages to the hull plating down the port side, from cargo tank #2 to the steering gear room; the hull was holed in three places, but the cargo tanks in the double hull were not penetrated. The *African Griffon* had \$5,000 in damages including an inset 15 feet long by 5 feet wide and a fractured frame to the port side of the hull adjacent to cargo hold #1. The *Don D* suffered \$504,519 in damages, which included multiple holes in the hull at the starboard stern and the port bow. The *Ever Grace* suffered \$97,188 in damages, which included two hull punctures and up to 2-foot-deep plate indents over an area 32 feet long and 12 feet wide on the port bow. Initial damage to the ADM Elevator Reserve Terminal was to two mooring platforms and catwalks, 100 feet of the concrete wharf, fenders, and a security camera/tower. Damages were revised to \$32,150,000 to demolish and rebuild the facility including the wharf, moorings systems, loading tower and foundation, ship loader, conveyor system, crane tower, and vacuum tower. Eleven ADM hopper barges suffered estimated damages of \$221,000. The PSL Upper Globalplex Reserve Wharf suffered \$5,881,210 in damages including a destroyed mooring dolphin and catwalk, damaged bridge, pipeline, conduit, wharf structure, and a navigation light. Combined accident damages to the ships, barges, and wharfs were \$40,563,851.

Postaccident damage from left: *American Liberty*, *Ever Grace*, *Don D*, and ADM Reserve Elevator Terminal. (Source: AECOM)
