National Transportation Safety Board

Marine Accident Brief

Flooding of Towing Vessel *Alton St. Amant*

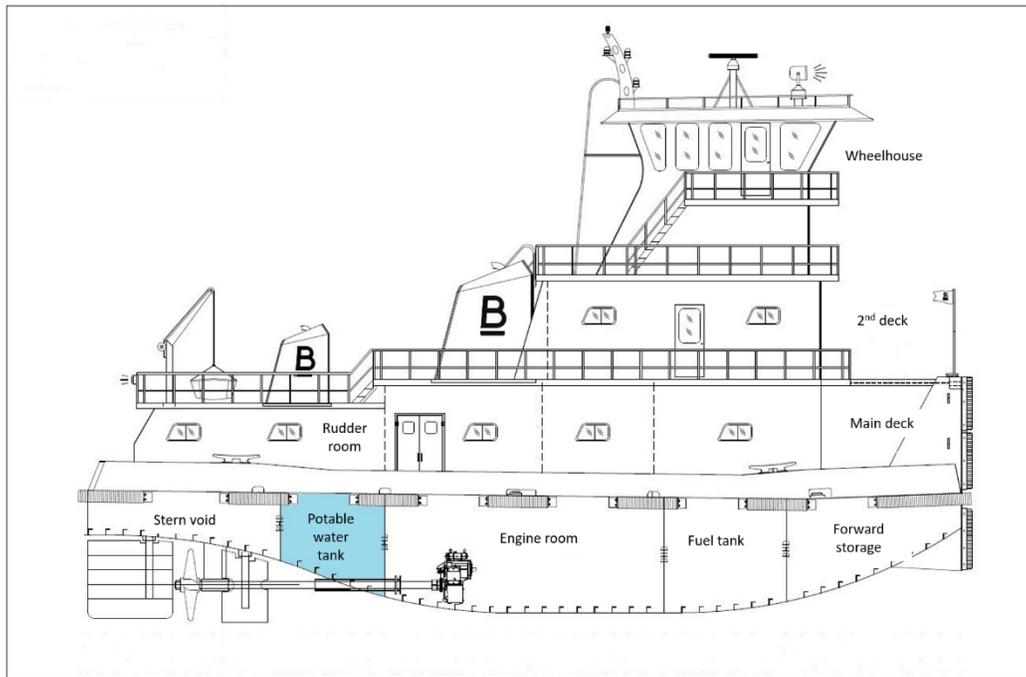
Simple profile of the *Alton St. Amant* (not to scale), with the potable water tank highlighted. (Source: Blessey Marine Services; annotated by NTSB)

On Friday, May 15, about 24,000 gallons of fuel were loaded onto the vessel. The flush hatches to the vessel's two potable water tanks located on the main deck in the rudder room had been opened for maintenance, but the covers were not reinstalled at the end of the day. That same day, the port engineer requested that the shipyard workers fill the two potable water tanks. A pipefitter, who had worked for Bollinger Quick Repair about 8 years, returned to the shipyard the following morning, on Saturday, May 16, and began reinstalling the bilge pumps with three other shipyard workers about 0500. About 1000, after completing the pump installation, he started filling the potable water tanks from a shoreside water manifold that was connected to the vessel's potable water fill pipe via a 2-inch hose through the open exterior engine room doors. He opened the supply (fill) valve at the shoreside manifold, and began filling the two tanks, which had a combined capacity of 13,233 gallons. Unaware that the potable water tank access hatches were open in the rudder room, he left the shipyard about 1030 with plans to return the next day. He intended to fill the tanks and then allow them to overflow onto the exterior main deck through their vents to flush out any residual debris inside before turning off the water supply.

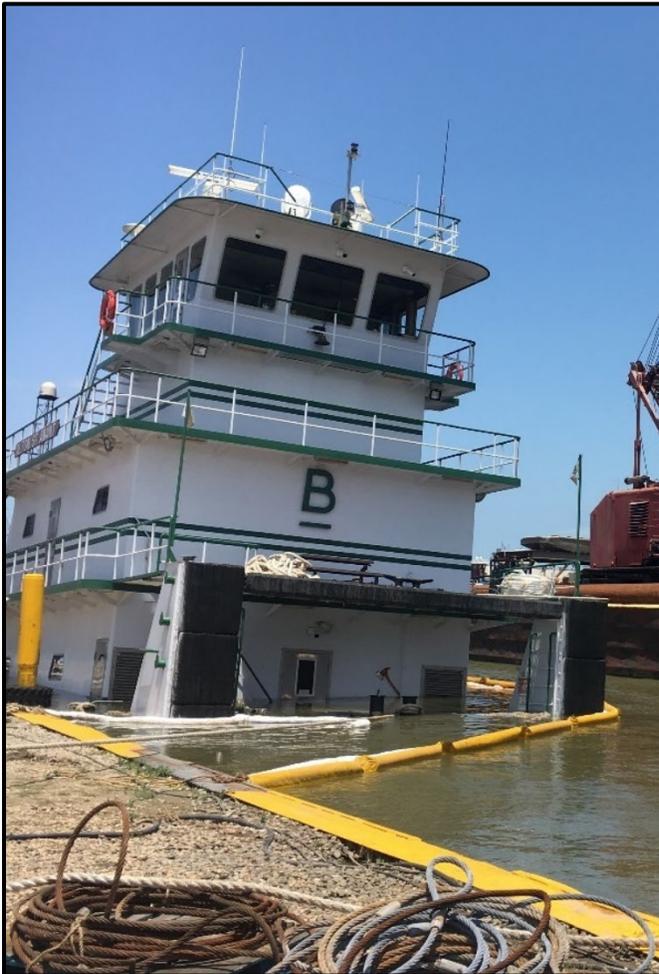
Alton St. Amant, partially submerged, on the morning of May 18. (Source: Coast Guard)

Upon arrival, the general manager found the *Alton St. Amant* partially submerged and resting on the bottom of the canal alongside the pier. The engine room was flooded, and the main deck was partially submerged. The US Coast Guard, Blessey personnel, and a local salvage company were notified. While observing the *Alton St. Amant*, the general manager noticed the potable water hose connected to the vessel was charged; he then closed the potable water supply valve on the pier manifold.

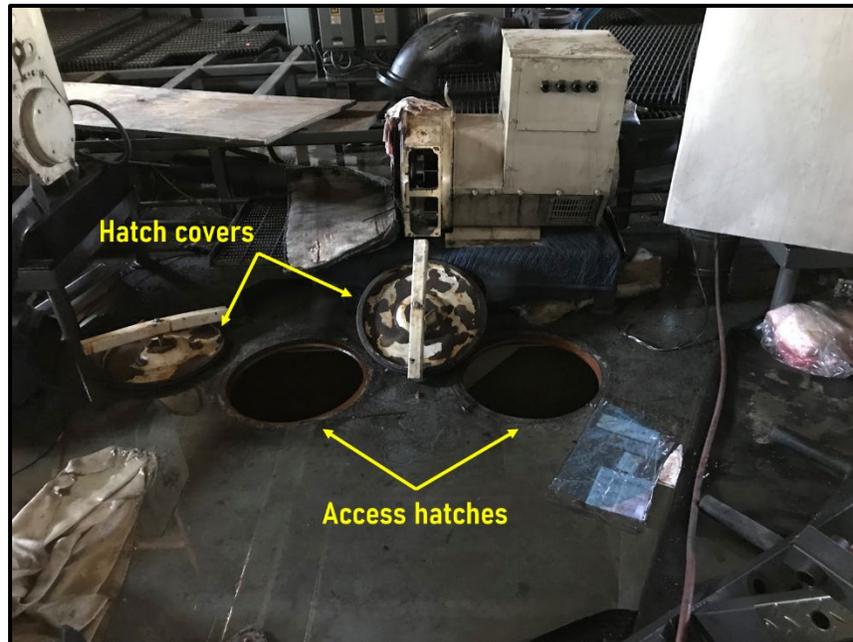
St. Amant. They also discovered that the access hatches for the potable water tanks in the rudder room were open.

Open access hatches and their covers for the two potable water tanks in the rudder room. (Source: Coast Guard)

After shipyard managers reported to the shipyard on the morning of the sinking, the potable water supply valve at the manifold ashore was found in the open position. Later that day, during the post-salvage inspection of the *Alton St. Amant*, the access hatches to the potable water tanks in the rudder room were found to be open and the 2-inch hose supplying water to the vessel was still connected to the vessel's fill pipe for these tanks. Fresh water had been filling the potable water tanks for over 20 hours.

The pipefitter was not aware of the open access hatches when he began filling the tanks. After he departed the vessel, no other persons came aboard to monitor the status of the tank levels, and there was no shipyard policy for monitoring the filling process. Having been filled for several hours, the potable water tanks reached capacity, resulting in an overflow through the open hatches in the rudder room (rather than the tank vents as planned). After the rudder room flooded, the water spilled over the open doorsill onto the main deck of the engine room and began flooding down into that space. With the bilge system inoperable due to planned maintenance during the shipyard period and no one aboard the vessel to monitor the water transfer, the potable water continued to fill the aft spaces undetected and submerged the vessel until it came to rest on the bottom of the canal.

The National Transportation Safety Board determines that the probable cause of the flooding of the towing vessel *Alton St. Amant* was the absence of shipyard pre-inspection and monitoring procedures for water transfer, which resulted in potable water tanks overflowing through their open access hatches during an unmonitored transfer.

After the sinking of the *Alton St. Amant*, Bollinger Quick Repair conducted an internal investigation and implemented procedures for conducting water transfers. These procedures were intended to ensure communication reached the shipyard's management and staff; project managers obtained approval from the facility superintendent; and a pre-inspection of tanks, valves, piping, and other components of the vessel's water system be conducted. Additionally, water transfers were to be monitored for the duration of the filling process.

Crew and shipyard personnel designated to conduct liquid transfers must be aware of the status of a vessel's tanks, including their access hatches and associated piping systems, whether ashore or at sea. When filling a tank, open access hatches create a risk of unintended flooding. Pre-inspection and monitoring of transfers provide the opportunity to identify and remedy any issues in order to ensure they are safely completed.
