National Transportation Safety Board

Marine Accident Brief

Collision between Offshore Supply Vessel *Cheremie Bo Truc No 22* and Articulated Tug and Barge *Mariya Moran/Texas*

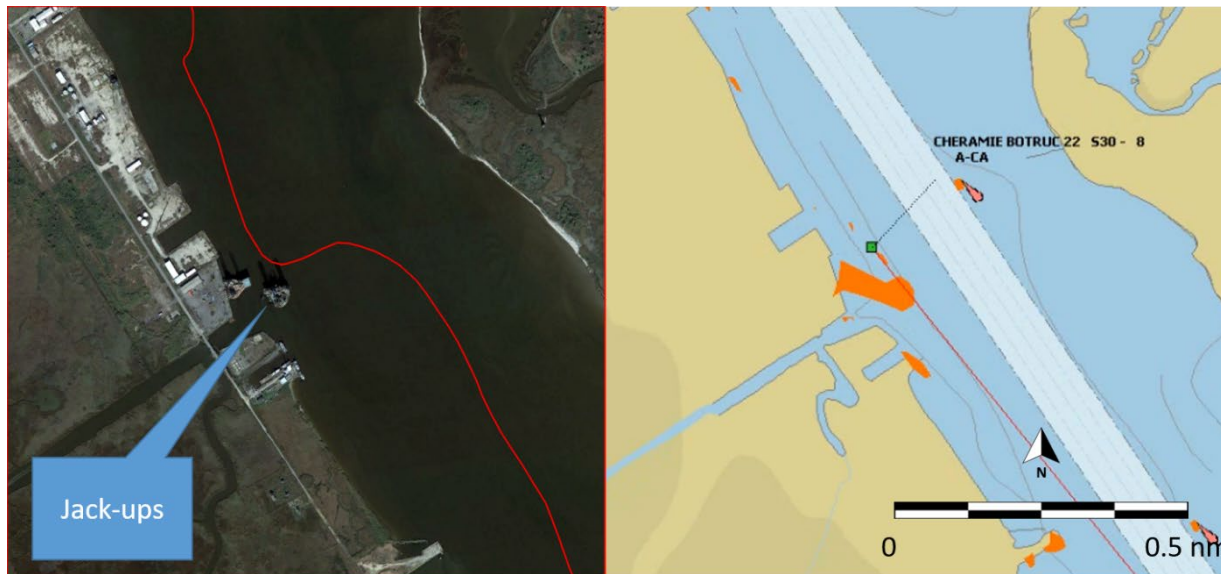
engineer. In describing the resulting erratic wake, the AB said, “I’m looking back there and it looks like a snake.” The AB stated that twice he and the engineer had to remind the mate to steer back into the channel. The mate ceased using the autopilot, returning to manual steering, as the vessel approached two stationary jack-up mobile offshore drilling units (MODUs) positioned near the Rowan Dock on the west bank.³

Sabine Pass in the vicinity of Rowan Dock, as seen by satellite (left) and VTS display (right). *Cheramie Bo Truc No 22*'s track is shown in red (left) passing close to two jack-ups. The jack-ups' radar return is shown in orange (right) and *Cheramie Bo Truc No 22*'s relative motion vector in red. (Sources: Google Earth [left]; Coast Guard [right])

this warning, the mate attempted to use the autopilot after getting under way on the accident voyage. As a result, he struggled to maintain a safe course during the first 12 minutes of the passage, nearly striking a stationary jack-up before returning to manual steering.

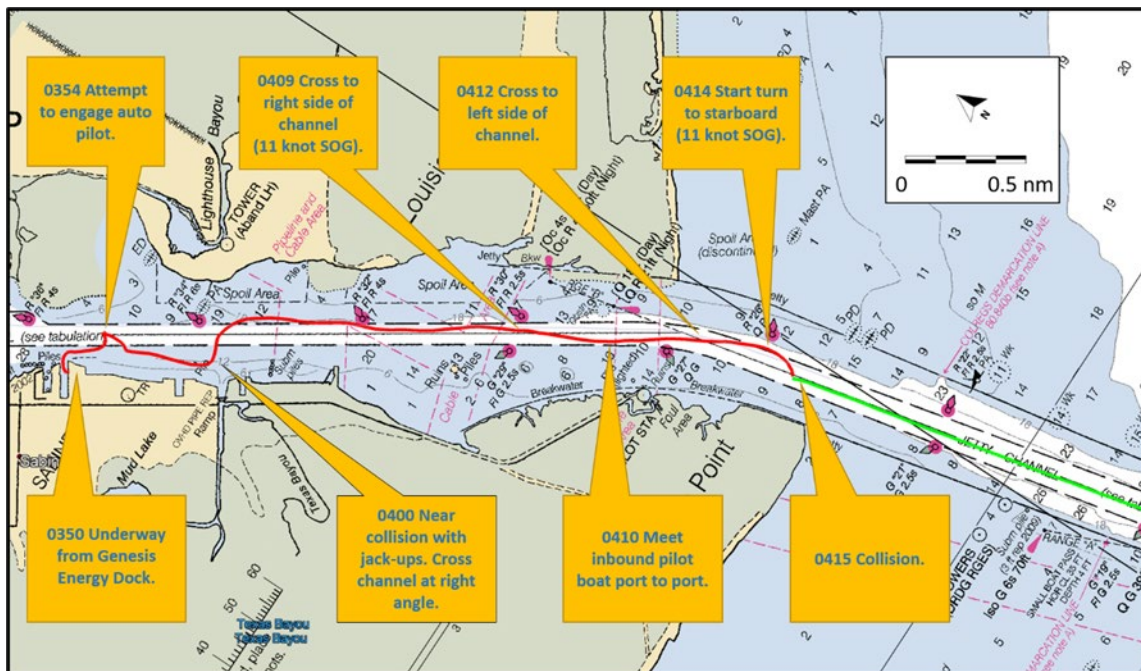
Sabine Pass chart showing path of *Cheramie Bo Truc No 22* (red) and *Mariya Moran/Texas* (green). (Source: National Oceanic and Atmospheric Administration Chart 11342, annotated by NTSB)

Following the return to manual steering, the *Cheramie Bo Truc No 22* crossed the channel three times and wound up on the east side prior to meeting the *Mariya Moran/Texas* ATB. Although both vessels were aware of each other, no VHF radio passing arrangement or maneuvering signals were made.

VTS and AIS data and statements by the *Cheramie Bo Truc No 22* AB and *Mariya Moran/Texas* pilot show that there was room to pass safely starboard to starboard had *Cheramie Bo Truc No 22* continued parallel to and along the east edge of the channel after passing buoy 27. The *Mariya Moran/Texas* pilot assumed a starboard-to-starboard passing based on the position of the *Cheramie Bo Truc No 22*. Inland Navigation Rules require either a port-to-port passage or communication either by radio or whistle signal for an agreed-upon alternate passage between two vessels. A radio call from the ATB prior to the pilot relieving the mate to confirm the offshore supply vessel's intentions may have kept the *Cheramie Bo Truc No 22* mate from steering across the ATB's bow. After the turn to starboard across the bow of the ATB, the collision was unavoidable.

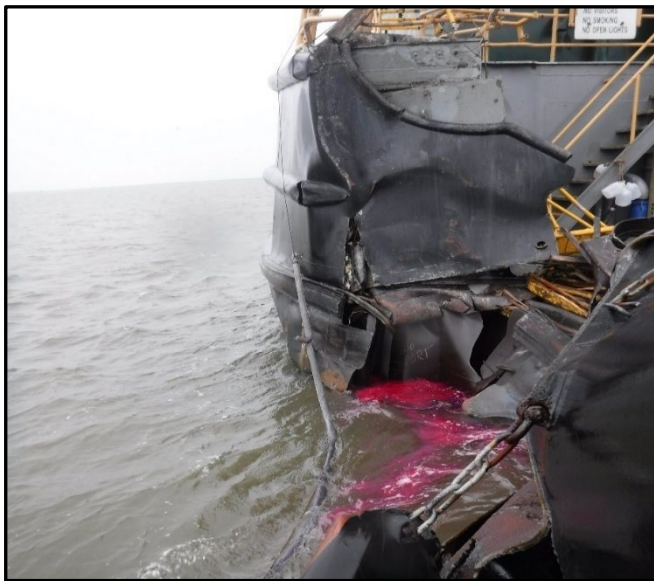
The port side of the *Cheramie Bo Truc No 22*, post-collision, showing the compromised no. 1 port fuel tank and oil spillage. (Source: Coast Guard)

The *Cheramie Bo Truc No 22*’s no. 1 port fuel tank was severely damaged. The no. 2 port fuel tank suffered less damage but was also compromised. An estimated 6,641 gallons of diesel

fuel were released into the environment. As a result of the damage, the *Cheremie Bo Truc No 22*, valued at \$1.2 million, was declared a total loss.

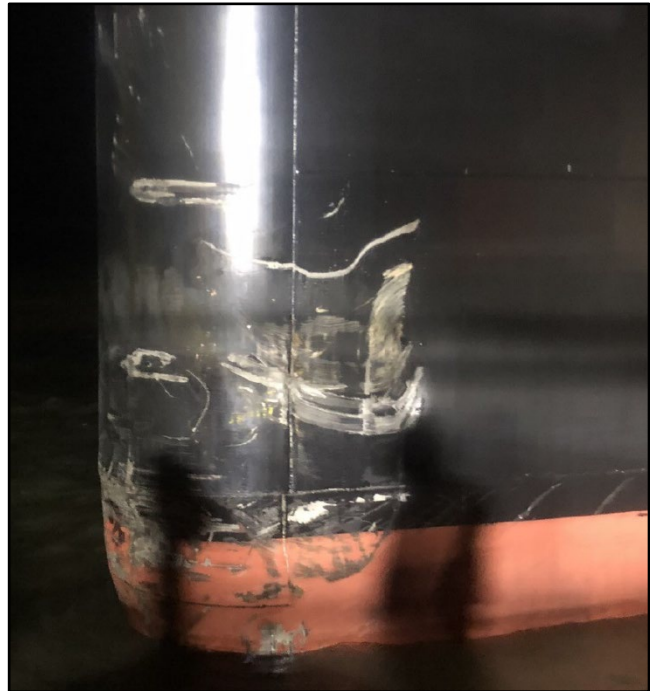
The *Texas* suffered hull damages amounting to \$594,846. The *Mariya Moran* required repairs to the rams that secured it to the *Texas* amounting to \$59,726. Neither vessel's hull was compromised.

Damaged stem of the barge *Texas*. (Source: Moran Towing Corp.)
