National Transportation Safety Board

Marine Accident Brief

Contact of Bulk Carrier *Atlantic Huron* with the Soo Locks West Center Pier

Accident type	Contact	No. DCA20FM023
Vessel name	<i>Atlantic Huron</i>	
Location	Soo Locks, Saint Marys River, Sault Sainte Marie, Michigan 46°30.16' N, 84°22.09' W	
Date	July 5, 2020	
Time	0250 eastern daylight time (coordinated universal time – 4 hours)	
Injuries	None	
Property damage	\$2.2 million est.	
Environmental damage	None	
Weather	Visibility 6 miles, scattered clouds, winds from southeast at 1.7 knots, calm water, air temperature 63°F, water temperature 67°F ¹	
Waterway information	The 77-mile St. Marys River flows in a general southeast direction and connects Lake Superior to Lake Huron. The Soo Locks, located in Sault Sainte Marie, Michigan, allow vessels to navigate a 21-foot elevation difference in the river. The water depth at the locks is about 28 feet.

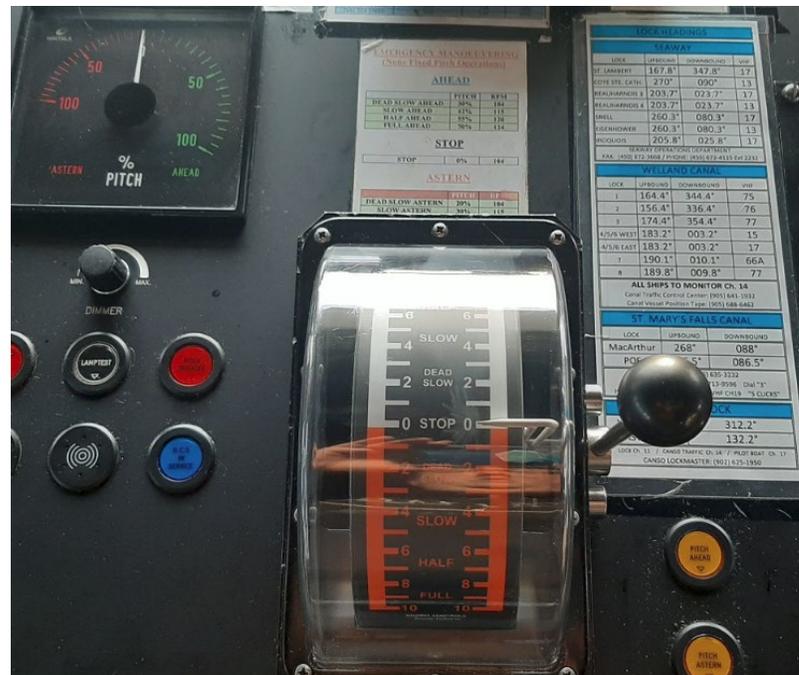
At 0245, the captain slowed the *Atlantic Huron* and allowed the vessel to “coast” toward the South Canal and the west center pier, where he intended to land the vessel and slide it up the pier wall toward the locks. As the vessel’s speed reduced to 3.8 knots about 0.5 miles from the end of the west center pier, the captain ordered full astern to slow the vessel further. At this point, the captain noticed that the CPP pitch indicator was “erratic,” fluctuating from full ahead, to full astern, to zero, and then back to full astern. He also received a pitch differential, or wrong-way, alarm, indicating that the requested propeller pitch from the helm station did not match the propeller’s actual pitch. Using the shipboard telephone, he called the engine control room (ECR) to report the inconsistent pitch indicator.

Bridge controls on the *Atlantic Huron*, including pitch indicator and throttle (rudder control not pictured). (Source: CSL)

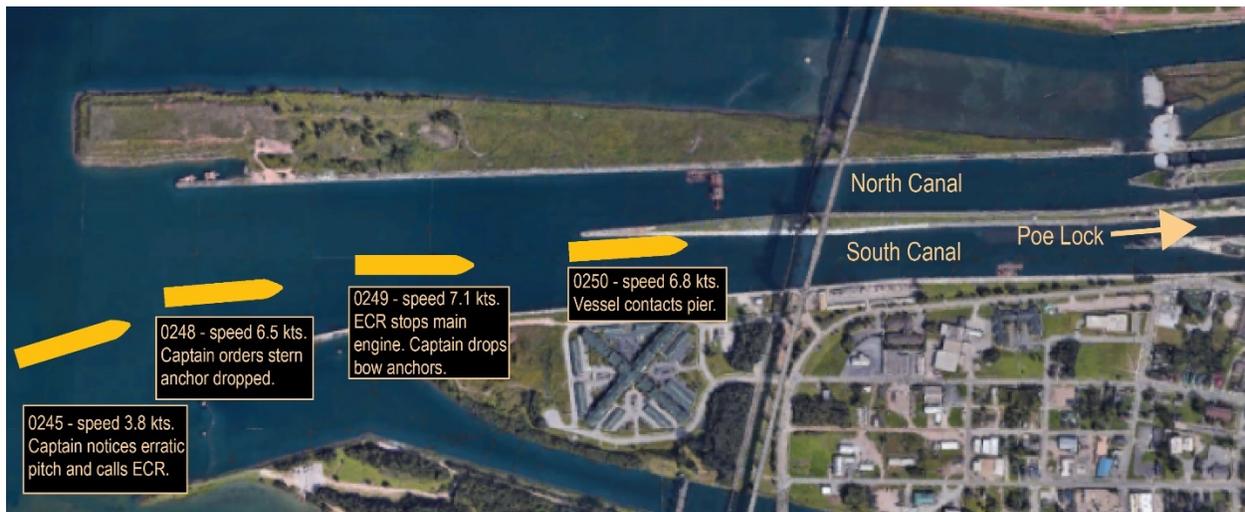
Five-minute accident sequence showing the *Atlantic Huron's* approach to the west center pier. (Background source: Google Earth)

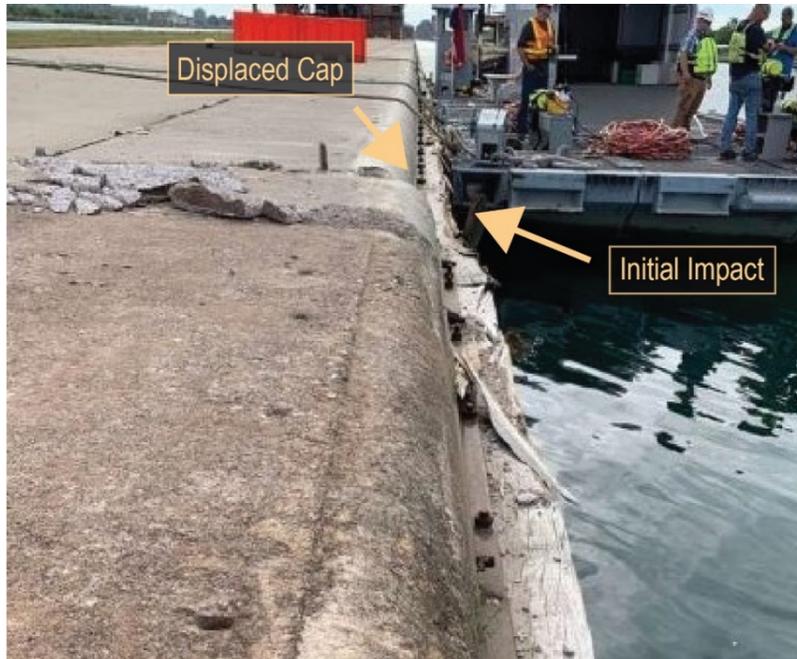
Damage and Repair. On July 14, an inspection and damage assessment were completed on the west center pier. Damage to both the underwater and above-ground sections were documented. At the point of initial impact, the timber fendering and crib wall concrete cap were pushed in 5.75 inches. The underwater section of the pier did not have visible signs of direct impact from the vessel, but there was evidence that the underwater section displaced laterally relative to the concrete cap above.

Postaccident photo of the west center pier. The location of initial impact is labeled and evident by a crushed timber fender. Displacement of a timber crib wall concrete cap is also labeled. (Source: Army Corps of Engineers)

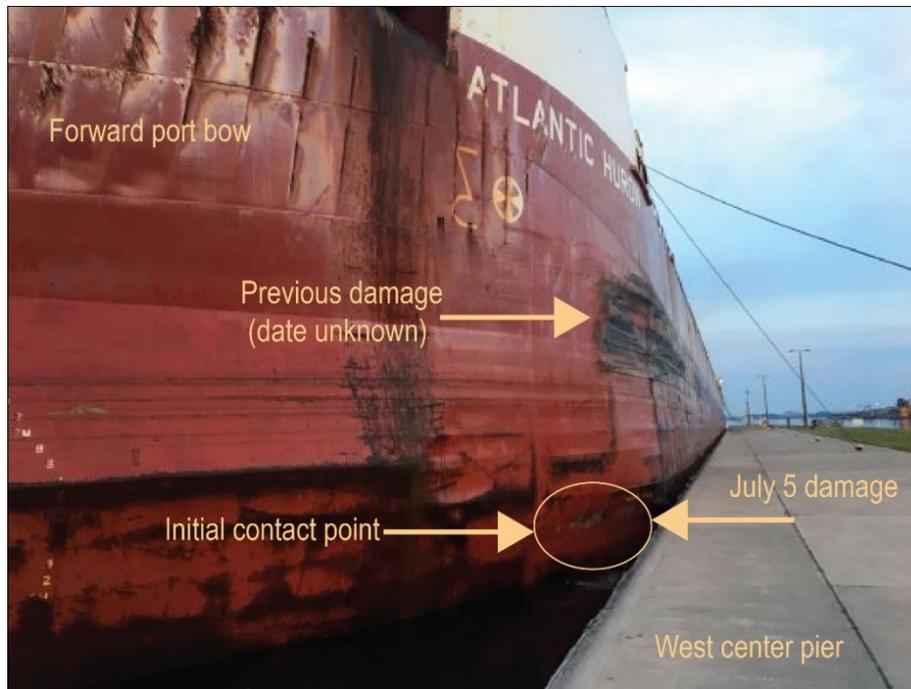
On the *Atlantic Huron*, contact with the dock caused damage to the portside shell plating, longitudinal web stiffeners, and web frames of the no. 1 port ballast tank. There was no hull breach or water egress. Repairs were made and approved by the classification society in early November 2020.

Postaccident photo of the *Atlantic Huron* alongside the west center pier. Point of contact and damage are indicated by arrows. (Source: US Coast Guard)

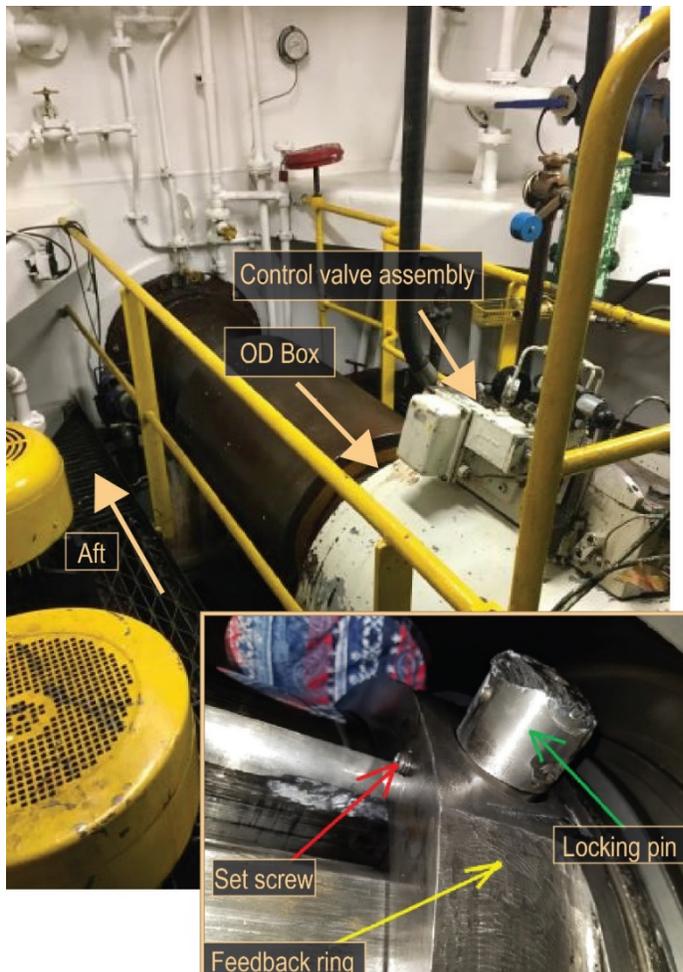
A technician from the OD box manufacturer attended the vessel and assessed the damages to the unit. Upon disassembly, “severe damage” to the unit’s valve block assembly was discovered, including the feedback arm (the OD box was not disassembled during earlier repairs on June 26). After removing the feedback arm, the technician discovered that the pin holding the feedback ring in place had backed out and contacted the arm, damaging both. Further investigation found that the set screw designed to hold the pin in place had also backed out.

The OD box manufacturer required that this set screw be installed using thread-locking fluid to prevent it from backing out. Thread-locking fluid is an adhesive applied to the threads of fasteners such as screws and bolts to prevent loosening, leakage, and corrosion. Inspection of the set screw by the technician revealed that it was “not damaged” and that there was “no evidence” of thread-locking fluid having been applied. Vessel maintenance records indicated that the last time the feedback ring pin set screw had been removed and reinstalled was in 2016 during maintenance to the vessel’s tail shaft. Investigators could not determine if thread-locking fluid had been applied to the set screw at that time.

Following the accident, CSL representatives confirmed that the manner in which the OD box and control valve assembly failed would have caused hydraulic fluid to be inadvertently directed, producing a full ahead pitch on the propeller blades when an astern pitch was ordered. Further, they found that the feedback mechanism bound and continued sending a full astern pitch indication to the bridge, ECR, and local indicator.

Postaccident photo of vessel's OD box and control valve assembly as viewed looking aft. Lower right: Postaccident photo showing damage to backed-out locking pin. (Sources: Coast Guard, CSL)

The set screw designed to secure the feedback ring locking pin was required by the original equipment manufacturer to have thread-locking fluid applied when installed; this requirement was clearly indicated on system schematics. Vessel maintenance records show that this set screw was last removed and reinstalled over 4 years before the accident, during a shipyard period. When the set screw was examined postaccident, technicians found no evidence that thread-locking fluid had been applied. As a result, the set screw and then subsequently the locking pin were both able to back out.
