# National Transportation Safety Board

## Marine Accident Brief

### Fire aboard Dive Support Vessel *Iron Maiden*

<b>Accident type</b>	Fire/Explosion	<b>No.</b> DCA20FM016
<b>Vessel name</b>	<i>Iron Maiden</i>	
<b>Location</b>	Gulf Intracoastal Waterway, mile 36, Larose, Louisiana 29°33.93' N, 90°23.29' W	
<b>Date</b>	April 16, 2020	
<b>Time</b>	0110 central daylight time (coordinated universal time – 5 hours)	
<b>Injuries</b>	None	
<b>Property damage</b>	\$900,000 est.	
<b>Environmental damage</b>	None	
<b>Weather</b>	Visibility 10 miles, clear skies, winds east-northeast at 12 mph, air temperature 63°F, water temperature 69°F <sup>1</sup>	
<b>Waterway information</b>	The Louisiana segment of the Gulf Intracoastal Waterway is 306 miles long, 12 feet deep, and 125 feet wide.

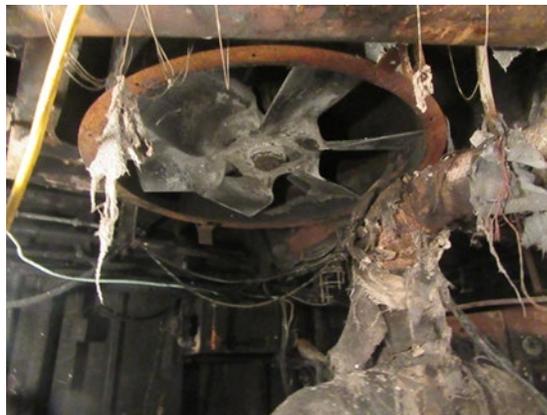
Following the movement of the *Iron Maiden*, Allied Shipyard workers entered the vessel at 0800 to conduct hot work with acetylene torches on the starboard exhaust trunk under the bridge deck and on the forecastle deck by the starboard-side mooring/securing bitt. Both work areas were located directly above the generator room on the main deck. The room had three diesel-engine-driven generators, which were secured. The number one generator was directly under the starboard exhaust fan (which was secured) and had a fire cloth over it for protection from

**Starboard exhaust trunk fan (post-fire) located above the number one generator. (Source: Coast Guard)**

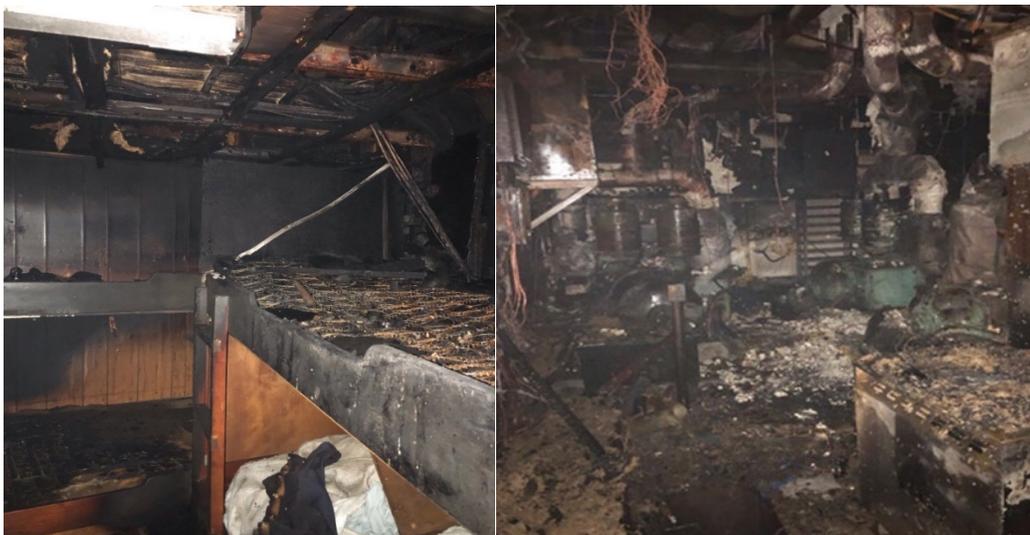
On April 16, fire investigators from the LaFourche Parish Fire District attended the *Iron Maiden* to investigate the cause of the fire. They noted extensive damage to the generator room, as well as significant damage to the passageway outside the generator room and living quarters (located above the generator room). In addition, they noted smoke damage to the mess area and the galley (located forward of the generator room) and the interior stern section of the pilothouse (located two decks above the generator room). They also noted sections of burned exterior paint around the starboard smoke trunk and pilothouse.

Fire damage to living quarters (left) and generator room (right). (Source: Coast Guard)

At some point, as the fire grew, the wood paneling and furniture in the space above the generator room ignited. After the wood and other combustible items caught fire, they provided a path for the fire to expand from the generator room up into the living quarters. With the vessel's fire detection system secured for the shipyard period and no continuous or periodic scheduled monitoring of the vessel by shipyard or owner personnel, the fire was able to spread undetected.

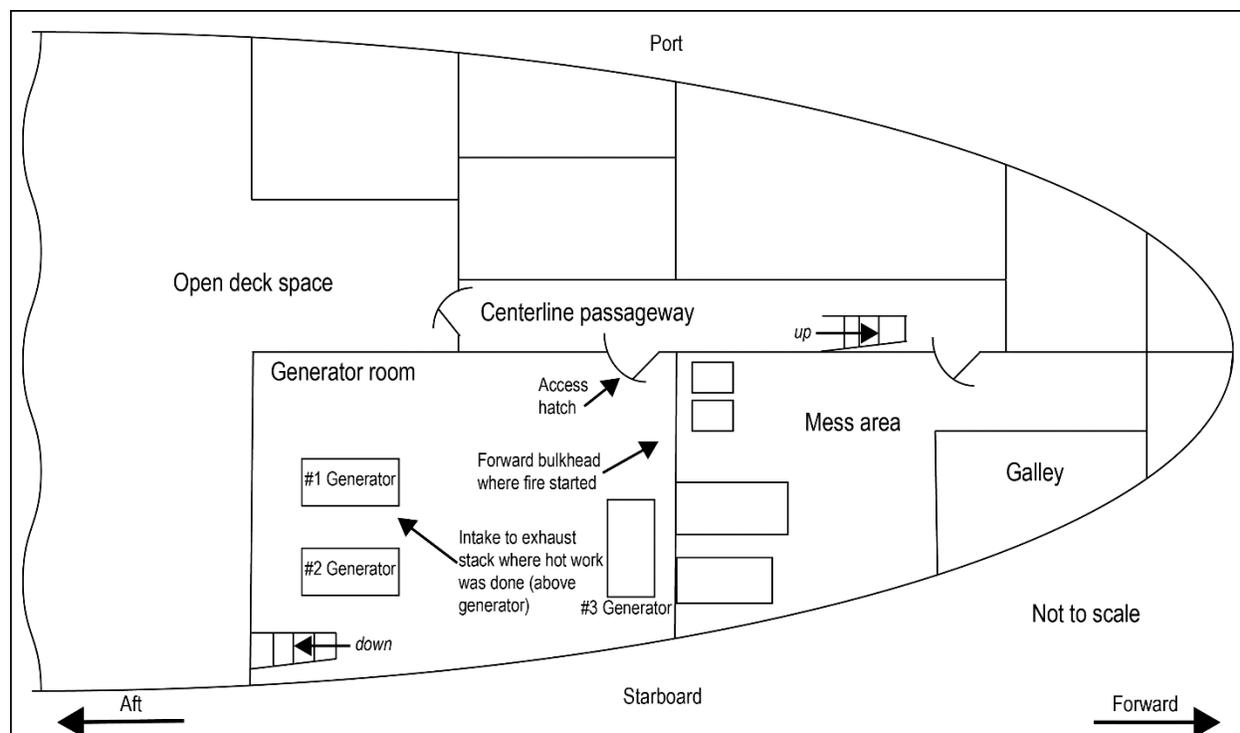
According to the fire investigator's report, "The fire started in the generator room on the wall area common to the mess area." They could not rule out the possibility of an electrical short as the potential source of the fire but were unable to determine the cause of the fire.

**General layout of the *Iron Maiden* generator room and surrounding main deck spaces with area fire started as identified by the LaFourche Parish Fire District.**

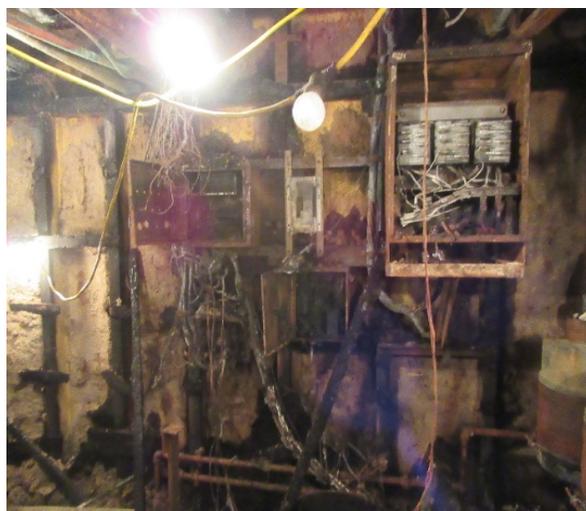
Within the generator room, the most severe damage was observed on the forward bulkhead near the access hatch from the passageway. The bulkhead area with the most extensive damage was where the battery charger, alarm panel, and generator push button start-stop panel were mounted.

**Forward bulkhead of the generator room where the source of the fire was identified by the LaFourche Parish Fire District (Source: Coast Guard)**

While there was extensive damage throughout the generator room, the fire pattern and damage indicated that the area of ignition where the fire started was the forward bulkhead. Because the battery charger, alarm panel, and generator push button start-stop panel were in the area of fire ignition identified by fire investigators, one of these components may have been the source of the fire as the result of an electrical short. However, the exact location of the source of the fire could not be identified by fire investigators.

The National Transportation Safety Board determines that the probable cause of the fire aboard the dive support vessel *Iron Maiden* was an electrical short from an unidentified source located on the forward bulkhead within the generator room. Contributing to the undetected propagation of the fire was the lack of continuous monitoring of the vessel while it was docked at the shipyard.

Fire and flooding are risks for both crewed and unattended vessels. To protect personnel, property, and the environment, it is good marine practice for owners, operators, and shipyard managers to coordinate and implement some form of continuous monitoring for vessels undergoing maintenance in a shipyard, in lay-up, or in some other inactive period without regular crews aboard. Continuous monitoring can consist of scheduled security rounds and/or active monitoring with sensing and alarm systems.
