National Transportation Safety Board

Marine Accident Brief

Flooding and Sinking of Fishing Vessel *Rebecca Mary*

Accident type	Flooding	No. DCA20FM021
Vessel name	<i>Rebecca Mary</i>	
Location	Atlantic Ocean, about 40 miles south of Martha's Vineyard, Massachusetts 40°47.0' N, 070°25.6' W	
Date	June 17, 2020	
Time	About 0530 eastern daylight time (coordinated universal time – 4 hours)	
Injuries	None	
Property damage	\$375,000 est.	
Environmental damage	Oil sheen visible, pollution potential of 3,000 gallons diesel fuel	
Weather	Clear skies, winds from east at 15 knots, seas 3–5 feet, air temperature 60°F, water temperature 57°F, sunrise 0509.	
Waterway information	Atlantic Ocean water depth west of Nantucket Shoals is about 160 feet.

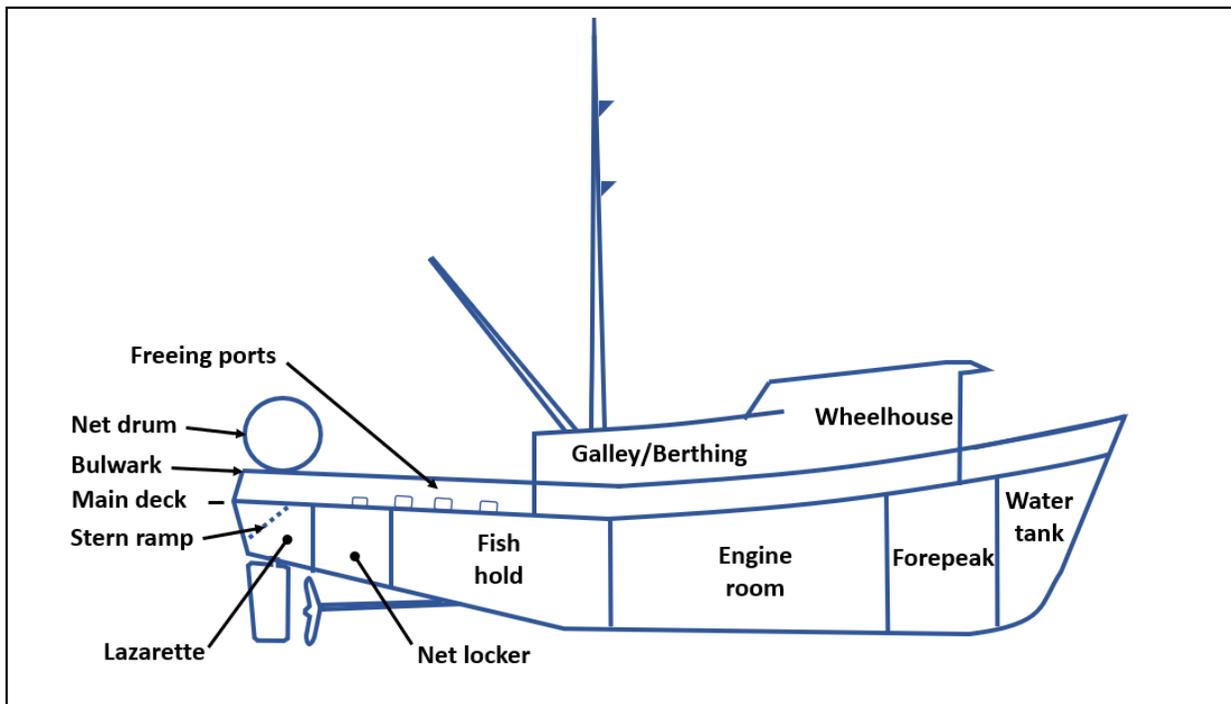
Simple representation of *Rebecca Mary* profile (not to scale).

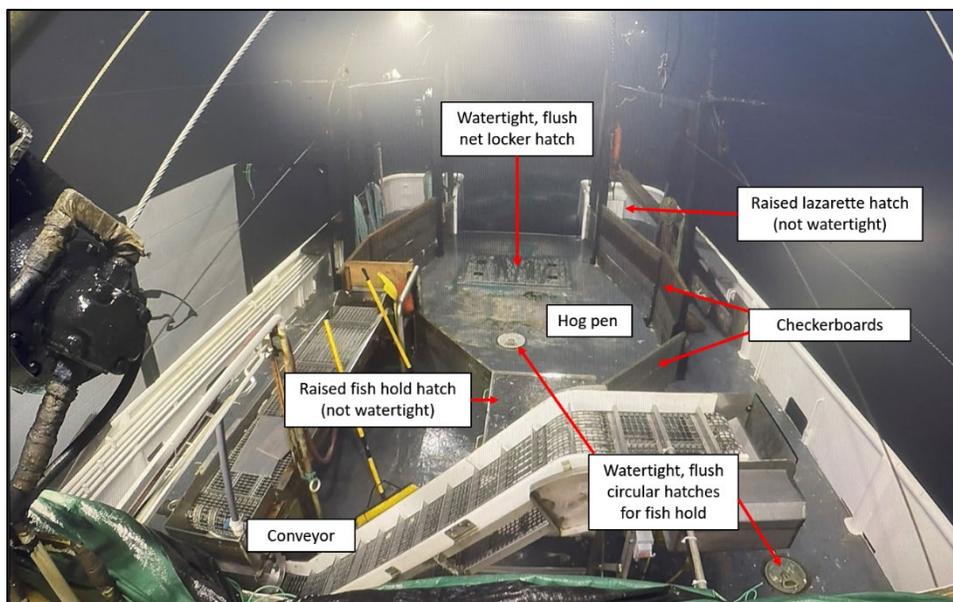
The net locker was used to store spare nets and other equipment and was equipped with a 12-dog, stainless-steel, flush watertight hatch cover. The lazarette, the vessel's aftermost compartment below the main deck, was located on either side of and below the stern ramp and contained the steering gear. The space was accessed through a raised portside hatch on the aft working deck, which measured 29 inches by 18 inches with a 26-inch steel coaming. The hatch was equipped with a non-watertight aluminum cover (lid) and no fastening devices.

Working deck of *Rebecca Mary*. (Source: Kevin Ralph, annotated by NTSB)

About 0400, crewmembers observed that the stern sank low enough that seawater began washing over and covering the non-watertight, raised lazarette hatch, which was equipped with a cover that could not be latched closed. The captain stated that he believed the cover for the lazarette was no longer sitting on top of the hatch after the water level rose above it. It is likely that the lazarette cover was displaced by the seawater, causing the lazarette to flood through the open hatch. As seawater entered the lazarette, the vessel's freeboard would have been reduced further.

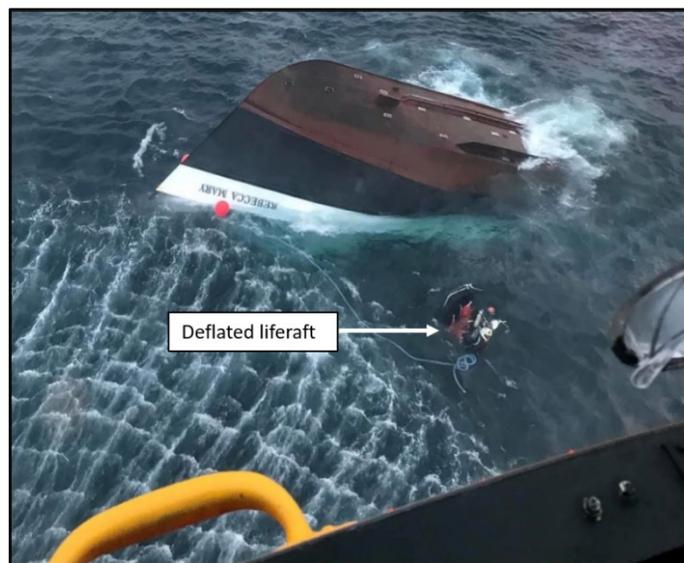
Inverted and mostly submerged *Rebecca Mary* during rescue operations on the morning of the sinking. (Source: Coast Guard, annotated by NTSB)

A Coast Guard helicopter launched from Air Station Cape Cod at 0446 and arrived on scene at 0507. Upon arrival, the helicopter crew reported that the *Rebecca Mary* was inverted and mostly submerged; an oil sheen was also observed. The helicopter crew hoisted all four crewmembers, and they were taken to Air Station Cape Cod, arriving at 0559.
