# National Transportation Safety Board

## Fire aboard Private Yacht *Andiamo*

<b>Accident type</b>	Fire/Explosion	<b>No.</b> DCA20FM007
<b>Vessel name</b>	<i>Andiamo</i>	
<b>Location</b>	Island Gardens Deep Harbour Marina, Miami, Florida 25°47.09' N, 80°10.74' W	
<b>Date</b>	December 18, 2019	
<b>Time</b>	1921 eastern standard time (coordinated universal time – 5 hours)	
<b>Injuries</b>	None	
<b>Property damage</b>	\$6.78 million est.	
<b>Environmental damage</b>	Oil sheen reported	
<b>Weather</b>	No precipitation, partly cloudy, winds from southeast at 3 mph, air temperature 79°F, water temperature 76°F, sunset 1733	
<b>Waterway information</b>	Island Gardens Deep Harbour Marina is located on the man-made Watson Island, northeast of the Main Turning Basin near the Port of Miami. The marina has a depth of 27 feet.

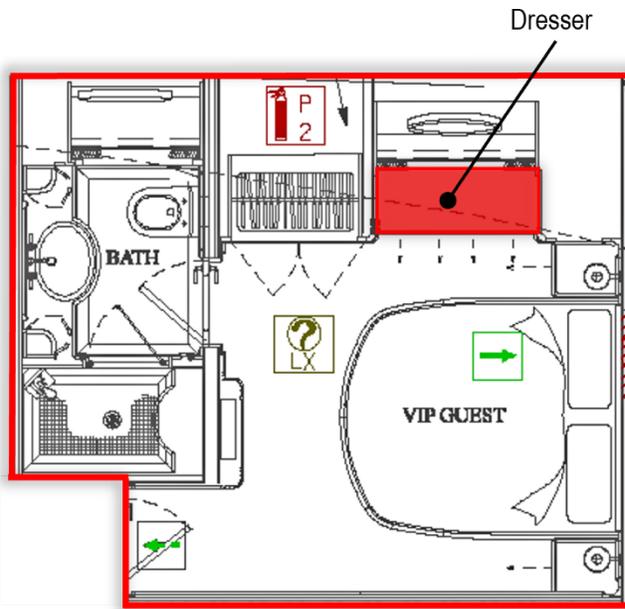
**Profile view of the port VIP suite on the lower deck where the candles were lit on the dresser. (Source: Benetti Fire & Safety Plan)**

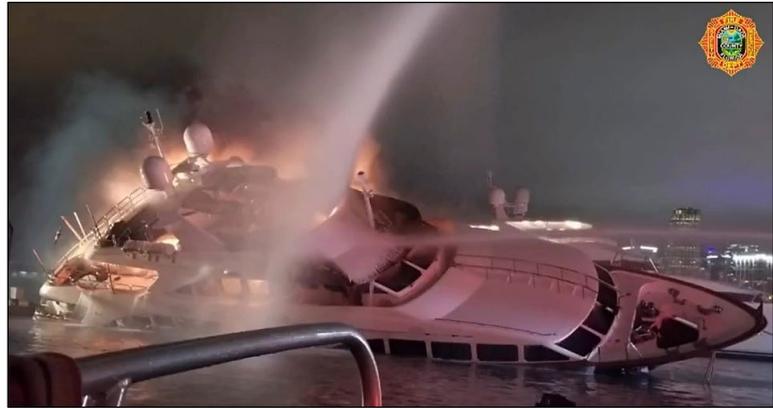
The fire was reported to be under control within two hours. However, as firewater flooded the upper decks of the vessel, the *Andiamo* started to list to starboard, rolled, and capsized on

***Andiamo* listing to starboard as fireboats attempt to extinguish the fire. (Source: Courtesy of Miami-Dade Fire Rescue)**

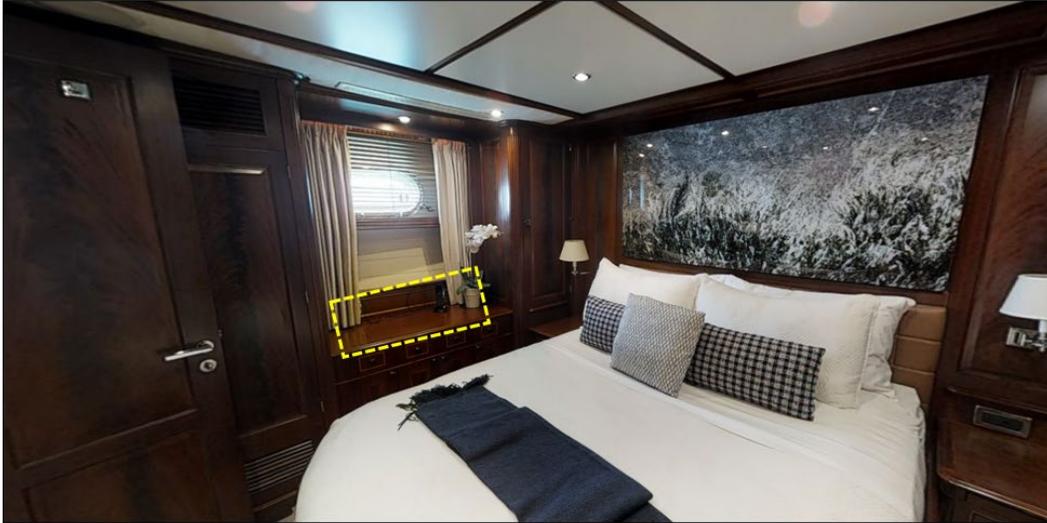
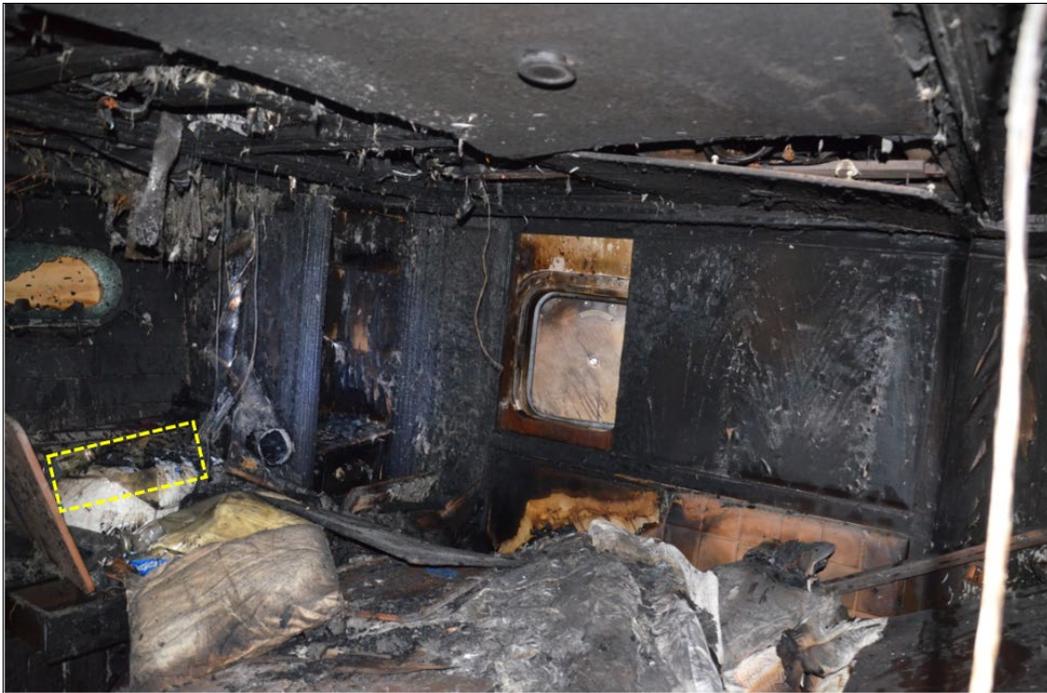
where the lit candles had been placed on the dresser beneath the room's porthole, was identified as the lowest point of burning. A V-pattern toward the fore end extended upward and out from the dresser.

The area of fire origin was determined to be at the top of the dresser in the port VIP suite. From there, the fire spread upward, vented through the overhead air-conditioning duct and open stairway in the guest lobby, and subsequently burned a hole through the ceiling above the dresser. The burned hole in the exterior staircase aligned with the dresser and base of the V-pattern in the main salon. The port VIP suite had minimum fire damage below the dresser.

Promotional and postaccident photos indicate location of the candles (yellow rectangle) in the unattended port VIP suite. (Source [top photo]: MCA Yachts, annotated by NTSB)
