Issued October 20, 2021

MAB-21/21

Collision of Tanker *Bow Fortune* and Commercial Fishing Vessel *Pappy's Pride*

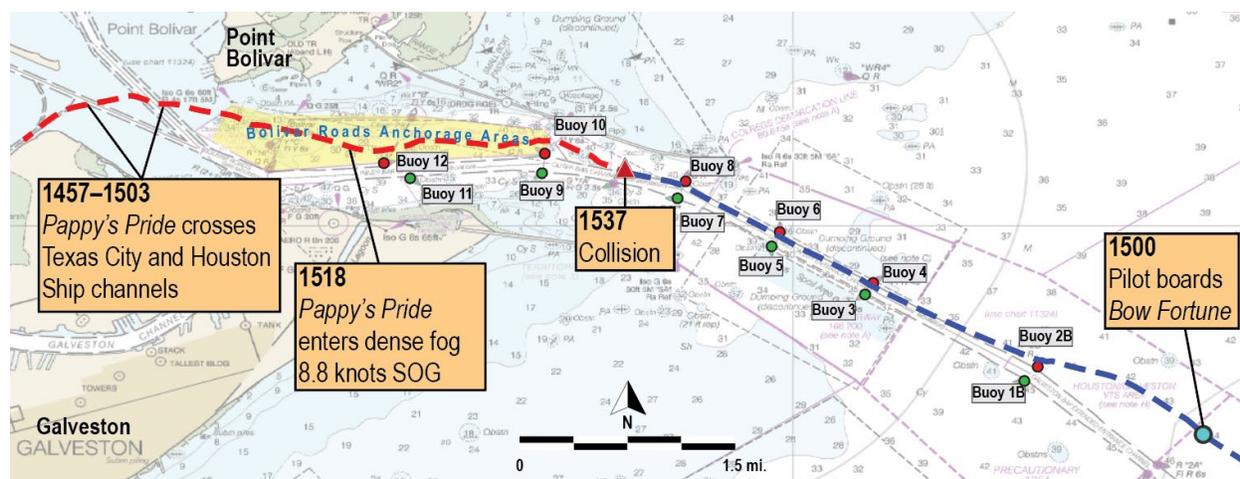
Figure 3. *Pappy's Pride* outbound track from Galveston (red) and *Bow Fortune* inbound track (blue) just before the collision. (Source: trackline data Coast Guard, background NOAA.)

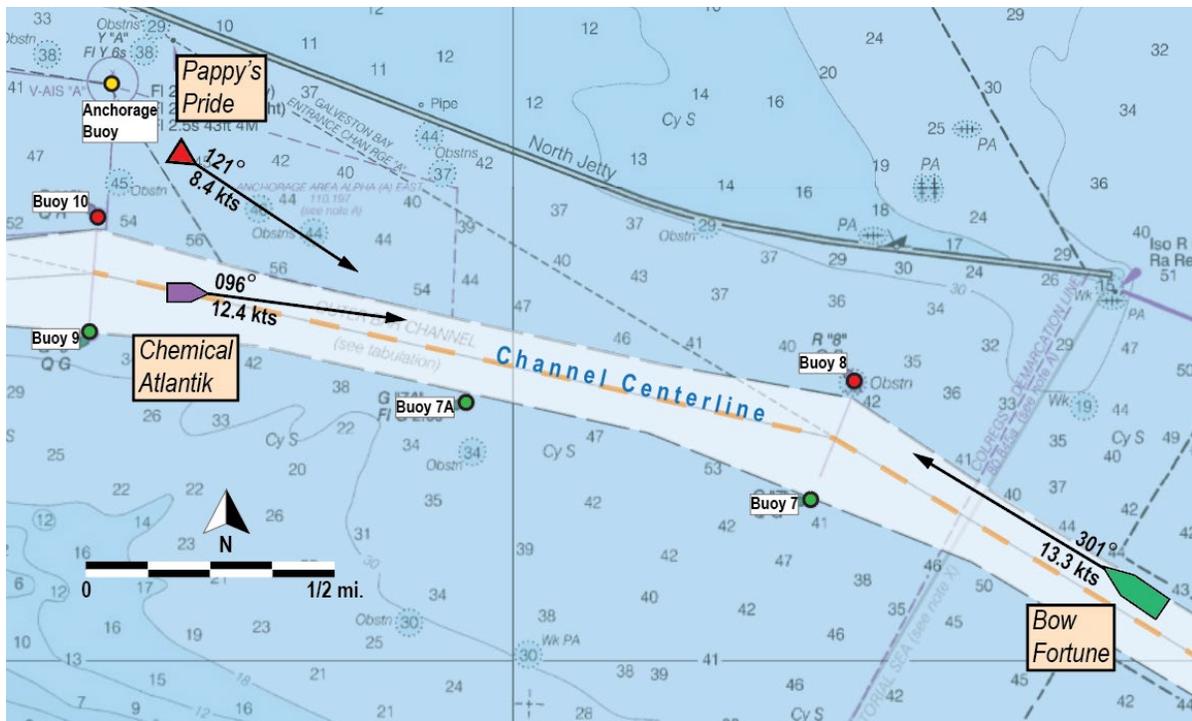
At 1532, the *Bow Fortune* pilot made a passing arrangement with the pilot on the *Chemical Atlantik*. The *Bow Fortune* pilot told investigators that, because the *Chemical Atlantik* had finished its turn across the channel's centerline, he intended to finish the *Bow Fortune's* turn on the outer edge of the Outer Bar Channel and give the channel to the *Chemical Atlantik*. The pilot stated he was at full ahead as the *Bow Fortune* approached the Galveston Entrance between the seaward ends of the jetty walls to counteract the effect of the combined 0.7-knot ebb current setting to the northwest with an ocean current, which the pilot estimated as a 1.5-knot cross current setting to the north.

Figure 4. Positions and headings of the *Pappy's Pride*, *Chemical Atlantik*, and *Bow Fortune* at 1532, when the *Bow Fortune* pilot hailed the *Chemical Atlantik* to make passing arrangements in the Galveston Bay Entrance Channel. (Background source: Coast Guard VTS)

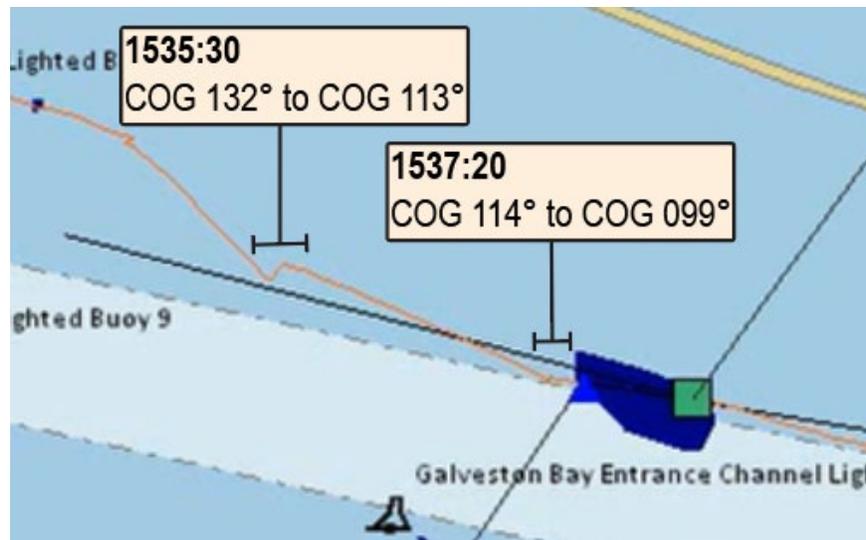
At 1535, the *Bow Fortune* pilot hailed the *Pappy's Pride* twice. Although the *Pappy's Pride* did not respond, electronic data shows that, shortly after the first attempted hail, the fishing vessel came 19° to port. The new heading, just north and slightly parallel to the outskirts of the channel boundary, put the *Pappy's Pride* predicted vector as continuing to enter the channel at a very shallow angle and crossing ahead of the inbound *Bow Fortune*. About 1536, the *Bow Fortune* pilot sounded five short blasts, and the electronic data shows the *Pappy's Pride* maintained its heading.⁴

Figure 6. Trackline of the *Pappy's Pride* course alterations. (Source: Coast Guard VTS)

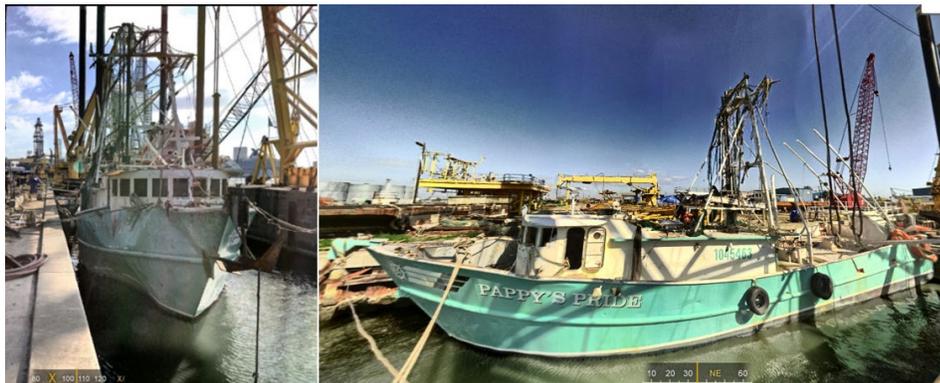
Figure 7. *Pappy's Pride* postaccident damage. (Source: Coast Guard)

When the vessels collided, the SOG of the *Bow Fortune* was 11 knots and *Pappy's Pride* was 8.4 knots, indicating the tanker was beginning to slow but the fishing vessel's captain did not appreciably change the propulsion engine speed or direction before the collision. The damage assessed on both vessels indicates the port side of the tanker's bulbous bow struck the starboard side of the fishing vessel during the collision, which in turn led to the vessel capsizing but remaining afloat as it passed down the port side of the tank
