Issued November 9, 2021

MAB-21/23

Contact of *Island Lookout* Tow with Centerville Turnpike Bridge

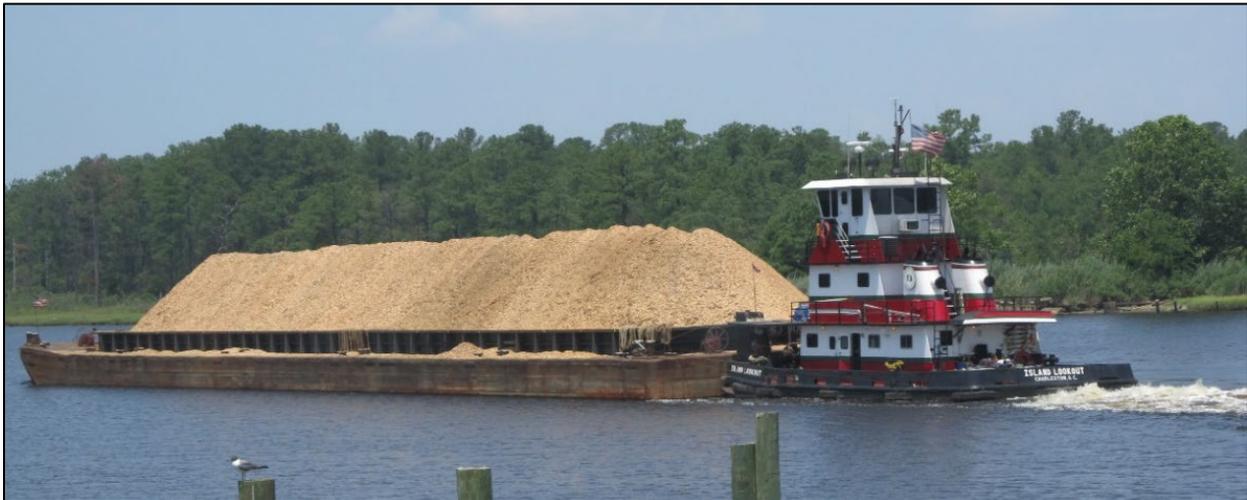
Figure 1. *Island Lookout*, pushing a barge similar to the *BH 2903*, under way before the accident. (Source: William L. Baxter)

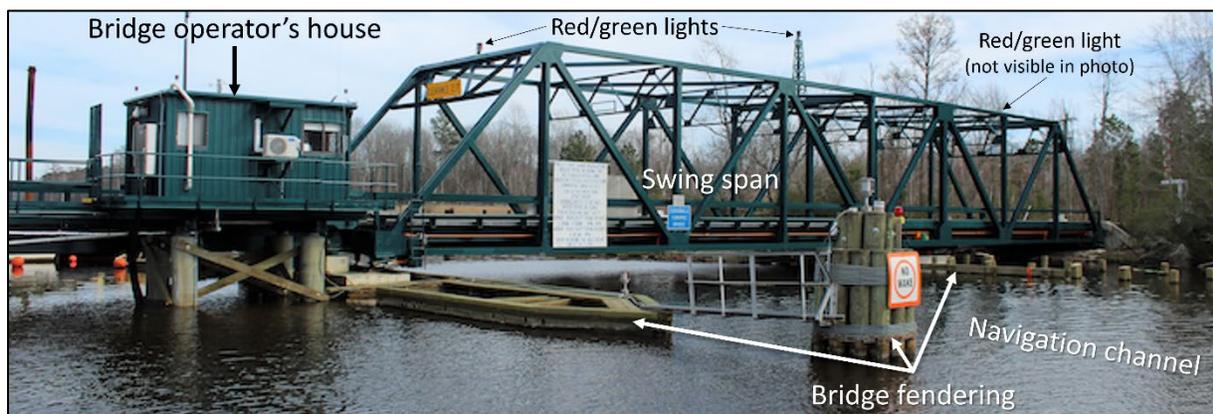
Figure 3. Centerville Turnpike Bridge in the closed position. (Source: City of Chesapeake)

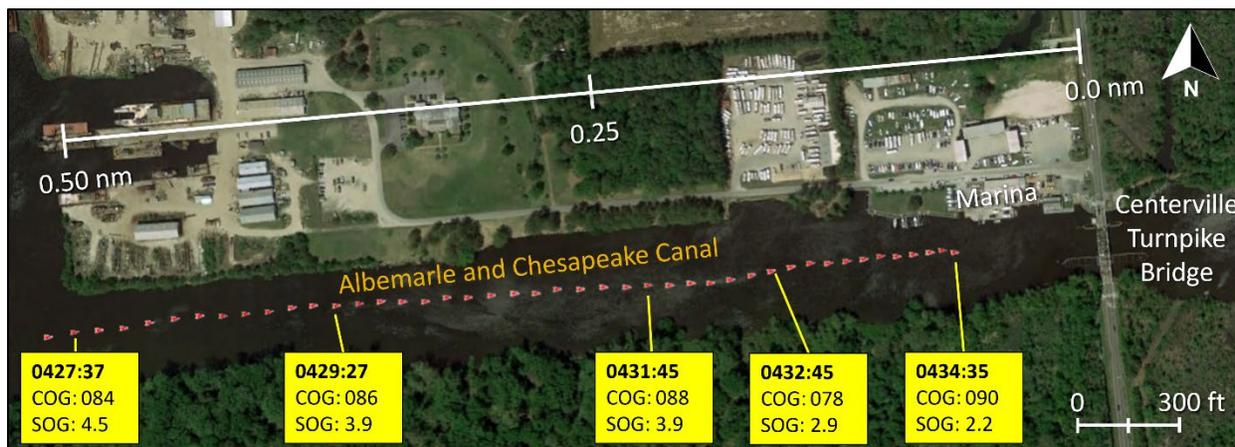
Figure 4. AIS track of *Island Lookout*, as represented by red arrow points. The AIS antenna was located on the towing vessel 315 feet aft of the bow of barge *BH 2903*. (Background source: Google Earth)

By the time the bow of the barge was about 175 feet from the bridge, the tow's speed had reduced to 2.8 knots, but while it continued to slow, its momentum carried it toward the bridge. At 0434:39, the forward starboard corner of the barge struck the end of the swing span as it was 6° from being fully open, with the bridge overhanging the fendering system by 7 feet. Based on the vessel's electronic charting system data, its heading as it struck the bridge was 090° and its speed was 2.0 knots.

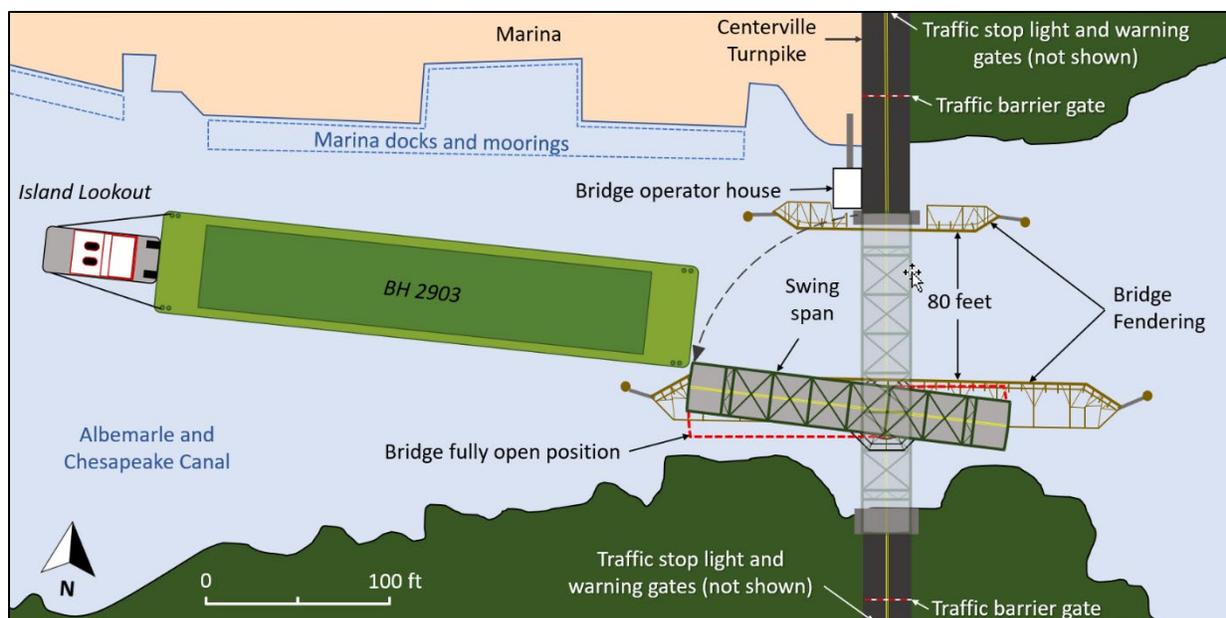
Figure 5. Illustration of the Centerville Turnpike Bridge at the time of the accident.

Steel I-beams and other structural members of the Centerville Turnpike Bridge swing span were bent and deformed by the barge strike, and the machinery for swinging the bridge was deformed and fractured, rendering it inoperative. Other damage included broken bolts, paint scrapes and indentations, and shattered wood fendering. The bridge was closed to vehicle traffic for over 6 months after the accident for repairs.

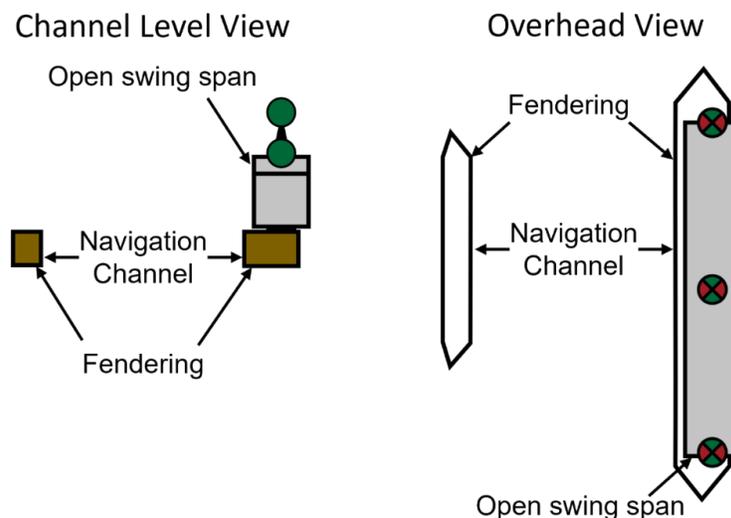
each end and at the center of the swing span, with the center light sitting atop a small tower. The lights had glass lenses divided in 90° segments that alternated in color between red and green. When viewed from the side of the bridge, the lights displayed red, and when viewed from the end of the bridge, the lights displayed green. Thus, when the bridge was closed, a vessel operator would see red lights, and when the bridge was open, the vessel operator would see green lights. When the bridge was opening or closing, a vessel operator could see red, green, or both colors, depending on the position of the bridge. The *Island Lookout* captain stated that when he had been at the helm while transiting the bridge opening at night, he knew when the bridge was fully open when the green lights were lined up vertically, similar to range lights. Investigators asked the mate if he had ever had trouble seeing the bridge; he answered, "No, the bridge has got plenty of lights. We can see the bridge."

Figure 6. Simple representation of swing span lighting.

time to prevent an accident. Using the red/green range lights on the bridge, the mate on the *Island Lookout* would have been able to determine the position of the swing span throughout its opening sequence and therefore should have had a clear understanding of the status of the bridge as he made his approach. He had 10 years' experience operating the *Island Lookout* with a barge in the Albemarle and Chesapeake Canal and thus understood the maneuvering limitations of the tow and the restrictions of the waterway. The evidence suggests, however, that the mate misjudged his speed of approach relative to the position of the bridge as it opened and did not sufficiently slow the vessel in time to safely pass.
