Issued November 10, 2021

MAB-21/24

Contact of Tanker *Atina* with Oil and Gas Production Platform SP-57B

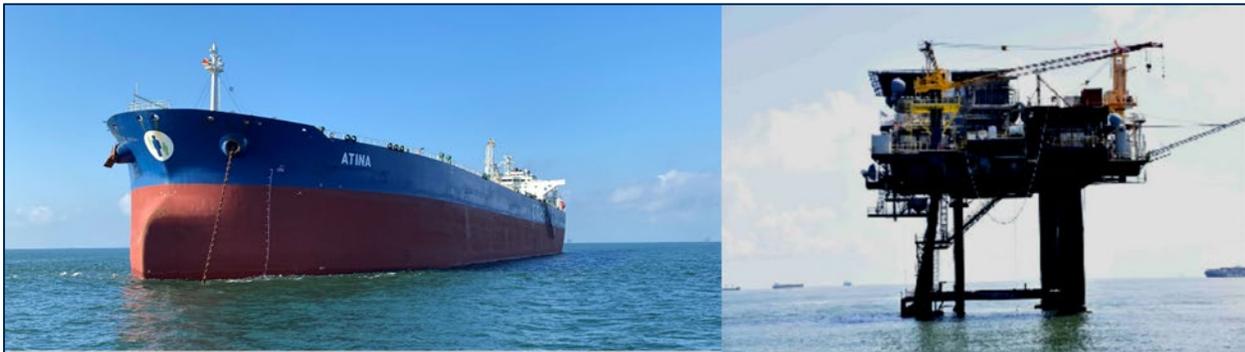
Figure 1. *Atina* postaccident (left); SP-57B preaccident (right). (Sources: US Coast Guard, Cox Operating)

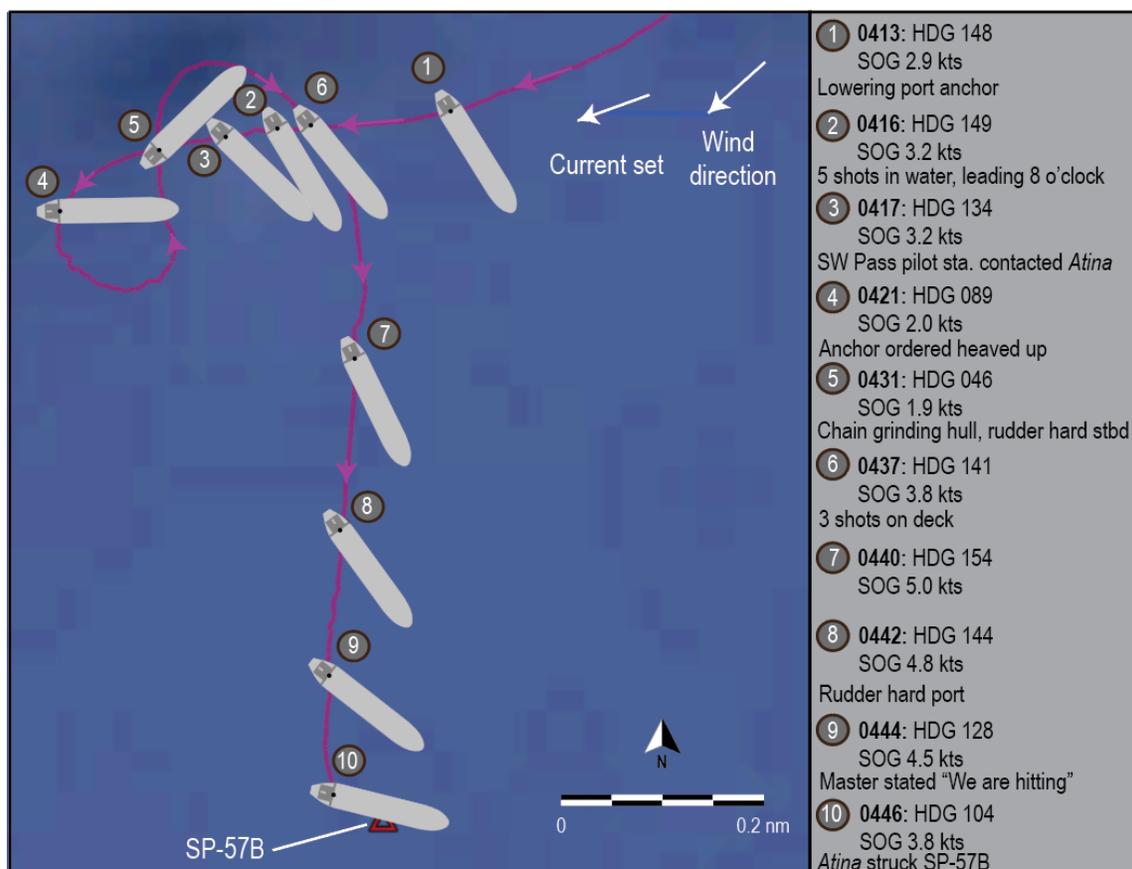
Figure 4. *Atina*'s trackline, taken from VDR data overlaid on a Google Earth image, showing the ship's heading and speed over ground before the accident.

The weather conditions included winds of about 25 knots out of the northeast. The Associated Branch pilot had informed the master of the strong westerly set, and the radar indicated a set and drift of about 247° at 1.5 knots. However, the master did not adequately account for the westerly setting current and northeasterly wind that pushed his vessel toward the platform. Likely preoccupied with bringing the anchor in clear from the hull, the master ordered hard starboard rudder while the platform was on the *Atina*'s starboard quarter and with the wind coming from dead ahead. By doing so, he ended up pivoting *Atina* toward SP-57B and putting the wind and current on the *Atina*'s port side, which caused the vessel to set toward the platform. As the platform's relative position to *Atina* shifted from the tanker's starboard quarter to the starboard bow and the ship pivoted about the anchor chain, the combination of set and *Atina* moving ahead brought the tanker in contact with the platform as the amount of chain in the water lessened and the ship gathered speed.

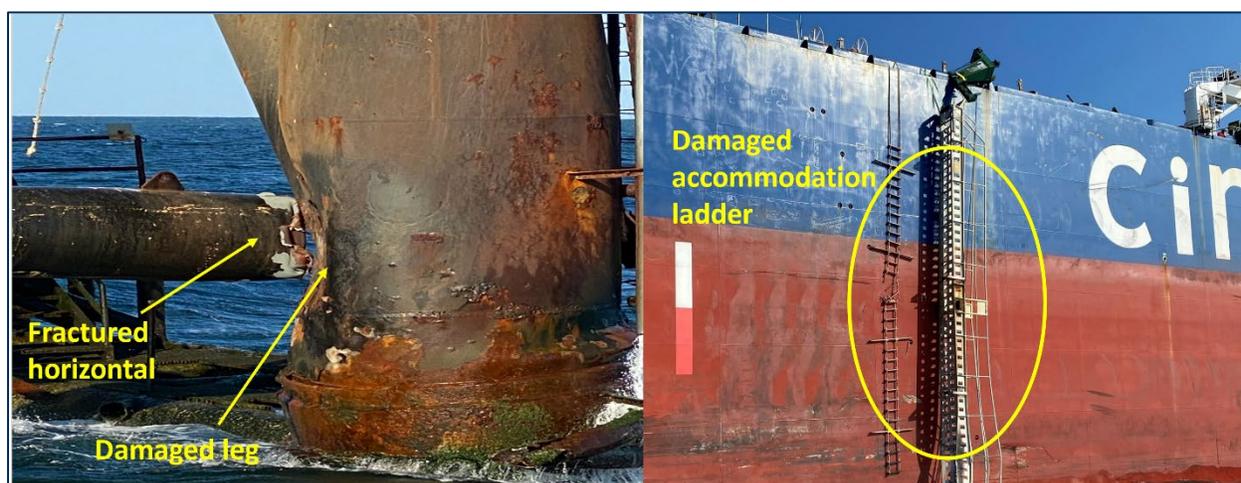
As a result of the strike, *Atina* sustained \$598,400 in damages to its starboard accommodation ladder and indentations to hull plating in ballast tanks 3-starboard and 5-starboard. SP-57B's owner/operator reported that SP-57B sustained a fractured and bulged leg as well as severed, buckled, and crushed structural members above and below the waterline. The total cost of damages to the platform was estimated at \$72.9 million.

Figure 5. Damage to SP-57B (left) and *Atina* (right). (Source: Coast Guard)

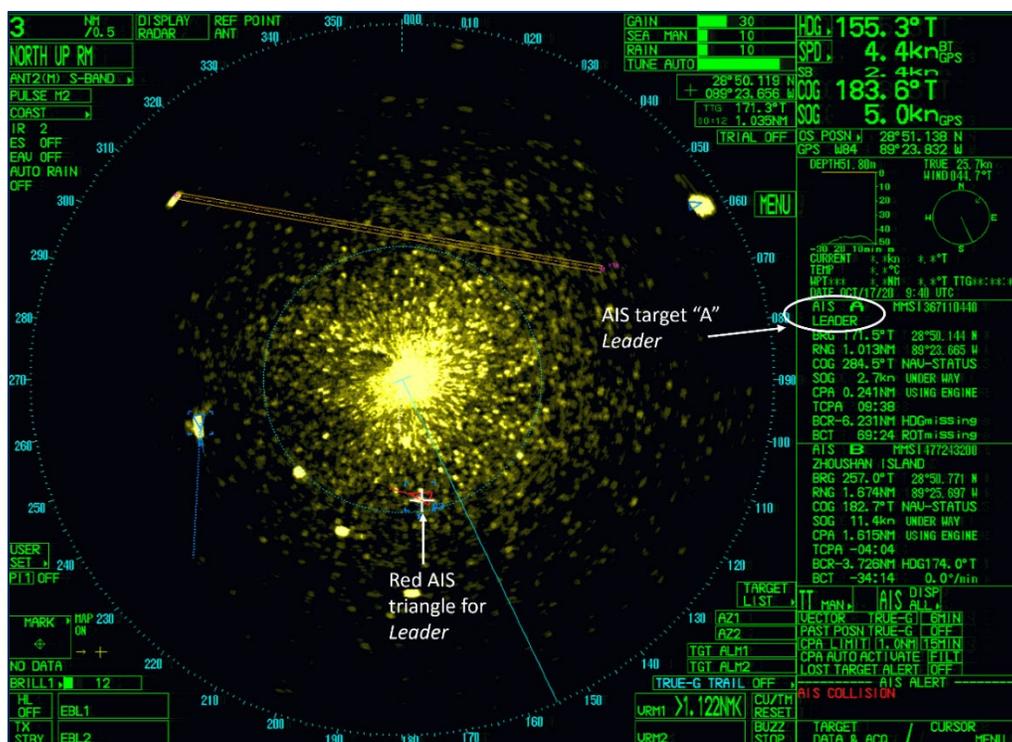
Atina’s VDR information included data from the S-band and X-band radars. At the time of the accident, the S-band radar was set to a 3-mile range. The S-band radar screen showed the offshore supply vessel *Leader* as an automatic identification system (AIS) target. The alarm “AIS COLLISION” was visible in red text under “AIS ALERT” on the S-band radar screen. The X-band radar was set to a 1.5-mile range and did not show any alarms or AIS information. The second mate told investigators that an alarm was activated on the radar he was referencing in the time leading up to the accident.

Figure 6. Screen capture of *Atina*'s S-band radar at 0441. The range is set to 3 miles and the offshore supply vessel *Leader* is listed as an AIS target. Also visible in the bottom right corner is the text "AIS COLLISION" in the "AIS ALERT" section.

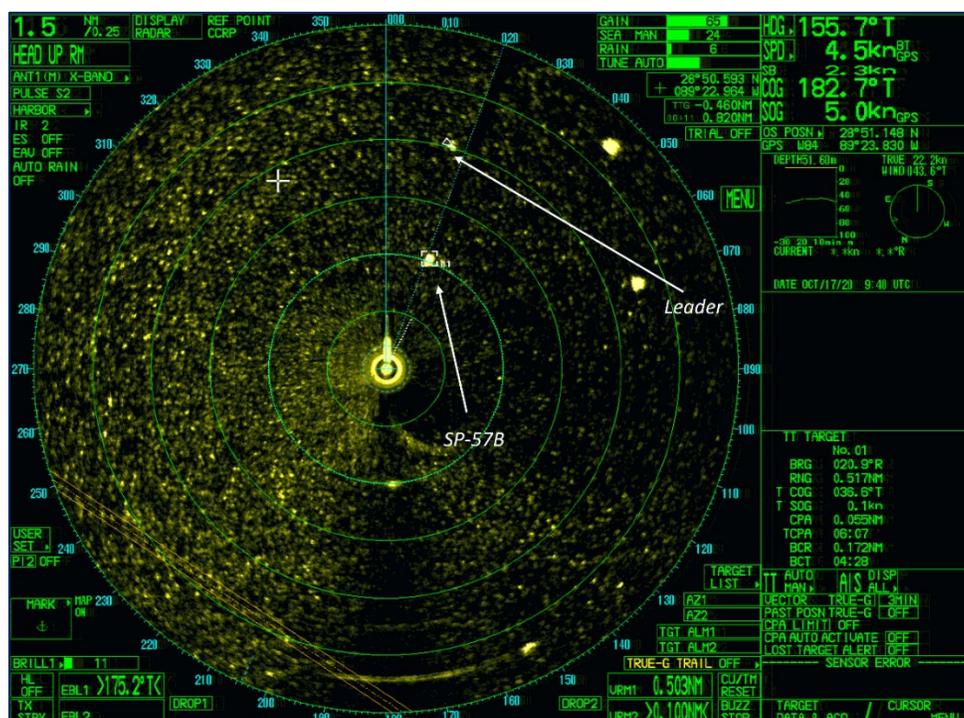
Figure 7. Screen capture of *Atina*'s X-band radar at 0441. The range is set to 1.5 miles.

After *Atina* had already begun anchoring, the Southwest Pass pilot station asked the vessel to move to a location greater than 4 miles from sea buoy SW, since *Atina* was within 4 miles of the sea buoy (the passage plan anchorage was outside the radius). As the crew was heaving the anchor to comply with this request, the bridge team lost track of the platform's location. Based on the VDR audio, it appears that the master believed the platform was another vessel. When the master asked what the vessel at 6 cables was doing (platform SP-57B was at that approximate distance), the second mate gave the master distances and information for the offshore supply vessel *Leader*, which was located 1.5 miles away from the tanker, 0.9 miles beyond SP-57B. The S-band radar was the only radar that included vessel names and the only radar showing an alarm. Because the second mate informed investigators that an alarm was activated on the radar he was using, it is likely that the second mate was looking at the S-band radar. The S-band radar was set at a scale of 3 miles, making platform SP-57B difficult to see because it was lost in radar clutter close to the *Atina*. The master was likely looking at the X-band radar, on which the scale was set to 1.5 miles, making the SP-57B easily visible at 0.5 miles.
