Issued December 1, 2021

MAB-21/25

Engine Room Fire aboard Fishing Vessel *Lucky Angel*

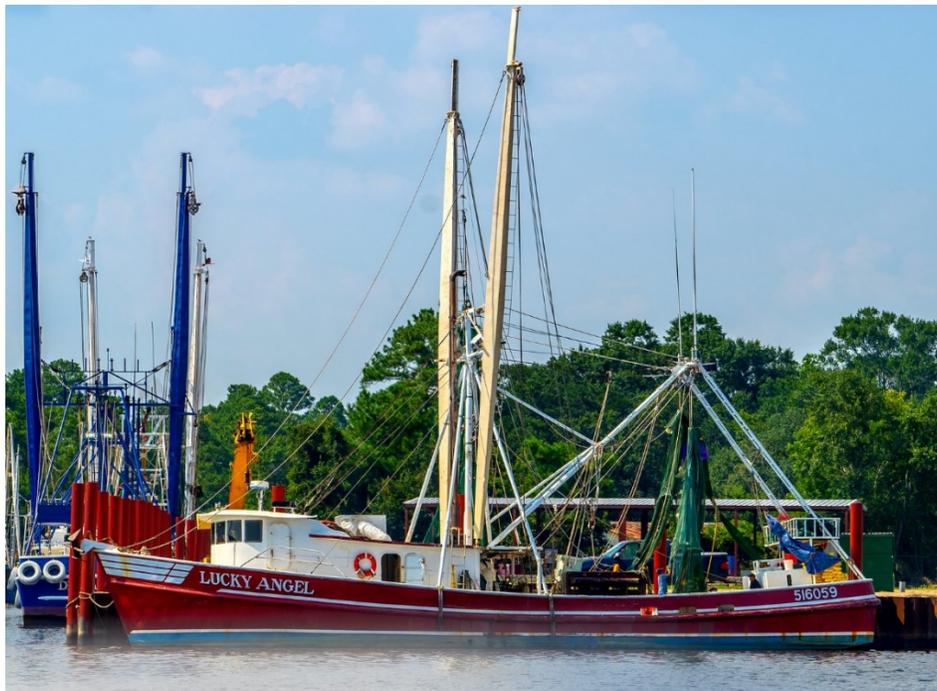
Figure 1. *Lucky Angel* pierside at Bayou La Batre, Alabama, before the accident. (Source: Julian Price)

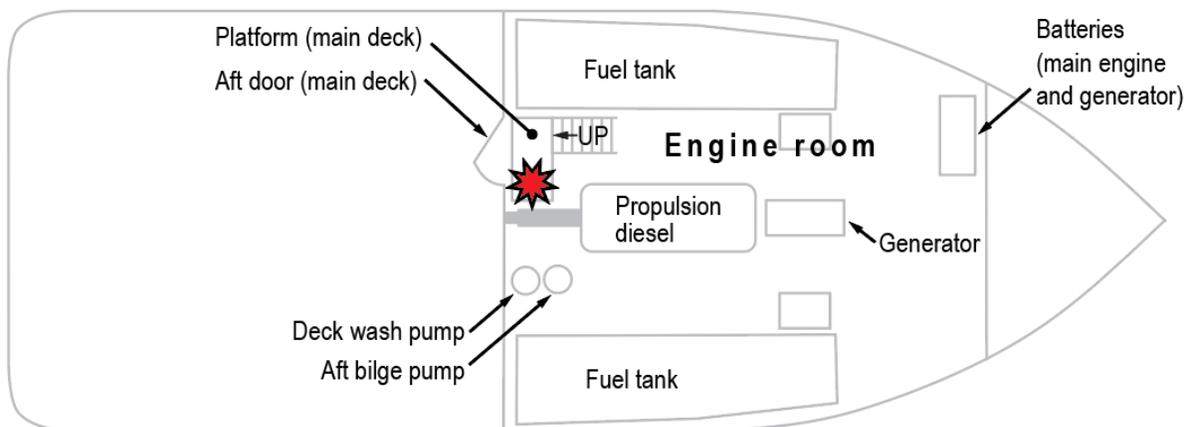
About 2205, a smoke alarm for the engine room indicated on the alarm panel in the wheelhouse. The captain immediately went to the open engine room door in the after part of the house. He could not recall hearing any unusual sounds coming from the space. From the inside platform, he saw white smoke that "smelled pretty much like [something] electrical was shorting." He said that he saw sparks coming from a bundle of wires located overhead and slightly to the right of the inside platform. Investigators later determined that the group of wires contained 120-volt AC wires to the deck flood lights and the aft bilge pump.

Figure 3. Engine room layout and area where captain observed sparking.

Investigators could not determine the precise cause of the fire aboard *Lucky Angel*, as the vessel was lost at sea and not salvaged. The captain stated that he saw sparks coming from a wiring bundle overhead in the engine room (later determined to be for the bilge pump and deck lights), that he saw white smoke near the wiring bundle, and that it smelled like something "electrical shorting." He also confirmed the only sound was the smoke alarm in the wheelhouse. There was no other sound (such as an explosion or vibration) or indication of a different initiating event. Since the main diesel and generator diesels continued to operate after the fire started, it is likely the fire's source of ignition was the electrical sparking the captain saw.

Since no maintenance records were kept for the boat and no pre- or post-purchase survey was made of the *Lucky Angel*, investigators were unable to determine the condition of the wiring bundle or if it had ever been replaced or repaired. If the wiring was original, dating back to 1968, it may have deteriorated due to decades of being subjected to the atmosphere and chemicals found in a hot engine room environment. Chafing from the material used to support the wiring, due to a vessel's motion at sea or vibration from vessel machinery, could have also caused the wires' insulation to fail. In either case, a failure in the floodlights and aft bilge pump wiring insulation likely caused arcing, which was the ignition source to the ensuing fire.

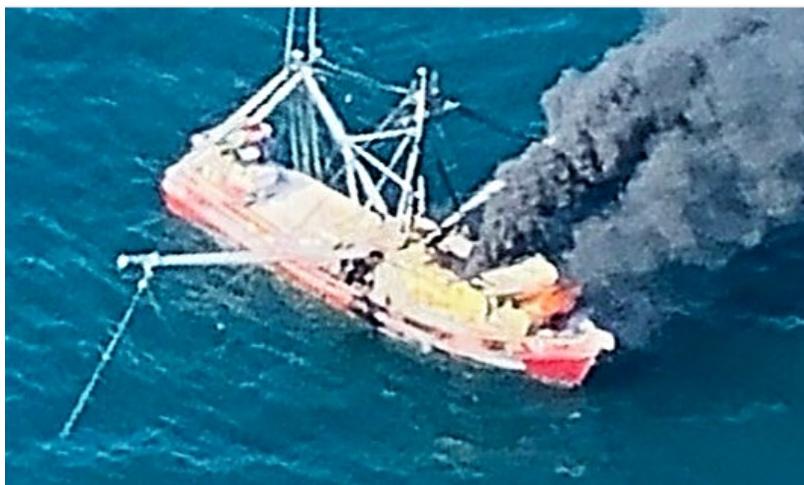
Figure 4. *Lucky Angel* on fire, December 11. (Source: Coast Guard)

The arcing would have had to ignite some form of nearby combustible material (such as fuel or lube oil, grease, rags, or even the insulation to the wiring) to initiate and sustain combustion, which obtained oxygen through open engine room vents. The fire then likely spread from the engine room to other combustibles in the house of the *Lucky Angel* as evidenced by the smoke and flames in the picture taken of the fishing vessel on the day after the fire started. Eventually, damage from the engine room fire likely caused a failure in hoses or piping connected to a through-hull fitting for a sea water system that allowed water to enter the hull and sink the vessel.
