## **MARINE CASUALTY REPORT**

**SS C. V. SEA WITCH - SS ESSO BRUSSELS (BELGIUM);  
COLLISION AND FIRE IN NEW YORK HARBOR  
ON 2 JUNE 1973 WITH LOSS OF LIFE**

**U.S. COAST GUARD  
MARINE BOARD OF INVESTIGATION REPORT  
AND COMMANDANT'S ACTION**

**REPORT NO. USCG/NTSB - MAR-75-6  
RELEASED 02 MAR 1976**

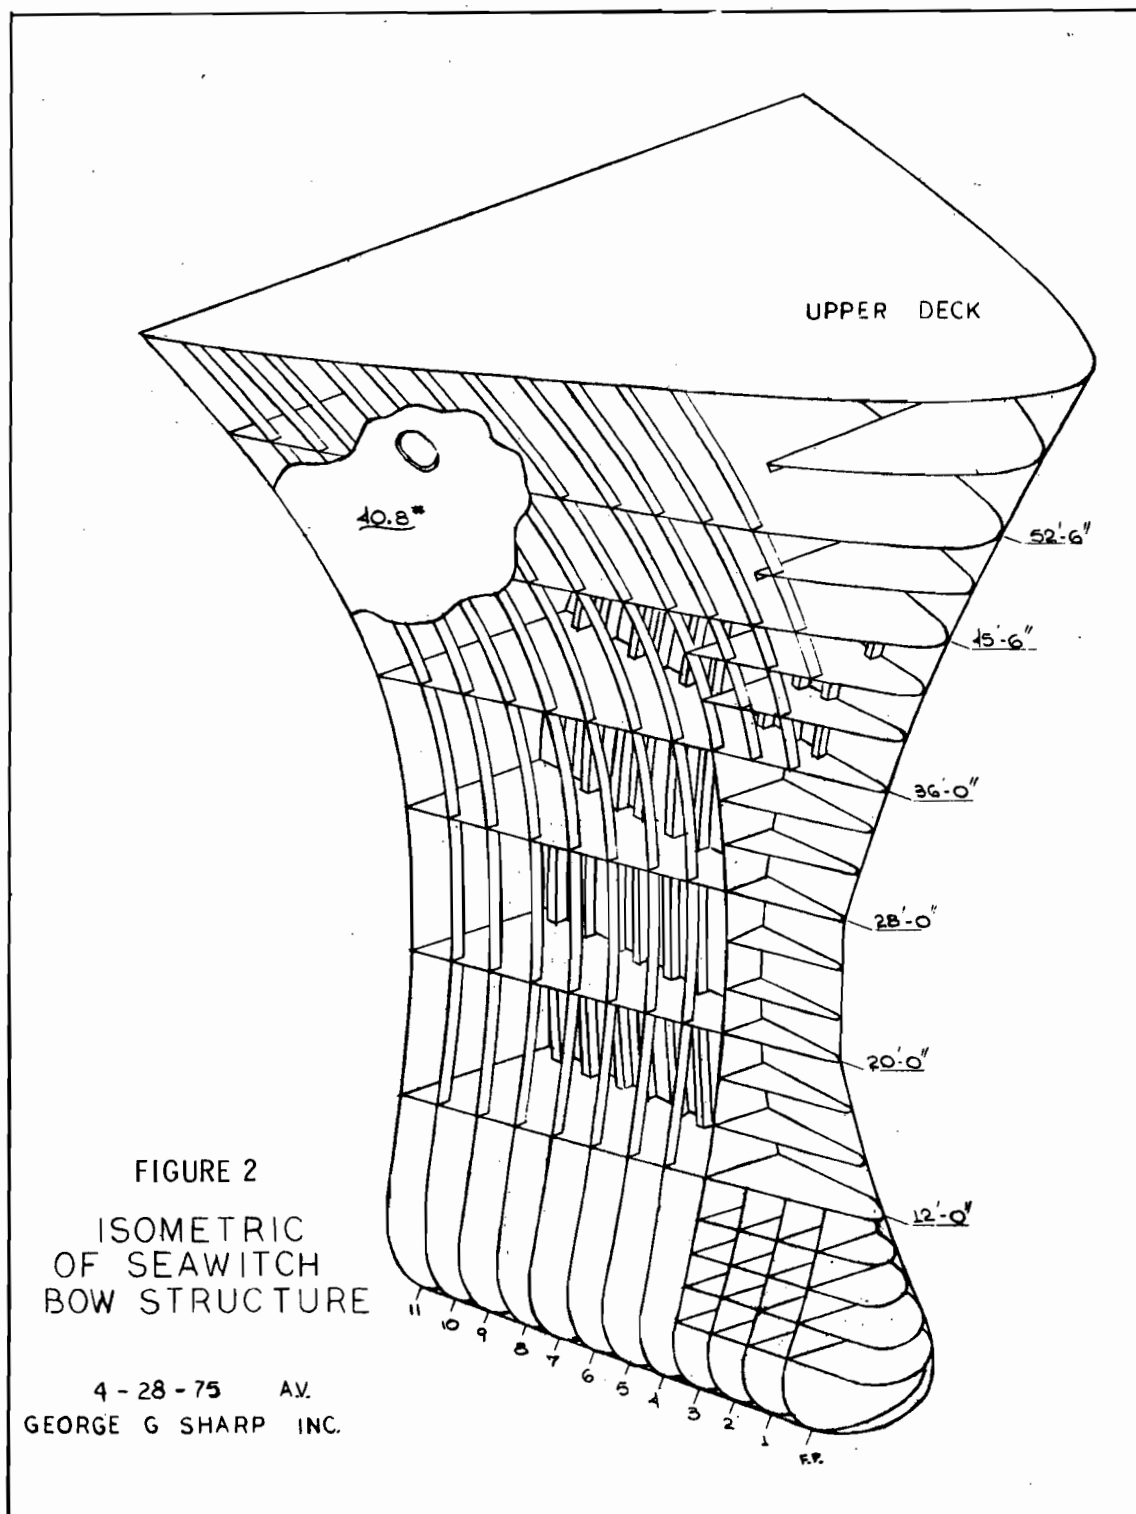
Calculations of the axial strength of the SEA WITCH's bow showed that it could exert a load of 5,000 tons at various stages of crushing before the bow collapses further. This load is about 2.5 times the maximum side resistance generated by a typical tankship of this size <sup>1/</sup> when its side shell ruptures. A nonpenetrating bow for the SEA WITCH, therefore, would require a reduction in its crippling strength of more than 2.5 times. A feasibility analysis was made to determine if this could be achieved, given the following practical requirements:

(See Figure 2 for an isometric view of the original SEA WITCH's bow design and Figure 3 for the design of the nonpenetrating bow. To increase clarity, some of the redesigned features, such as the increased stem radius and the prebuckled decks, are not shown in Figure 3.)

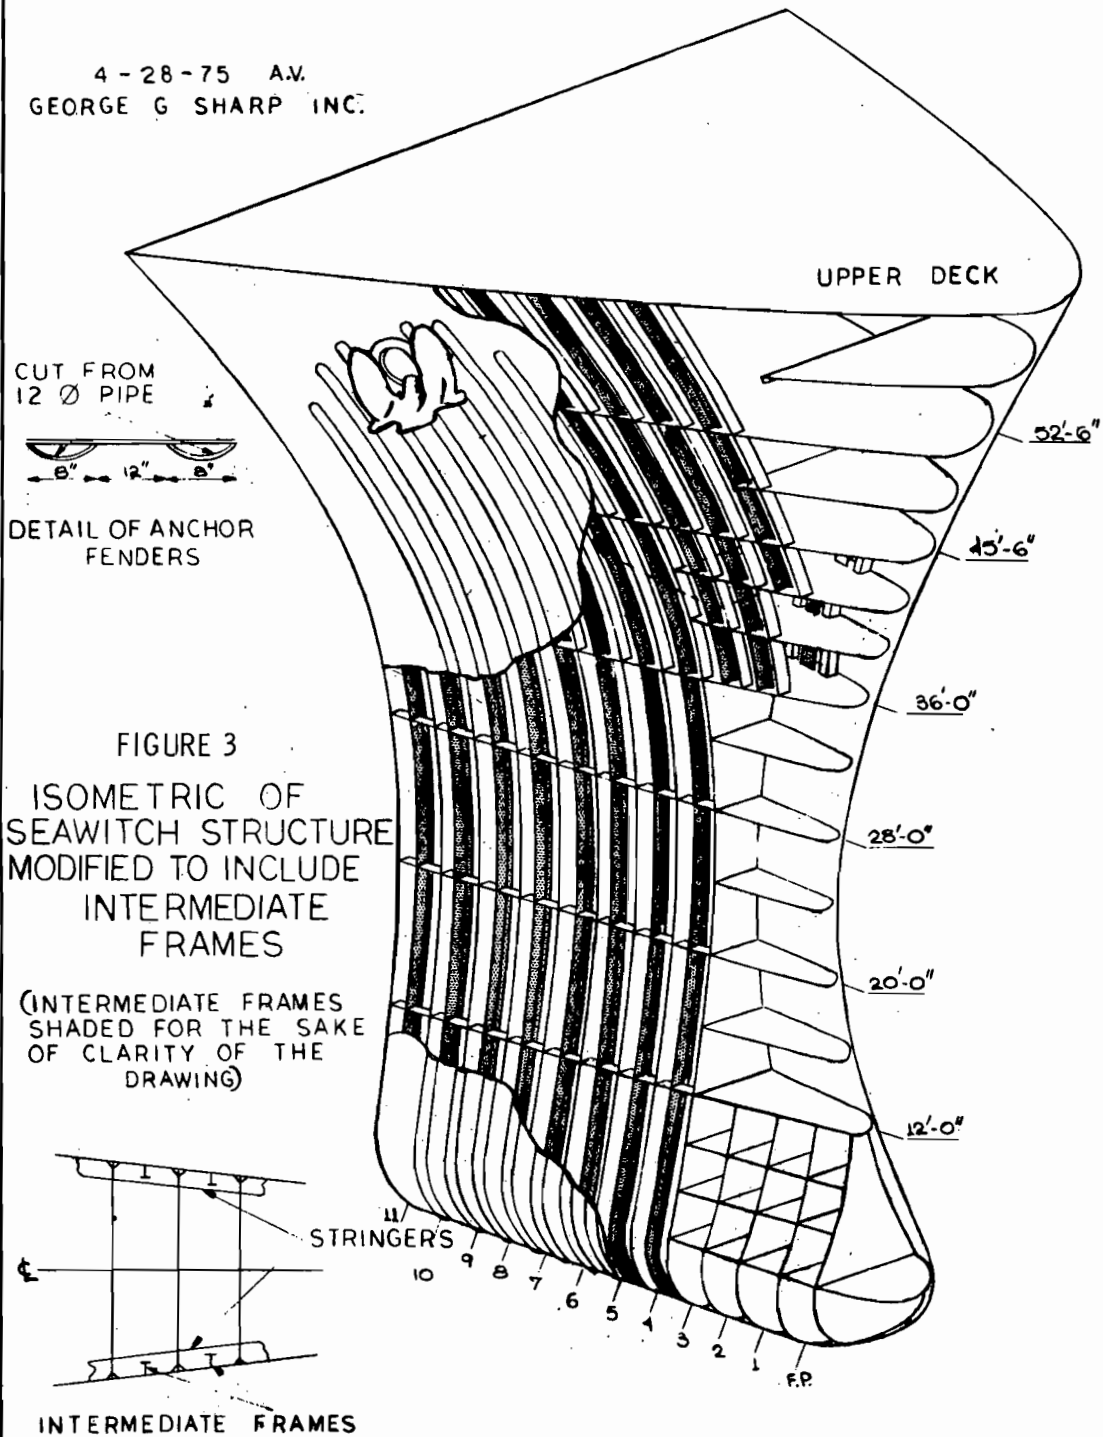
In order to limit bow crushing to  $1/20$  of the ship's length, it was necessary to determine the limiting striking velocity which would allow the bow to absorb all of the ship's kinetic energy within that distance. For the SEA WITCH in the fully loaded condition, the limiting striking velocity was determined to be about 6.8 knots. The SEA WITCH struck the ESSO BRUSSELS at about 5 knots. If the SEA WITCH had had this nonpenetrating bow, it would have lacked

the axial strength to penetrate the side of the ESSO BRUSSELS, and the bow could have absorbed the energy without damage to the SEA WITCH's collision bulkhead.

- c. All flats in the peak should be eliminated where possible. Floors can replace flats as shell supporting members, floor separation can be increased, and intermediate frames can be added.

- g. The heavy shell plating under the hawse pipe bolsters, which protect against the abrasive action of the anchors, must be eliminated. It can be replaced by half-round fenders cut from pipe and placed vertically.
