MARINE ACCIDENT REPORT

COLLISION OF THE S/T TEXACO IOWA
AND THE M/T BURMAH SPAR
ON THE MISSISSIPPI RIVER
PILOTTOWN, LOUISIANA
OCTOBER 3, 1978

NTSB-MAR-80-3

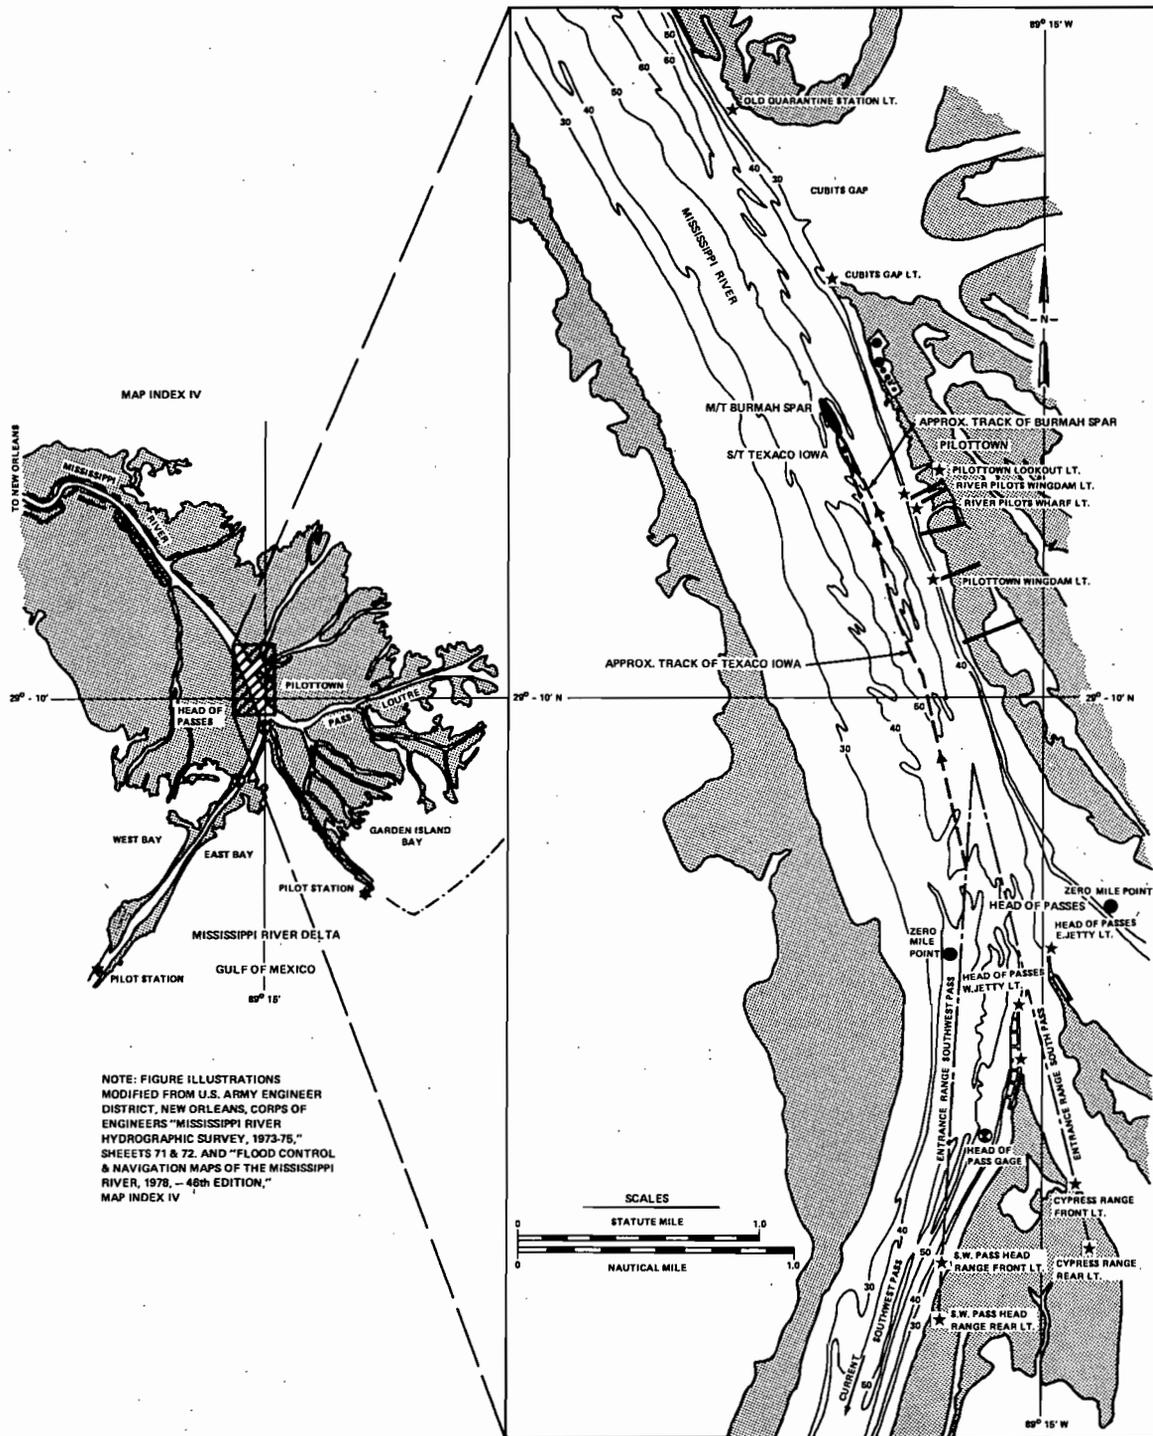
Shortly after 0400, 1/ on October 3, 1978, a Mississippi River pilot 2/ left the Pilottown pier on a pilot boat to board the inbound Liberian flag tanker M/T BURMAH SPAR. While on the pilot boat, he noticed the S/T TEXACO IOWA moving up river from Southwest Pass and about a mile away. The weather was clear and he could see the vessel's range lights and portside light as it approached Pilottown to exchange pilots. (See figure 1.)

FIGURE 1. S/T TEXACO IOWA – M/T BURMAH SPAR collision site.
