NATIONAL TRANSPORTATION SAFETY BOARD

MARINE ACCIDENT REPORT

**COLLISION OF
BRITISH BULK CARRIER
M/V PALM PRIDE WITH THE SIOUX CITY
& NEW ORLEANS BARGE FLEET
IN THE MISSISSIPPI RIVER
NEAR THE LULING-DESTREHAN BRIDGE
JUNE 23, 1986**

NTSB/MAR-87/03

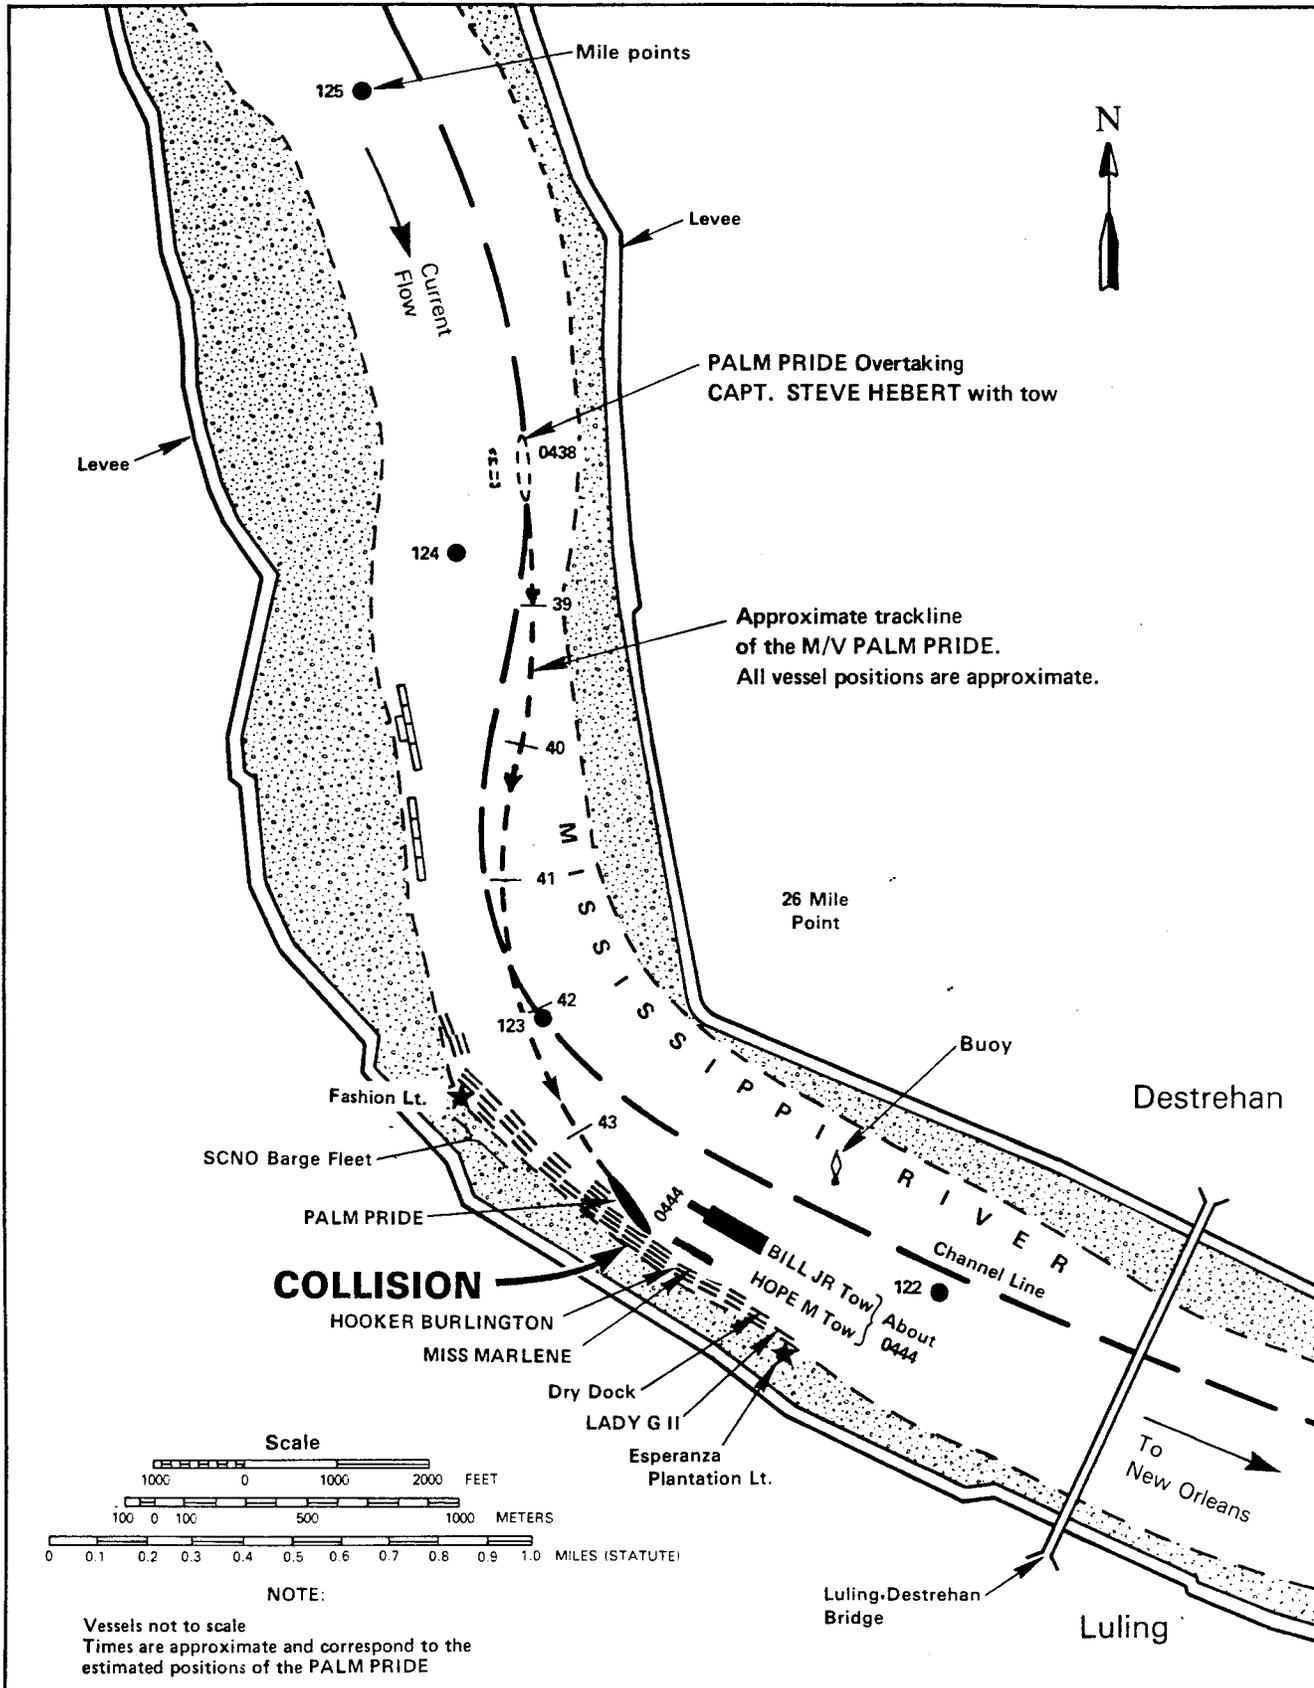
Figure 1—Location of the accident.

When the vessel was nearing 26 Mile Point, mile 123 AHP (see figure 1), the pilot, the master, the chief mate who was in charge of the bridgewatch, and the helmsman were in the pilothouse located aft on the vessel. A lookout was located at the bow. At some time before 0438, the bow lookout reported to the bridgewatch that a tow was ahead. Shortly thereafter, he left the bow to call the relief helmsman. The PALM PRIDE's pilot later stated that he was not aware that a lookout was posted. He said that he was unaware of the tow until he was "right on top of him" because of the "poor lighting on the tow." The pilot further stated that he called the towboat's operator by radiotelephone to arrange a two whistle overtaking agreement, 3/ but he got no response. He did not make use of the vessel's whistle to reach an agreement. The pilot estimated the tow was about 200 feet to starboard when the PALM PRIDE passed. While passing, the towboat was identified as the CAPT. STEVE HEBERT which was pushing a seagoing barge. After moving ahead of the HEBERT, the PALM PRIDE's pilot ordered 20° right rudder to bring the vessel closer to the right descending river bank off 26 Mile Point.
