MARINE ACCIDENT/INCIDENT SUMMARY REPORT

GROUNDING OF THE
U.S. PASSENGER VESSEL ISLANDER
WOODS HOLE, MASSACHUSETTS
JULY 29, 1988

1. Report No. NTSB/MAR-90/01/SUM		2. Government Accession No. PB90-916404		3. Recipient's Catalog No.	
4. Title and Subtitle Marine Accident /Incident Summary Report--Grounding of the U.S. Passenger Vessel ISLANDER, Woods Hole, Massachusetts, July 29, 1988				5. Report Date May 17, 1990

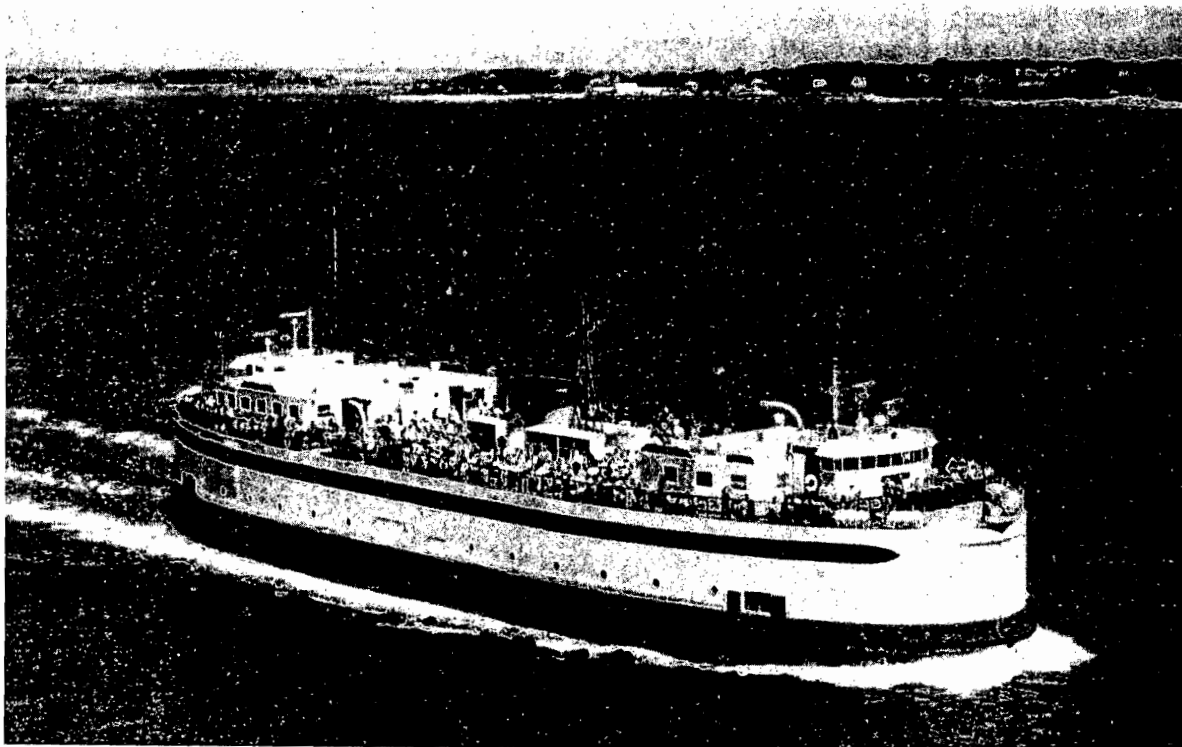
Figure 1.--The Motor Vessel ISLANDER.

At 1045, on July 29, 1988, the steel-hulled, double-ended passenger/car ferry ISLANDER (see figure 1) commenced the return trip to complete its second round trip of the day when it left Woods Hole, for Martha's Vineyard Island, Massachusetts with 509 passengers and 50 automobiles aboard. (See figure 2.) The 7-mile trip normally took 45 minutes. On the crossing before

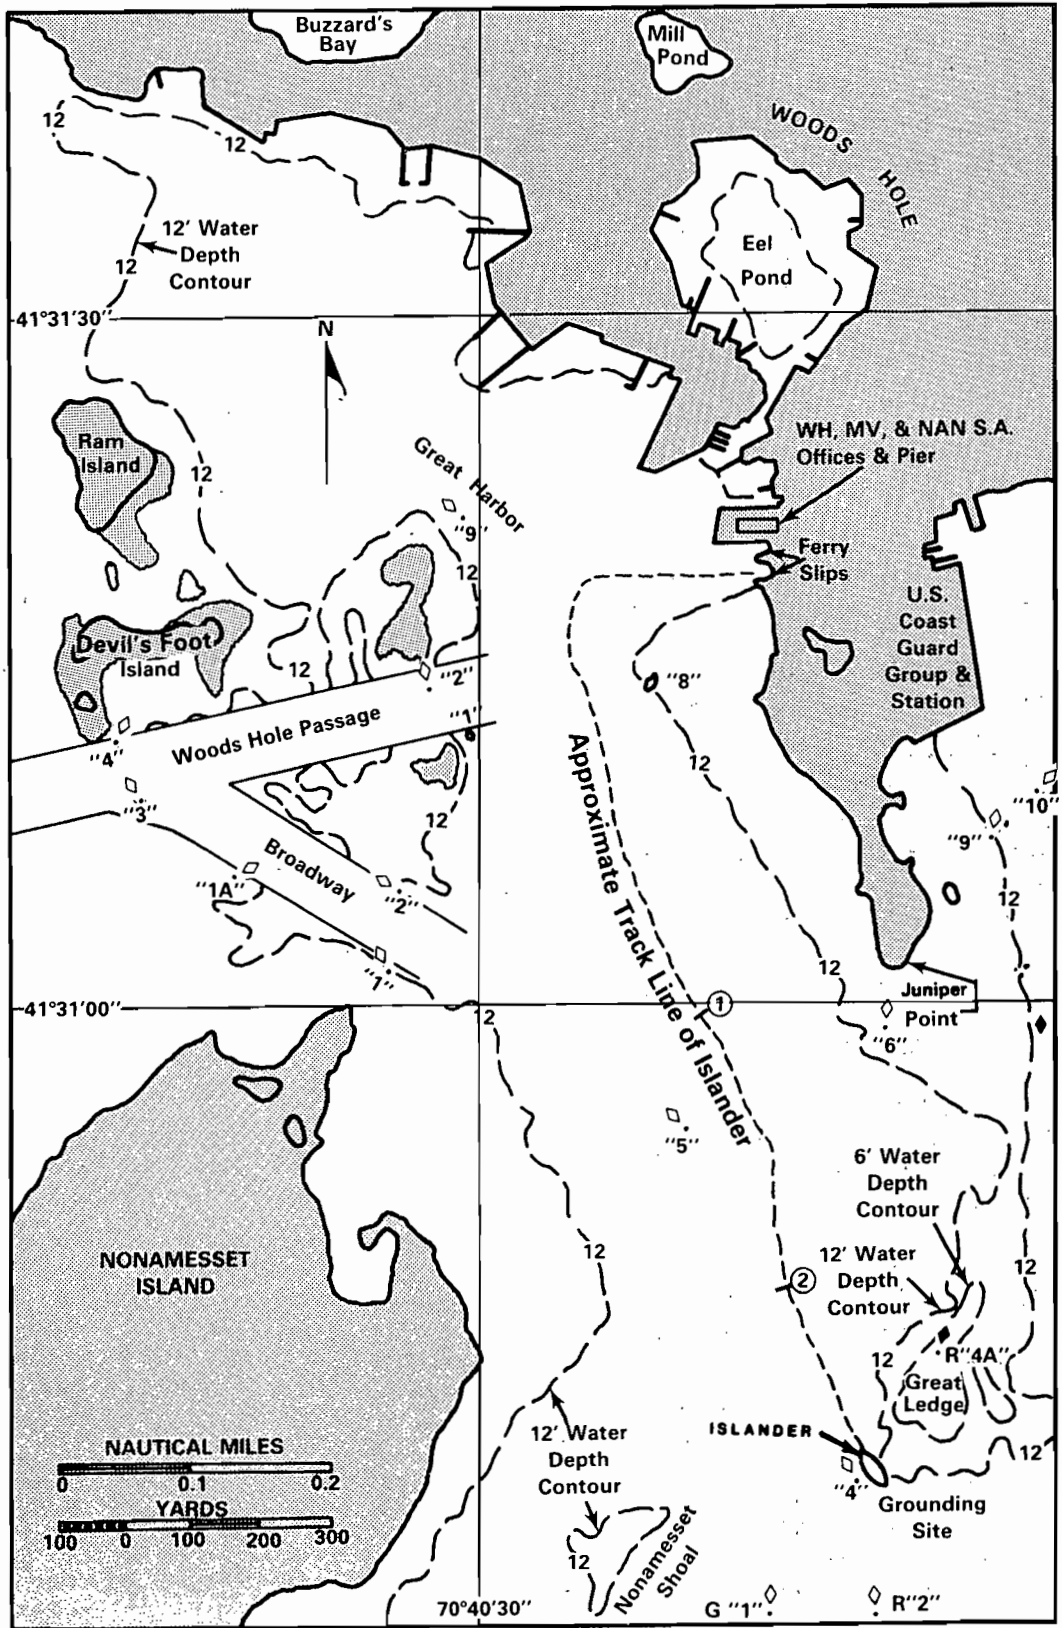
Figure 3.--Accident site.

Shortly thereafter, the master noticed two radar contacts crossing Great Ledge [shoal] approximately 20° on the ISLANDER's port bow on a constant bearing which indicated that the vessels were approaching the ISLANDER on a collision course. Before the vessel was steadied on course 170°T, the master stopped the engines, sounded the danger signal, and backed the engines. (See figure 3, position 2.) One radar contact appeared to slow down while the other appeared to change course. At an undetermined short time later, the master ordered full right rudder and as he "...kicked engines ahead...", the lookout at the forward window reported sighting buoy "4" on the starboard bow. The master immediately backed the engines; however, the maneuver was not made in time to prevent the vessel from grounding on the southwest corner of Great Ledge at 1057, on a heading between 160°T and 170°T. Immediately after the grounding, the master sighted two recreational boats, a 26- to 30-foot sailboat and a 36-foot power boat, about 50 to 60 feet off the port side of the ISLANDER.

In order to have navigated safely out of Great Harbor, the ISLANDER would have had to navigate between Woods Hole Great Harbor Entrance Buoys "1" and "2" (buoys "1" and "2"), leaving buoy "4", which marks the shoal waters of Great Ledge, to port. The master was familiar with these waters and knew the set of the current toward Great Ledge. His selection of course 170°T when abeam of buoy "5" was appropriate for the approach to buoys "1" and "2" and may have required only minor adjustment to leave buoy "4" to port.

However, when he stopped and backed the engines momentarily at position 2, the master should have known that unless he took further action there was a near certainty that the current would move the vessel to the vicinity of Great Ledge. His monitoring of the vessel's movement on radar should have confirmed this expected movement towards Great Ledge. Instead of permitting the vessel to drift toward Great Ledge after stopping the engines, he could have selected a course at minimum speed (for example, stemming the current) which would have avoided collision with nearby vessels, or he could have anchored. Since he did neither, the ISLANDER drifted to the shoal side of buoy "4" before he unsuccessfully attempted to avoid the shoal by backing the engines.
