Grounding of U.S. Passenger Vessel  
*Empress of the North*  
Intersection of Lynn Canal and Icy Strait  
Southeast Alaska  
May 14, 2007

ACCIDENT REPORT

NTSB/MAR-08/02  
PB2008-916402

# Marine Accident Report

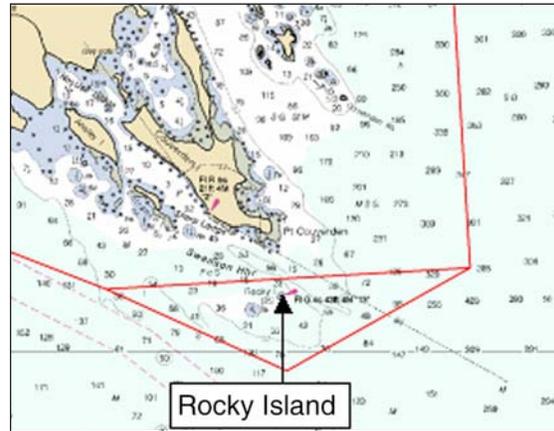
The monitors for the two electronic navigation charts were next to the helmsman's station (figure 4). The Nobeltec showed a trackline going between Rocky Island and Point Couverden, the ECDIS showed a trackline going south of Rocky Island, and the paper chart showed tracklines both north and south of Rocky Island. The paper chart was used to mark navigation fixes (vessel positions), but the Nobeltec was used for navigation purposes, according to Majestic America Line.

**Figure 4b.** Tracklines marked on paper navigation chart.

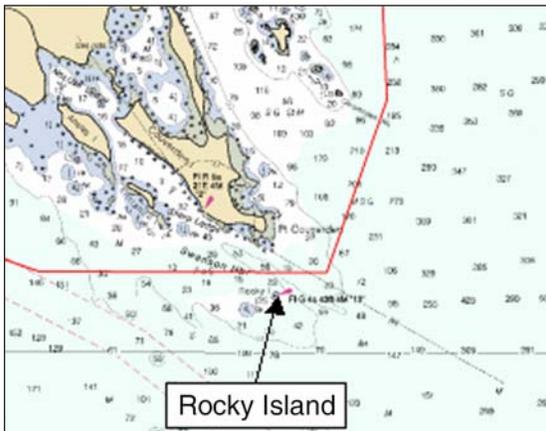
**Figure 4c.** Trackline marked on Nobeltec.

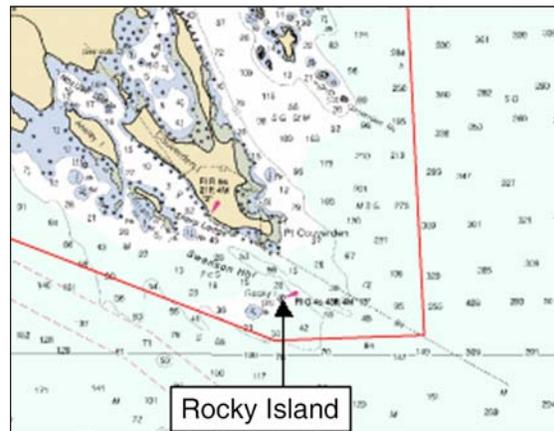
**Figure 4d.** Trackline marked on ECDIS

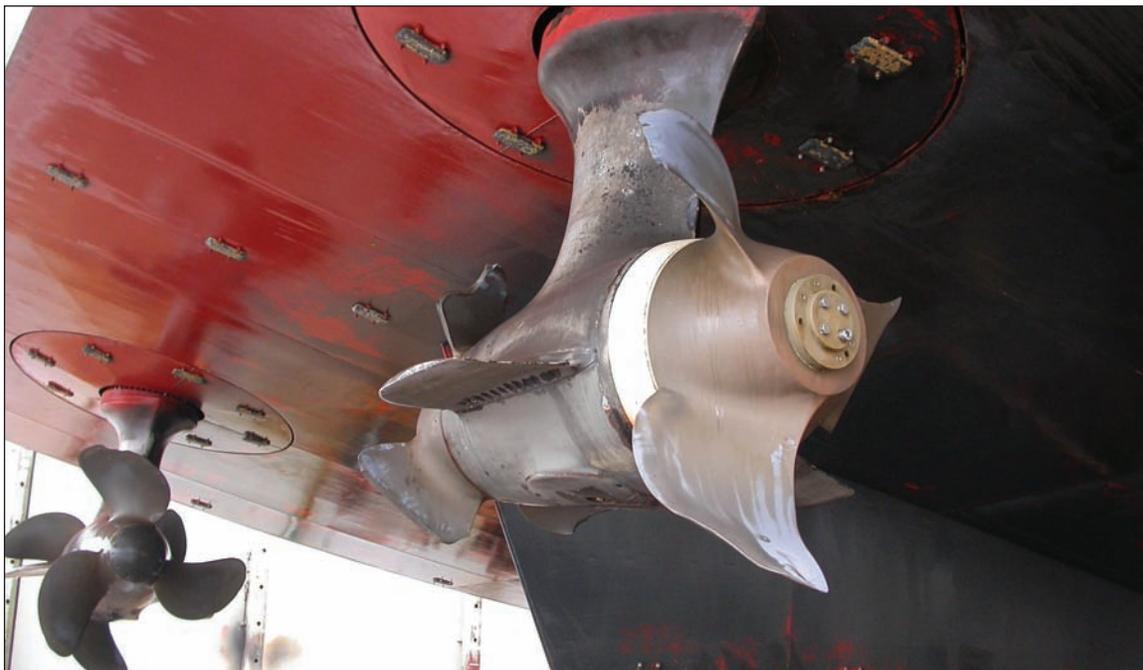
All the underwater damage was to the vessel's starboard side. Both propellers on the starboard propulsion thruster were damaged to such a degree that they had to be replaced (figure 8). The grounding also extensively damaged the steel plating on the underwater hull's starboard side (figure 9).

**Figure 8.** Damage to propeller blades of starboard propulsion thruster (foreground). Port thruster (rear) was not damaged in the grounding.

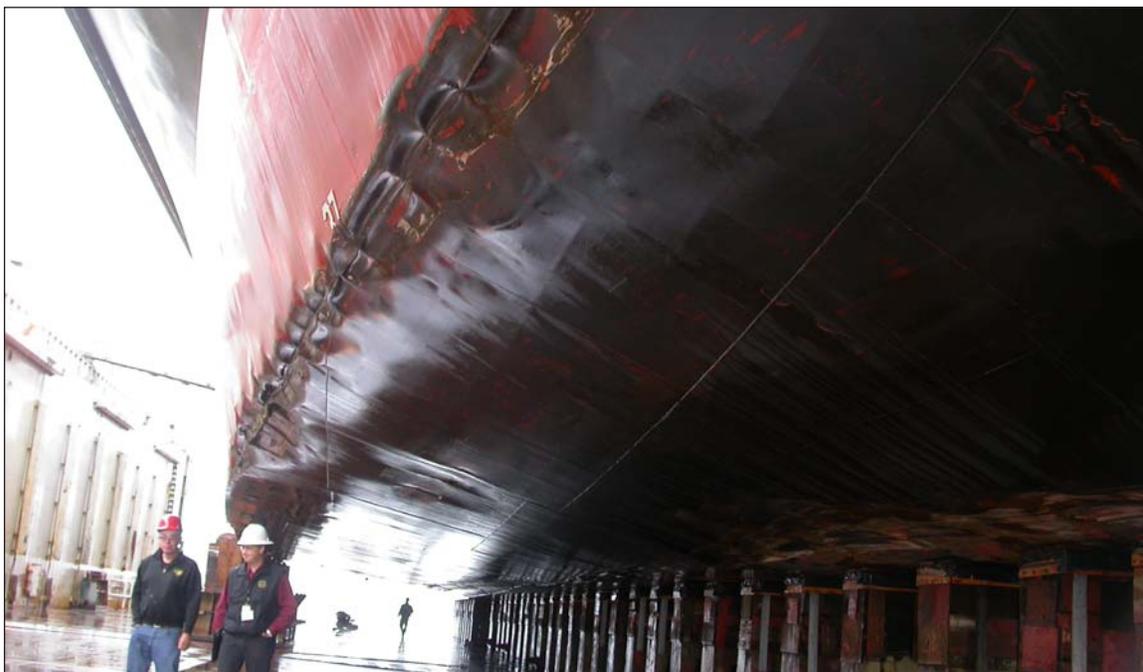
**Figure 9.** Damage to steel plating on starboard side of the *Empress of the North* hull.

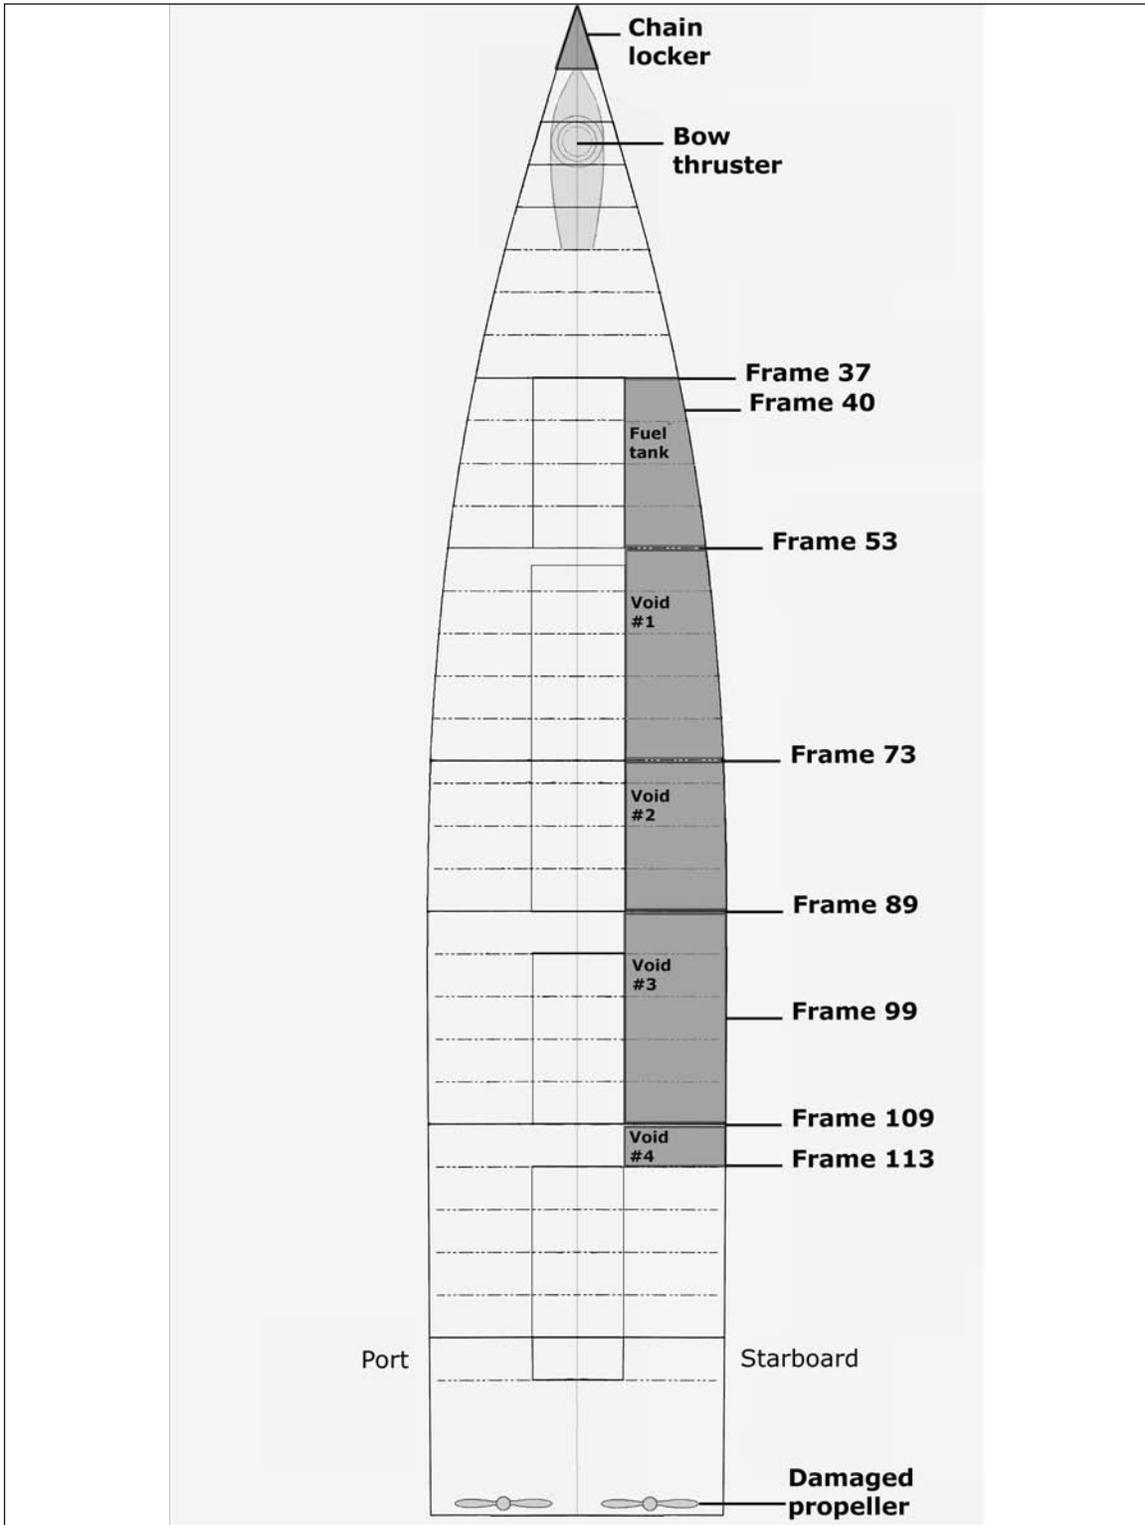
The underwater damage is described below, going from bow to stern and referencing the transverse frames, which were numbered from 0 to 150, starting at the bow (figure 10). The vessel's stem below the waterline, just forward and above the point where the keel transitioned upward toward the bow, sustained damage that bent this section of the hull to the port side. The stem was also cracked open for several feet in the same area. The empty starboard fuel tank between frames 37 and 53 was breached during the grounding and was split at the chine.<sup>43</sup> The split was intermittent from frames 40 to 53 and about 0.5 inch wide for approximately 30 feet.

Void 1, aft of the starboard fuel tank between frames 53 and 73, was breached along its flat centerline keel plate, as well as at the chine at frame 73. Some vertical internal framing members were also bent back by the force of the grounding. Void 2, on the vessel's bottom from frames 73 to 89, was holed at the chine at frame 73. The 0.5-inch-wide split ran approximately 3 feet along the length of the hull. The damage at frame 73 also buckled the internal bulkhead between voids 1 and 2, causing a loss of watertight integrity between the two spaces. Void 2 also had bent internal frames.

Void 3, which ran along the hull's underside from frames 89 to 109, was breached at the keel at frame 99. The crack was approximately 1.5 feet long and 0.5 inch wide. Frames in void 3 were also bent. Void 4, from frames 109 to 113, took on water after the grounding. The space had lost its watertight integrity when the bulkhead between it and void 3 buckled at frame 109.

**Figure 10.** Damage to underwater hull and starboard propeller. Dark-shaded sections were breached. Bow thruster was not damaged but is shown for reference.

Once the initial repairs in Ketchikan were complete, the *Empress of the North* sailed to Cascade General Shipyard in Portland for final repair work, arriving there on June 9. About 52.5 tons of steel were replaced in repairing the vessel. The repairs were completed on June 27, 2007, and the vessel returned to service in Alaska on July 7.

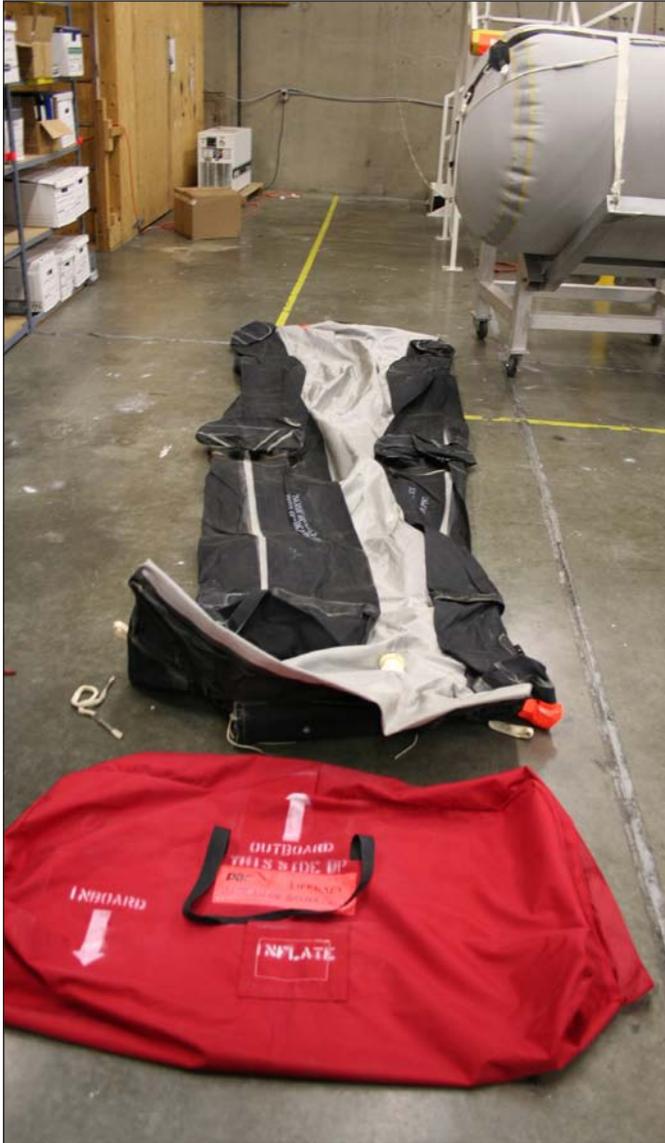
The crew could not flip the slide into the correct position because the tethering lines were too taut, so they cut it loose. The second slide also inflated upside-down and blocked the exit. It too was cut loose, and crewmembers manually turned both slides over and secured one at the embarkation area. According to the chief mate, the crew spent about 15 minutes trying to deploy each slide.

**Figure 11.** Evacuation slide laid next to a valise in preparation for packing. Photo was taken during tests at the DBC Marine Safety Systems warehouse in November 2007, after the company had labeled its valises THIS SIDE UP (see “Other Actions Since the Accident” section).
