Allision of Bahamas-Registered Tankship
M/T *Axel Spirit* with Ambrose Light
Entrance to New York Harbor
November 3, 2007

NTSB/MAR-09/02
PB2009-916402

Marine Accident Report

Abstract: This report discusses the November 3, 2007, accident in which the tankship *M/T Axel Spirit* allided with Ambrose Light, an aid to navigation, at the entrance to New York Harbor. The impact left a 60-foot-long indentation and scrapes along the starboard side hull of the vessel and damaged Ambrose Light beyond repair. No injuries or pollution resulted from the accident.

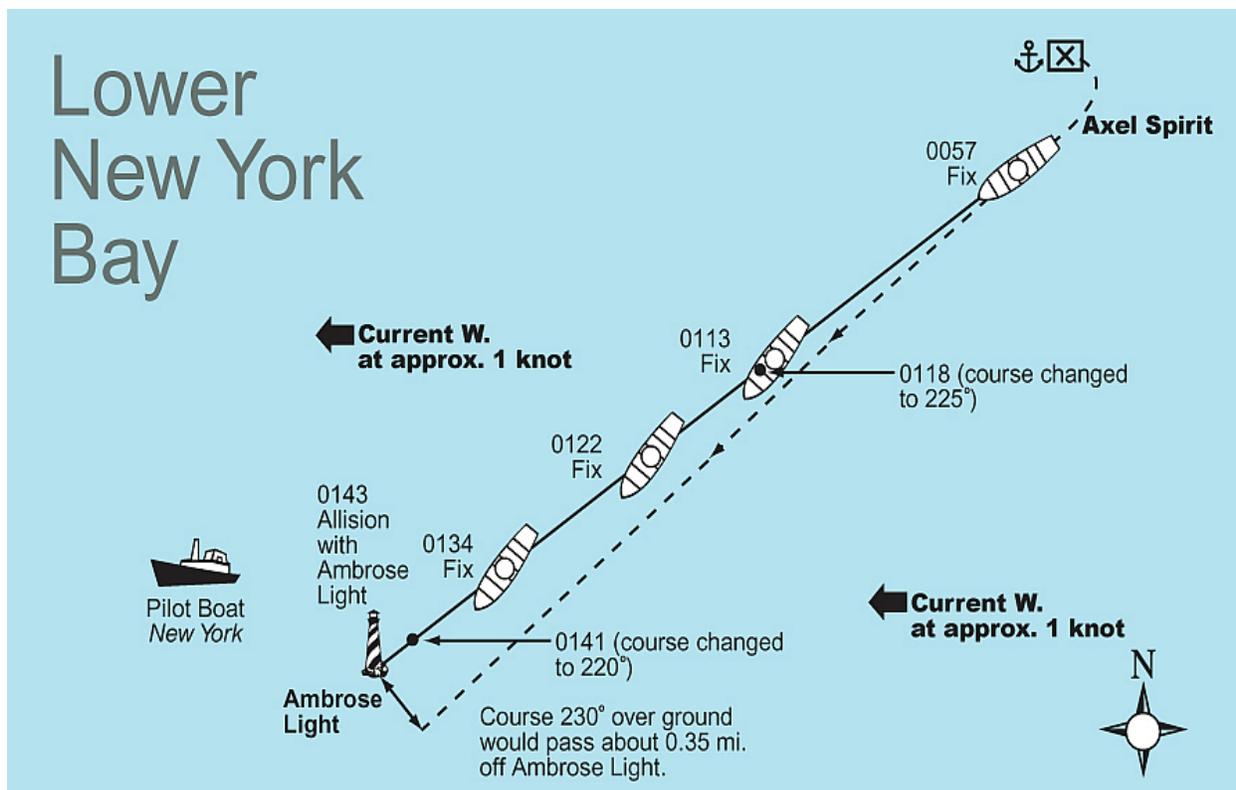
The pilot boarding area was about 4.5 nautical miles from the anchorage location. The *Axel Spirit* was ahead of schedule, causing the master to proceed at slow speed and to stop the engine on two occasions to consume time so that the vessel would arrive at the scheduled time of 0200. The first engine stop occurred at 0103 and lasted for about 11 minutes, until 0114. The second stop occurred at 0120 and lasted about 4 minutes, until 0124. The master told investigators that when he stopped, ocean swells caused the vessel to yaw 5° to 6° from the desired course.¹¹ At 0058, Ambrose Light was bearing 235°, about 3.5 nautical miles from the *Axel Spirit* (figure 5). The vessel's speed was 4 to 5 knots.

Figure 5. Graphic illustrating the *Axel Spirit's* approach from the anchorage location toward the pilot boarding area. Image not to scale.

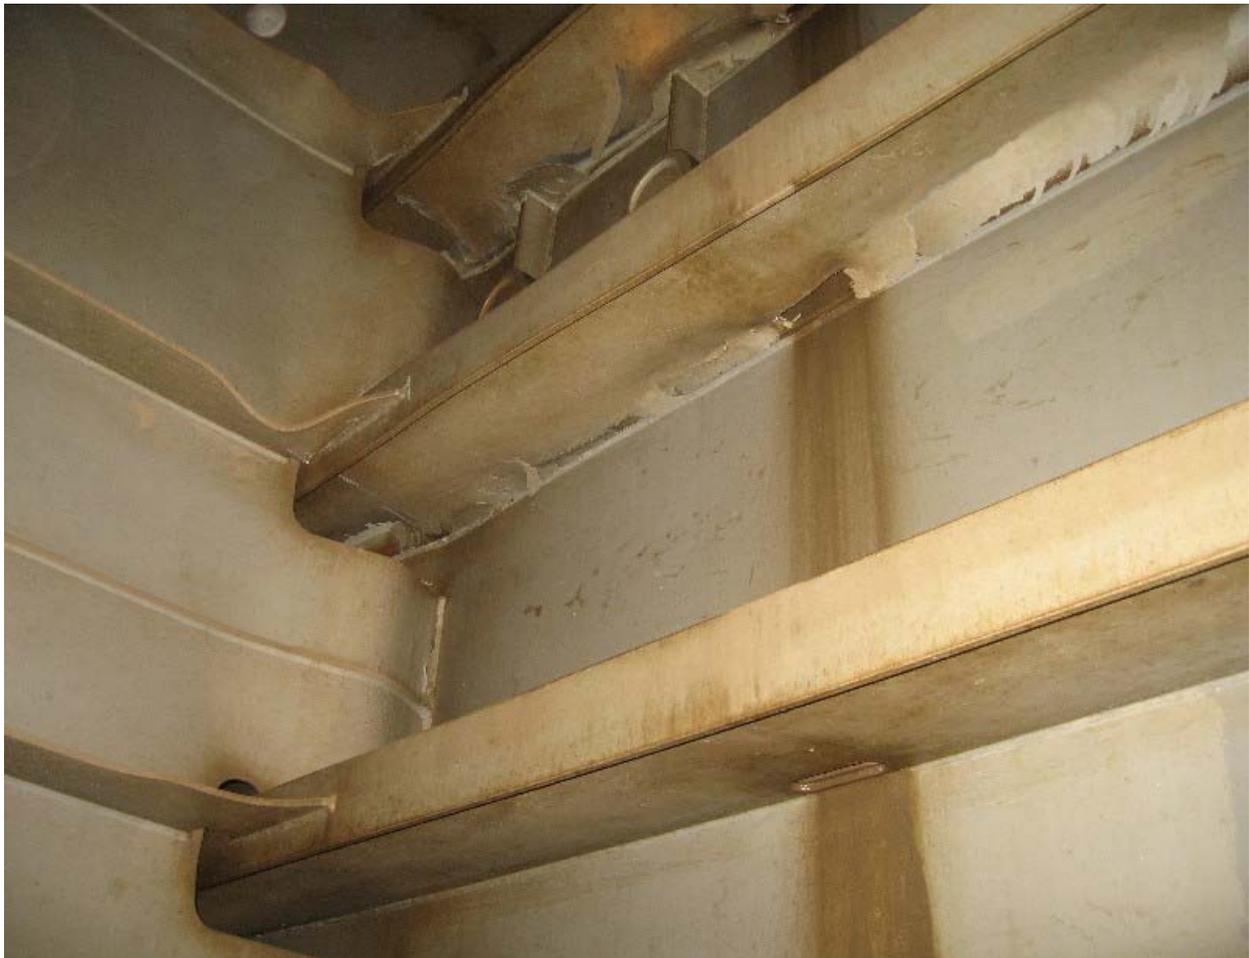
Axel Spirit. A damage assessment of the *Axel Spirit*, conducted at the Chevron berth on November 3, revealed damage to the vessel's starboard ballast tanks 4 and 5. Internal structural members (side longitudinals, transverse framing, and stiffeners) were buckled in the impact area (figure 6). Both tanks exhibited deformed side shell plating where the vessel allided with Ambrose Light. The hull plating was not penetrated but was inset above the waterline and at the turn of the bilge, running fore and aft about 60 feet, almost the entire length of each ballast tank (figure 7). The vessel's safety railing above the impact area was also damaged. The damage to the ship was estimated at \$1.5 million.

Figure 6. Photo of damage to the interior hull, showing deformation and cracks in the starboard side longitudinals.

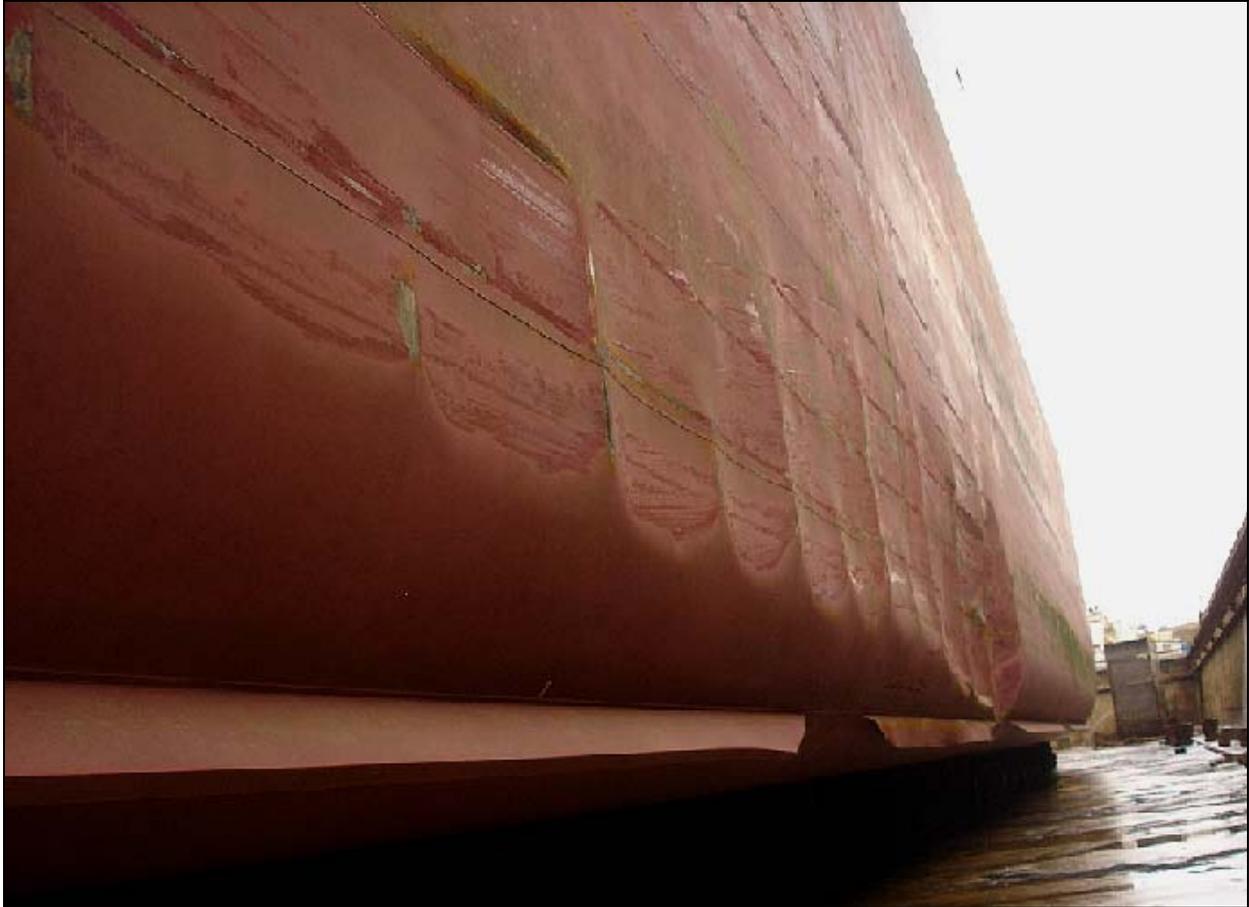
Figure 7. Photo of damage to the exterior starboard hull, showing buckled, scraped steel plates.

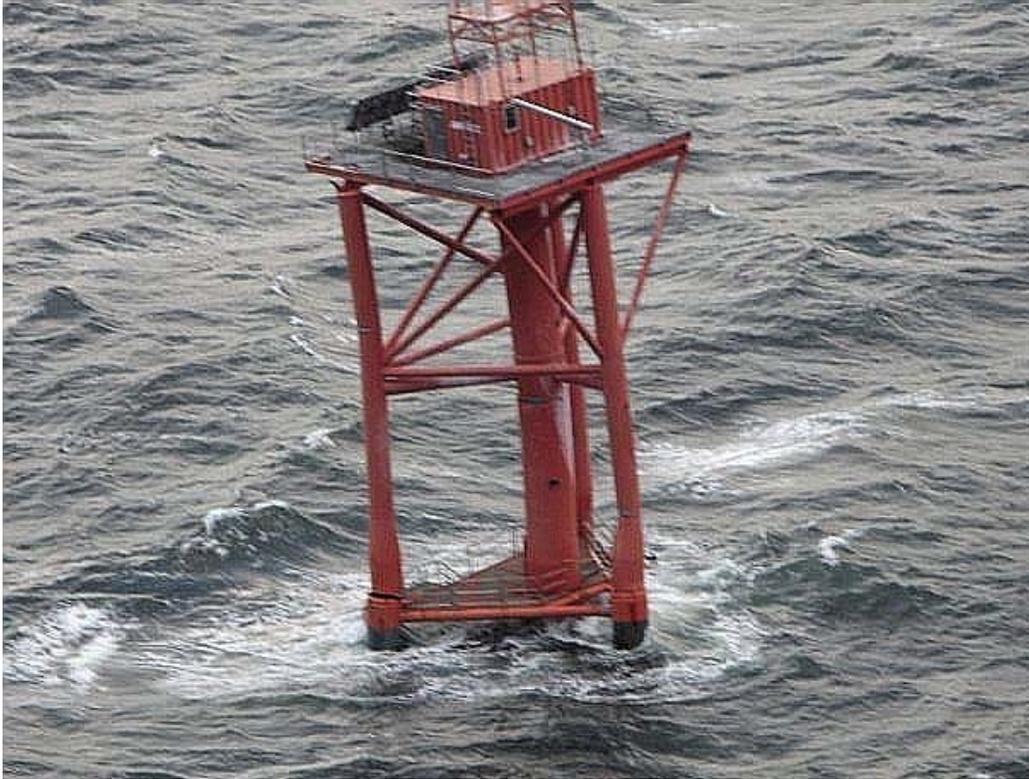
Ambrose Light. About 1300 on November 3, the pilot boat *New York* performed the first damage assessment of Ambrose Light. Subsequently, the Coast Guard assessed the damage. The tower had sustained damage to its three legs and to the center column, causing the structure to lean (figure 8). The southeast and southwest legs were inset, their welds partially or completely separated, about 8 feet above the waterline. The center column was distorted and the light beacon was stuck in one position, with the light on. The Coast Guard estimated that the tower was damaged beyond repair and would be removed. To construct another tower would have cost about \$10 million.

Figure 8. Ambrose Light, leaning after sustaining damage. Photo by the Coast Guard.

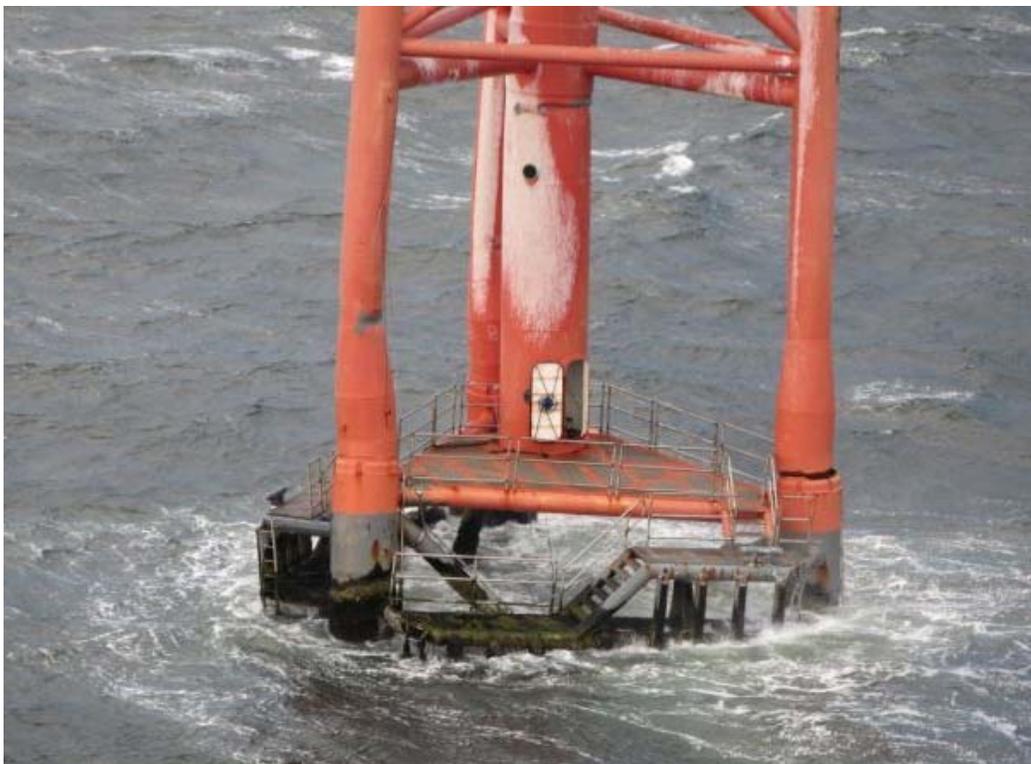
Figure 9. Damage to Ambrose Light. Photo by the Coast Guard.

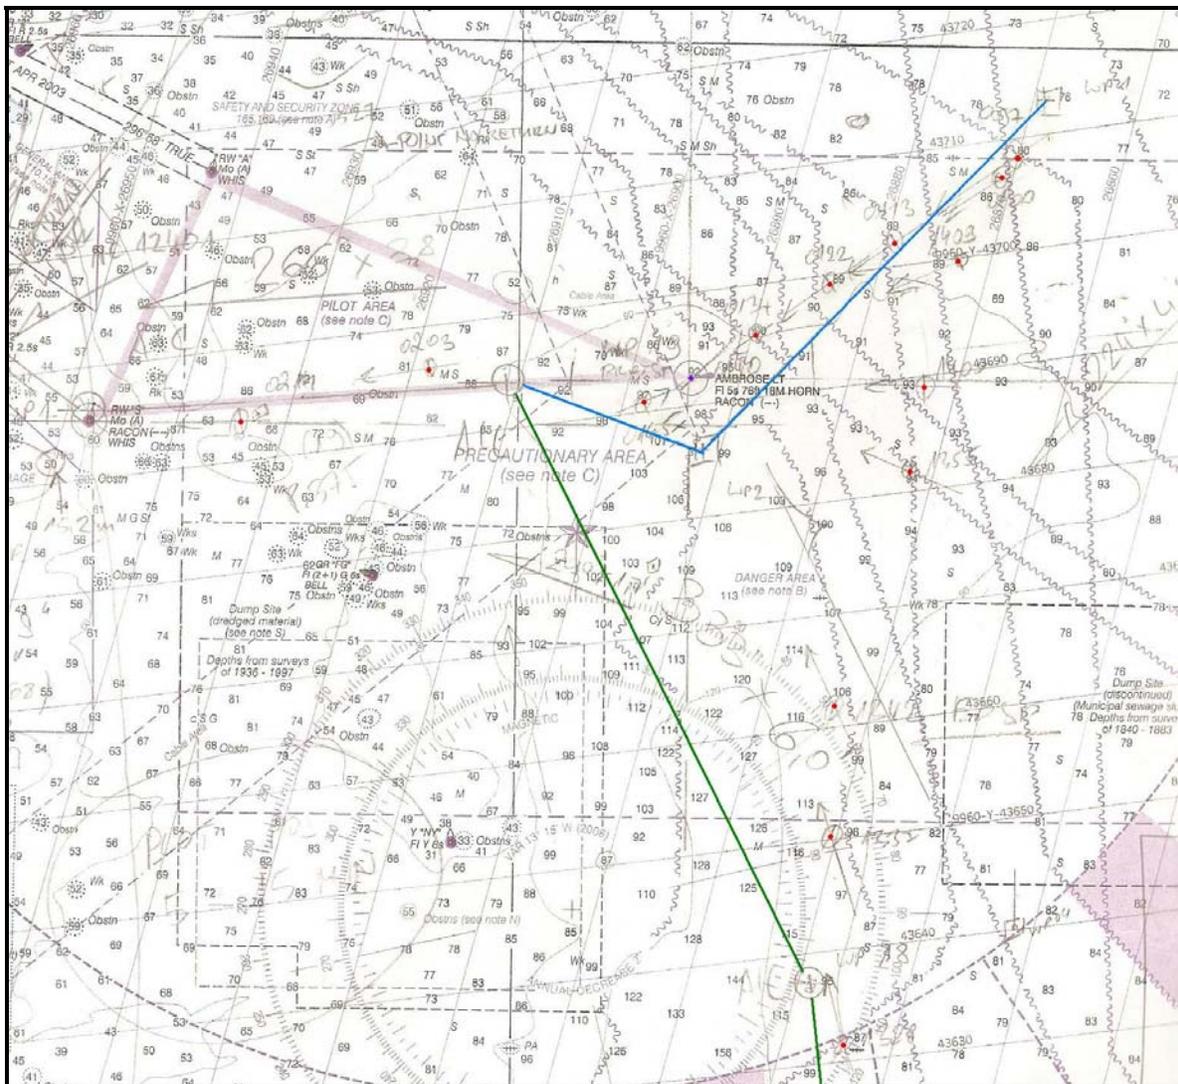
The second officer told investigators that, sometime on November 3, after the allision with Ambrose Light, he laid down a revised trackline on the paper chart for the segment from the anchorage position to the pilot boarding area (figure 10). He also generated an amended waypoint checklist, which he signed and inserted into the original passage plan. The second officer told investigators that no discussion about the original passage plan and navigational chart had taken place on the night of the accident because "there was no time to discuss" it.

Figure 10. Extract from the *Axel Spirit's* onboard navigation chart, with color enhancement added. The original intended trackline in the vessel's passage plan is overlaid in green, with waypoints 18 and 19 marked using small circles to intersect the trackline. The amended trackline that was placed on the chart by the second officer after the allision is overlaid in blue. Actual position fixes taken by the second officer on the 1200-to-1600 watch on November 2, 2007, and the 0000-to-0400 watch on November 3, 2007, are identified by a red dot. NOAA Chart 12326.
