Allision of Liberia-Registered Fruit Juice Carrier M/V *Orange Sun*  
with U.S.-Registered Dredge *New York*  
Newark Bay, New Jersey  
January 24, 2008

**Accident Report**

NTSB/MAR-09/03  
PB2009-916403

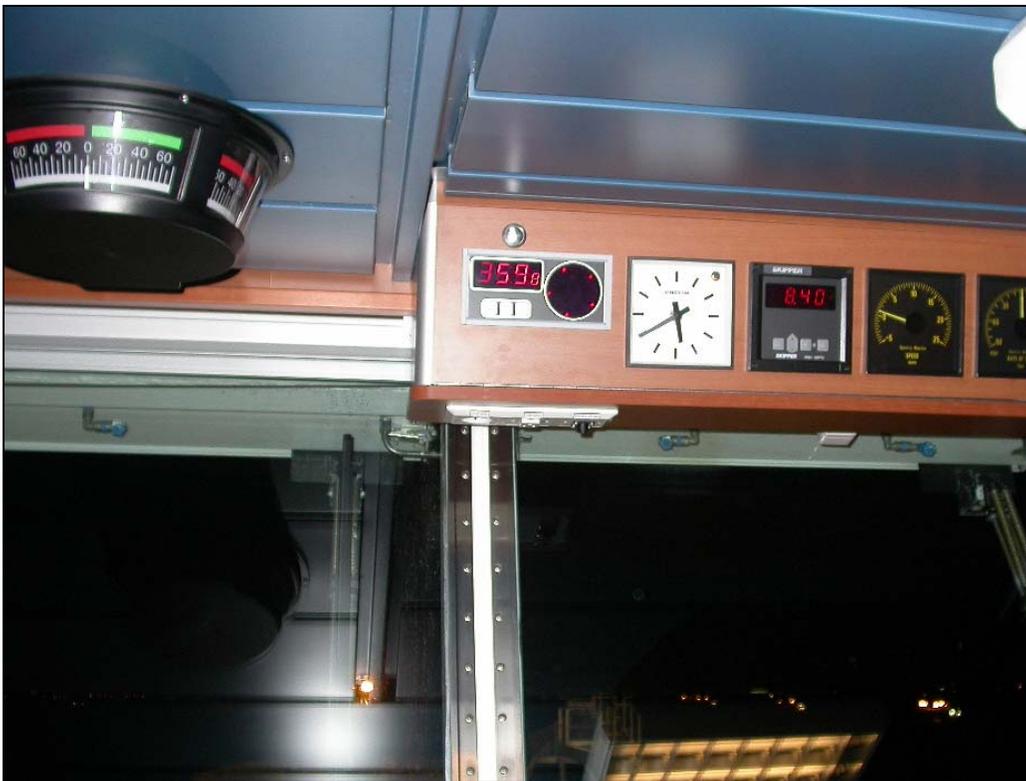
**Figure 5.** The *Orange Sun*'s rudder angle indicator, visible in the upper left corner.

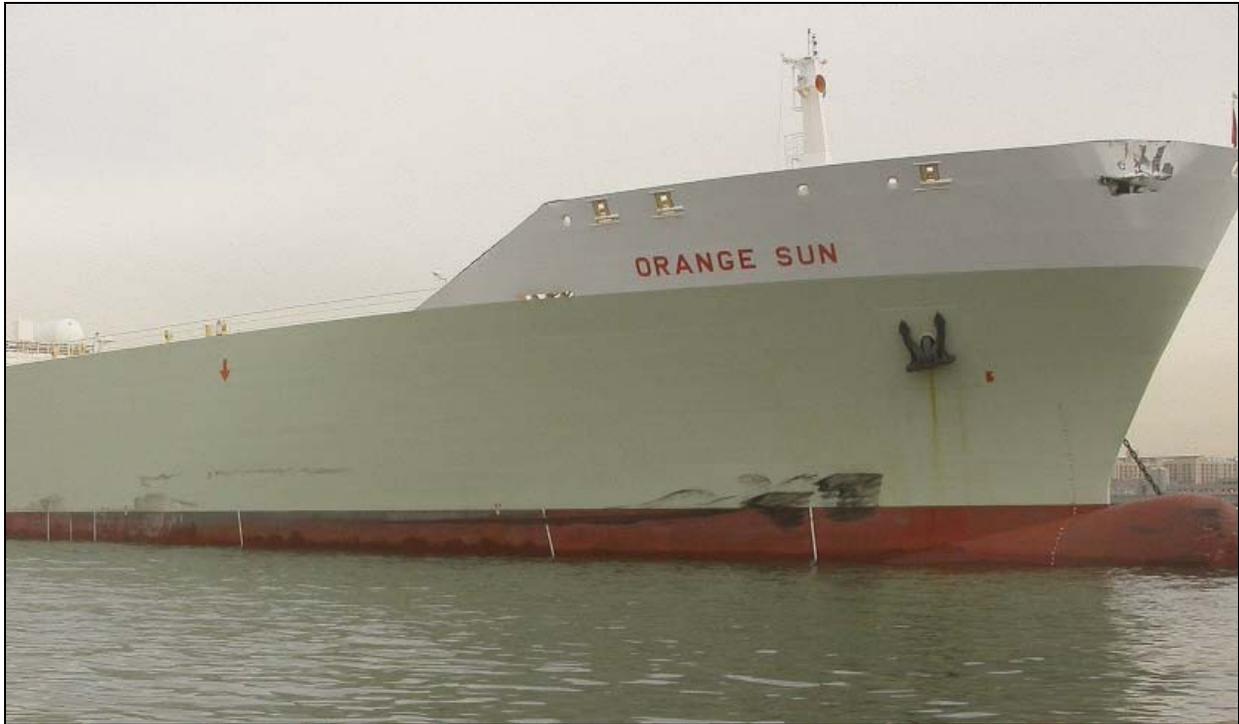
**Orange Sun.** The starboard side of the *Orange Sun* sustained moderate visible damage (figures 6 –8). The repair costs totaled about \$330,000.

**Figure 6.** Starboard-side scrapes and smudges on the *Orange Sun*.

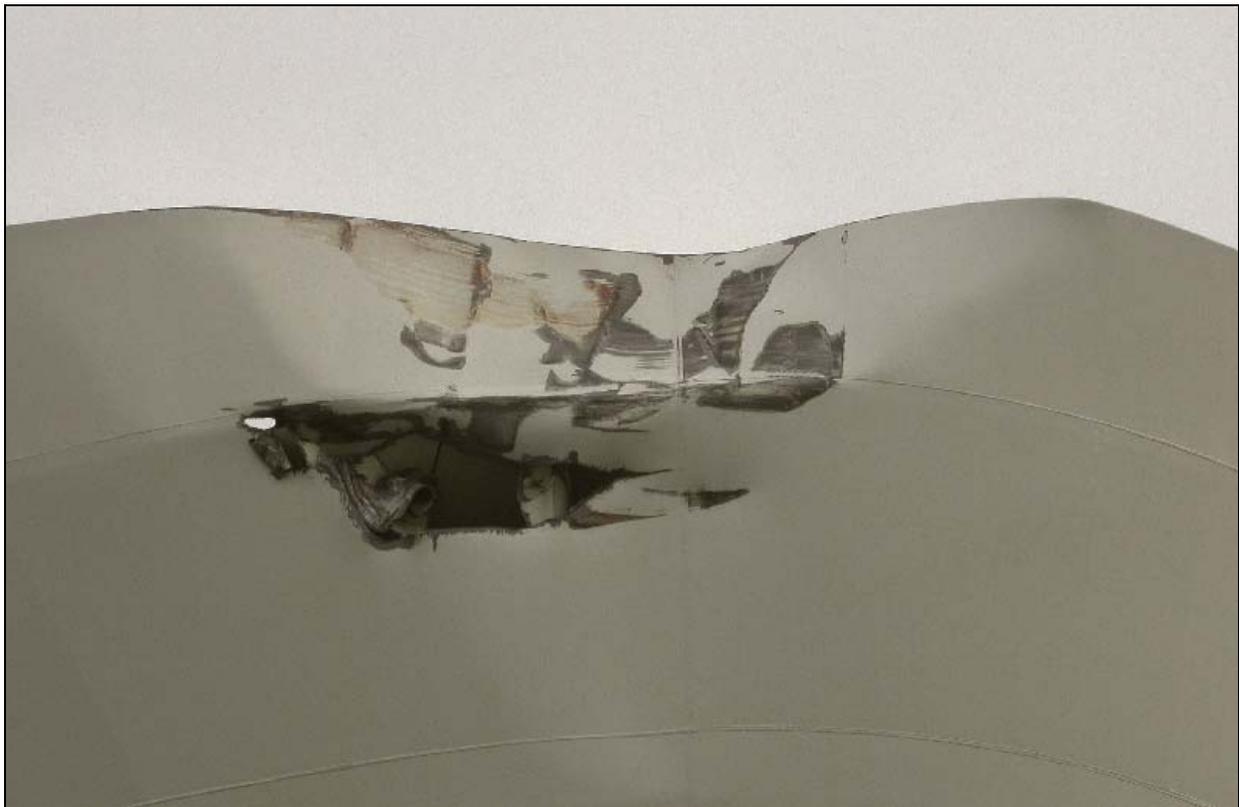
**Figure 7.** Inset, puncture, and scraping to the *Orange Sun*'s bulwark on the upper starboard-side bow.

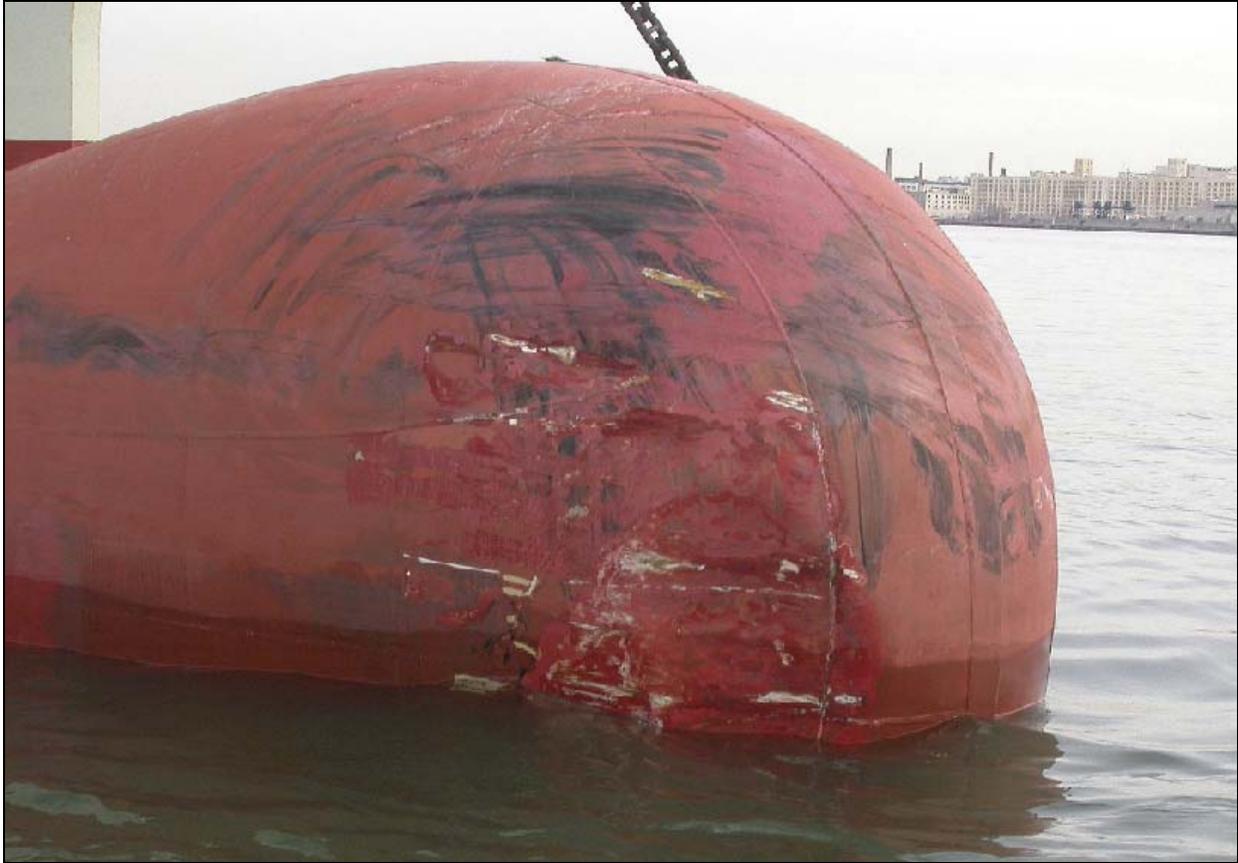
**Figure 8.** The scraped and dented bulbous bow on the *Orange Sun*.

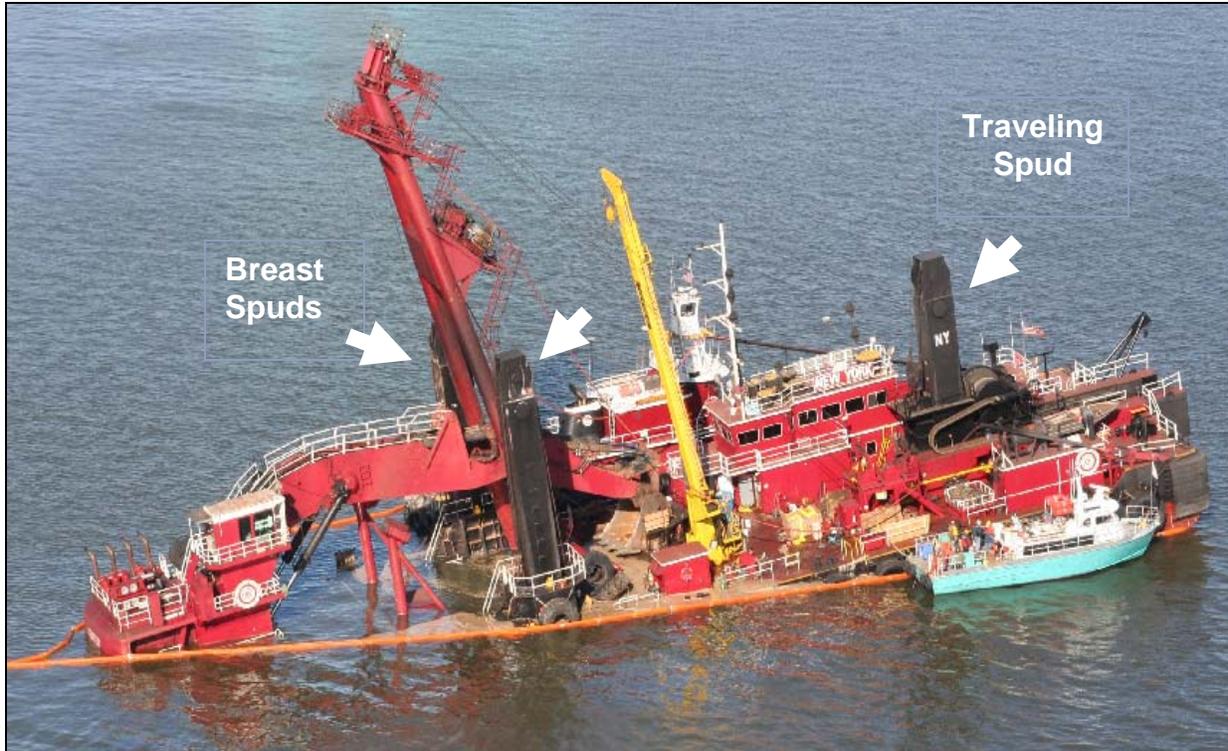
**New York.** The *New York* sustained damage to its portside hull and framing below the waterline. Flooding occurred in the winchroom, portside transformer room, the starboard-side toolroom, and centerline storeroom, in each case to near-overhead or overhead levels. The three manual watertight doors between the flooded spaces were in the open position. Machinery, transformers, controllers, and equipment in those spaces were damaged by salt water. The main excavator's large rotational base bearing was submerged and required repair.

The port breast spud could be retracted from the bay bottom. It appeared to have suffered minimal damage, although the upper portion of it probably made contact with the *Orange Sun*. The starboard breast spud was bent about 45° and needed to be cut off under water, about 39 feet from the bay bottom, to refloat and move the dredge. The aft traveling spud was slightly bent and could not be raised. Like the starboard breast spud, it had to be cut off (figure 9).

**Figure 9.** The *New York* after the allision, with its submerged bow resting on the breast spuds.

Salvage and temporary repairs were made to the *New York* before the dredge was towed to the Brooklyn Navy Yard graving dock for permanent hull repairs. The salvage work included fitting a temporary welded plate "box" over the shell opening, securing watertight doors and pumping out the vessel, and cutting off the starboard breast and aft traveling spuds. According to a Great Lakes Dredge & Dock Company official, the cost of salvage repairs and towing totaled about \$2,000,000, while the cost of drydocking and permanent repairs to steel and equipment were estimated to be an additional \$4,000,000. The dredge returned to service in August 2008.

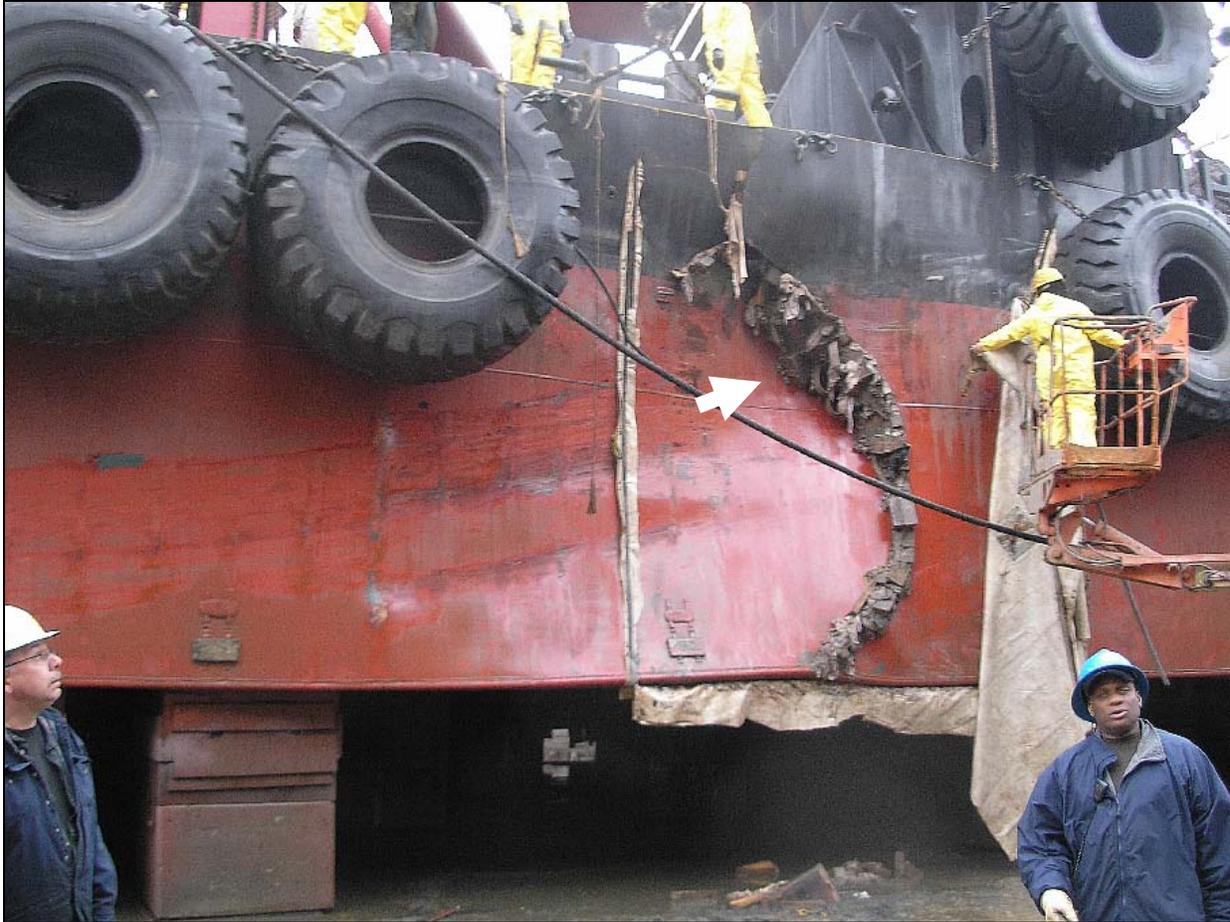
The rubber wrap-around fender and supporting structure above the waterline was also damaged, at about frame 14 at the port forward corner of the trim tank. The hull shell plating was punctured on the port side at the winchroom, with a large curved vertical tear over 1 foot wide, extending about 9 feet from the chine<sup>18</sup> to above the water line (figure 10). All of the internal web frames of the hull's plating were severed or deformed in the damaged section.

**Figure 10.** The curved tear in the portside hull of the *New York*. Photo by Great Lakes Dredge & Dock Company.

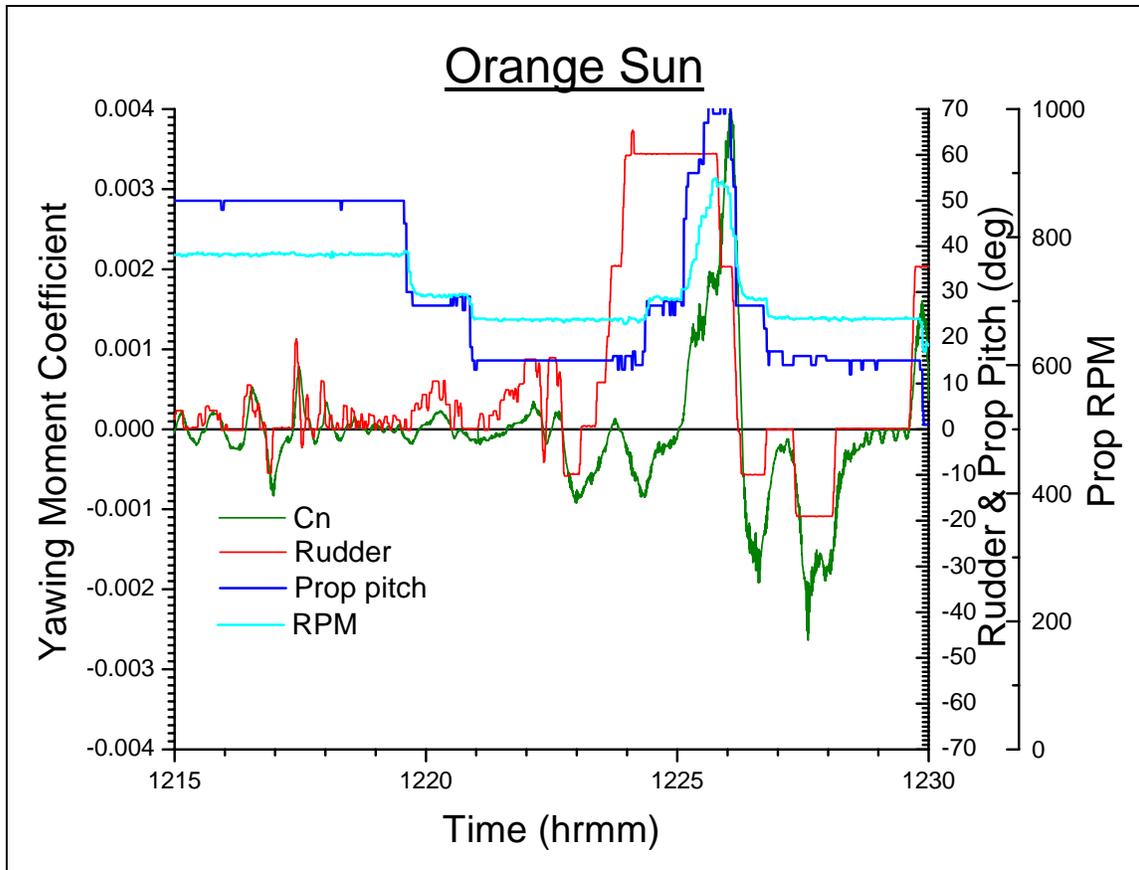
According to the *Orange Sun*'s VDR data, the reduced steering effectiveness during the inbound transit on January 19 occurred between about 1215 and 1230. Investigators analyzed the data for that timeframe, extracted the vessel's yawing moment coefficient, and plotted it the first graph. Yawing moment coefficient is a term for the representation of "force" that turns the ship, and is a function of rudder deflection, propeller pitch, and RPM. As can be seen in the graph, the vessel's turning yawing moment coefficient follows, or matches, the rudder until about 1219, when the pilot reduced the propeller pitch and RPM. From that point, as indicated in the graph, the vessel's turning yawing moment coefficient trends loosely with the rudder until about 1223, when the pilot ordered 60° of rudder. The turning yawing moment does not respond to the 60° rudder deflection until about 1225, when the propeller pitch and RPM were increased. In other words, the reduction in propeller pitch and RPM significantly reduced the effectiveness of the rudder in turning the ship. In addition, the rudder was deflected well past its stall point. Note that the yawing moment doubles about 1226, when the pilot reduced the rudder deflection from 60° to 35°. Reducing the rudder deflection to below the stall point doubled the rudder's effectiveness.

Yawing moment coefficient, rudder, and power applied during the *Orange Sun's* inbound transit on January 19, 2008, from 1215 to 1230.

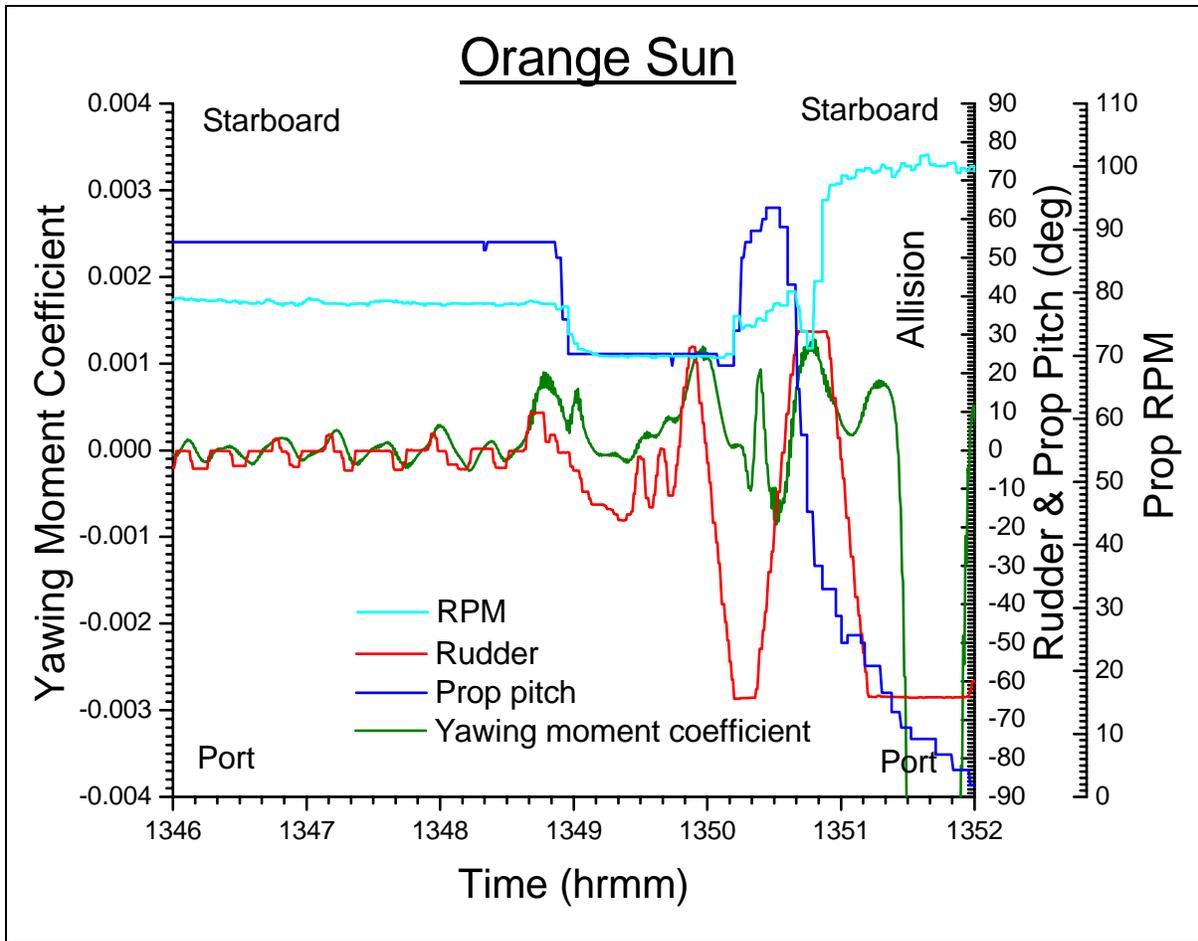
The vessel's yawing moment coefficient and rudder response, together with propeller pitch and RPM during the accident on January 24, 2008, are plotted in the next graph. The yawing moment coefficient follows, or matches, the rudder until 1345:30, when the power was reduced. At 1348:55, propeller pitch and RPM were reduced and the subsequent port rudder command was followed only by a reduction of starboard yawing moment coefficient to about zero. Yawing moment coefficient does, however, appear to follow the starboard rudder input at 1349:50. Response to the 60° port rudder about 1350 was limited although propeller pitch and RPM increased during this time period. Yawing moment coefficient initially follows the starboard 30° rudder at 1350:40, but starboard yawing moment coefficient is then reduced as the propeller pitch was reversed at 1351:30, just before the allision.

Yawing moment coefficient for the accident.
